REHABEND 2020

DAMAGE CAUSED BY THE COLLAPSE OF GYPSIFEROUS ROCK MASSES. CALLOSA D'EN SARRIÀ (SE SPAIN) CASE STUDY

DAÑOS DERIVADOS DE COLAPSOS EN MACIZOS ROCOSOS YESÍFEROS. ESTUDIO DE UN CASO EN CALLOSA D'EN SARRIÀ (SE ESPAÑA)

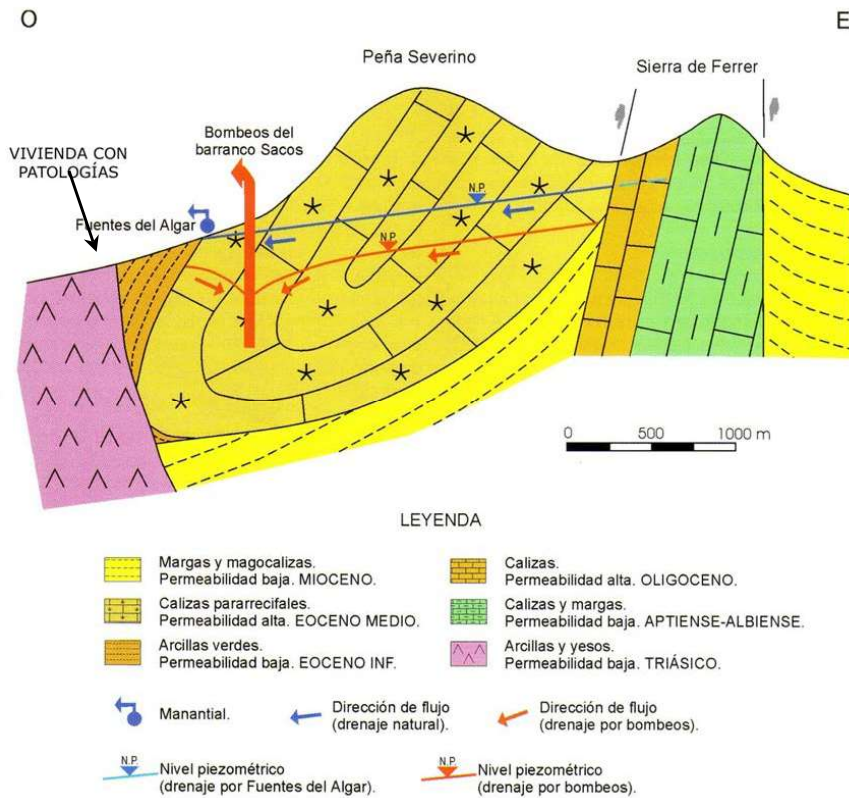
Figura 2. Corte hidrogeológico sintético del emplazamiento de los manantiales del Algar y ubicación de la vivienda afectada por patologías (modificado de [1]).

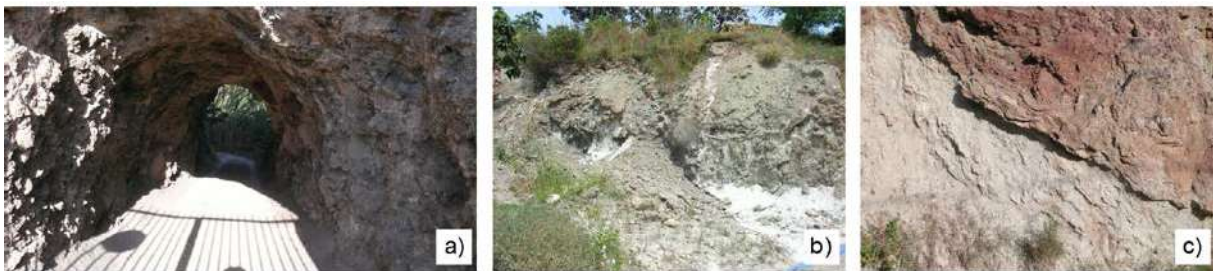
Figura 3. Afloramientos yesíferos junto a la vivienda afectada: a) Galería kárstica re trabajada artificialmente, b) Acumulaciones de sulfatos disueltos (color blanco) en un afloramiento yesífero y c) Contacto entre yesos rojizos triásicos (zona superior) y arcillas verdosas del eoceno (zona inferior).

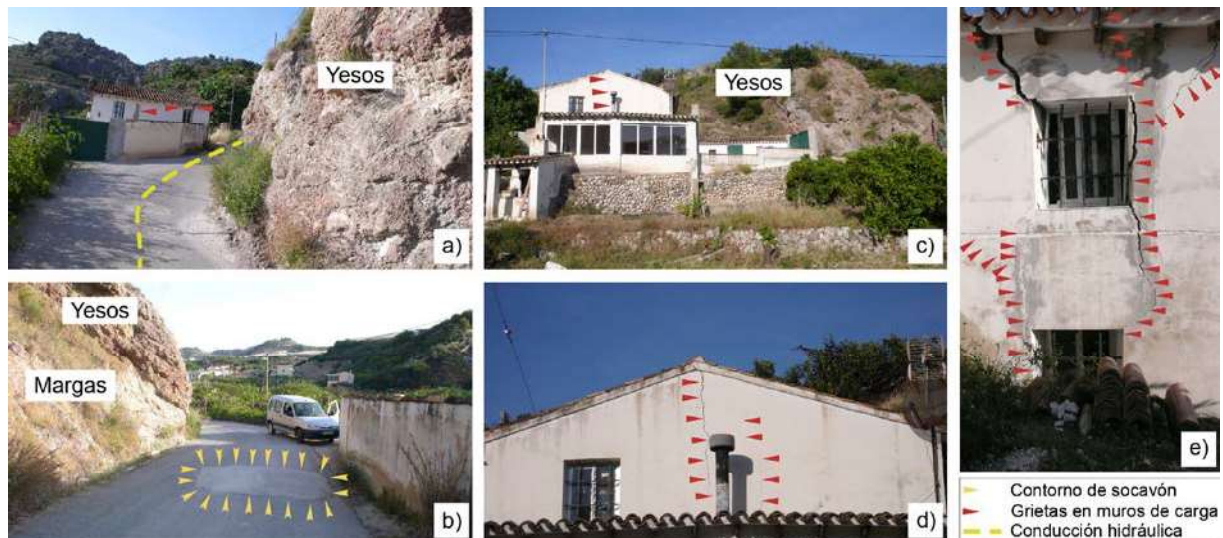
En este caso concreto, la inspección visual de la morfología de las grietas en los muros de carga (Figura 4) permite dilucidar el mecanismo que las originó, aunque no la causa. Para ello, se deben analizar otros aspectos que se tratan a continuación.

Los daños en la vivienda, visibles en forma de grietas de hasta 12 cm de apertura, son compatibles con un hundimiento parcial y súbito del terreno bajo el cimientado de los muros de carga. Por otra parte, estos daños se superponen en el tiempo con la rotura de la conducción hidráulica que transcurre por el camino junto a la edificación, lo cual puede inducir a conclusiones precipitadas si no se valoran todos los elementos ampliamente expuestos anteriormente. Sin embargo, tras la revisión del proyecto de la conducción hidráulica, se constató que tanto el diseño de la tubería como su ejecución eran las adecuadas para el caudal y presión de proyecto. Asimismo, se identificó que la forma de rotura de la tubería estaba relacionada con esfuerzos de flexión, fallando ésta a través de la junta de unión de los tubos (Figura 4).

Figura 4. Diversos aspectos sobre los daños inventariados en la construcción rural y alrededores: a) Camino de acceso a la vivienda, con indicación del trazado de la conducción y la presencia de grietas en la fachada este, b) Socavón reparado en el camino junto a la vivienda, c) y d) Vista general de la vivienda con grietas en la fachada sur y detalle de éstas, y d) Grietas de gran apertura en la fachada norte.

Según los resultados de todos los aspectos analizados, la zona se encuentra localizada sobre un karst yesífero en el que se dan todas las condiciones para que se desarrollen colapsos, lo cual, dada la calidad geomecánica del macizo y la tipología estructural de la construcción existente, permite concluir que éste es el origen de los daños.
