# Violin Ceramic Joist Slabs: Evaluation and Proposal for Intervention with Duplex-Type Stainless Steel

Antonio Salmerón <sup>1,\*</sup>, Miguel-Ángel Climent <sup>2,\*</sup>

**Citation:** Salmerón, A.; Climent, M.-Á.; Ivorra, S. Violin Ceramic Joist Slabs: Evaluation and Proposal for Intervention with Duplex-Type Stainless Steel. *Buildings* **2022**, *12*, 942. <https://doi.org/10.3390/buildings12070942>

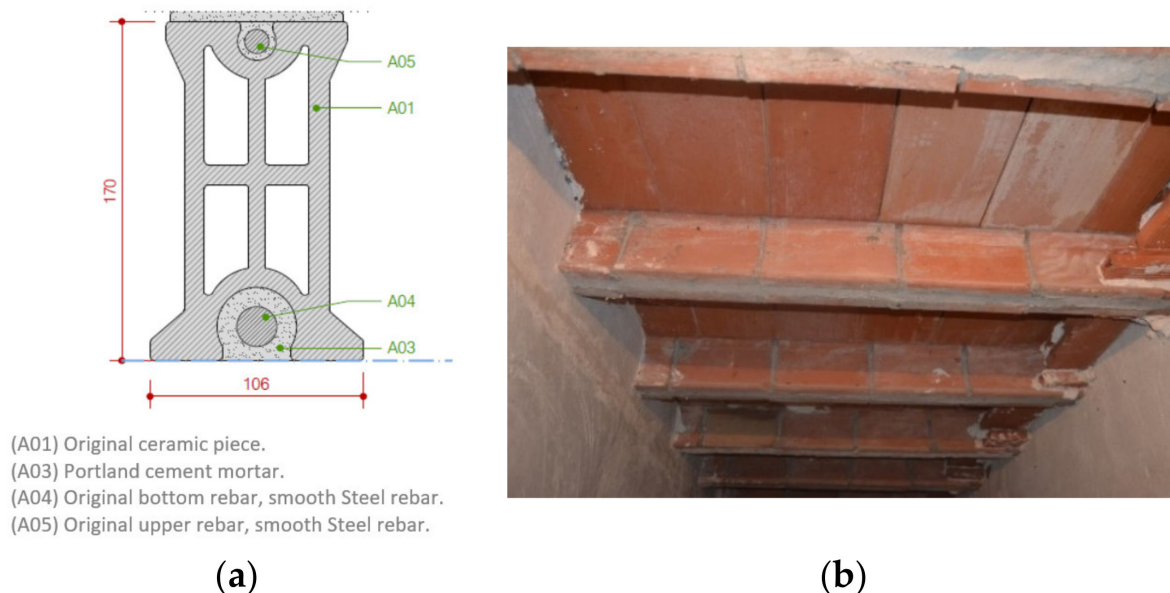
**Figure 1.** Original clay joist: (a) Detail of existing joist (mm); (b) Photo of original violin joist in storeroom.

The direct consequences of the geometric design of the ceramic joist (Figure 1a) were: firstly, protection against corrosion provided by the mortar covering layer to the steel bar was scarce [4]; and secondly, when repairing, it was physically impossible to remove all the possibly carbonated and chloride-contaminated mortar around the bar, clean the whole surface of the bar and restore its passivity [5], meaning that repairs could not have been expected to last for a long time.

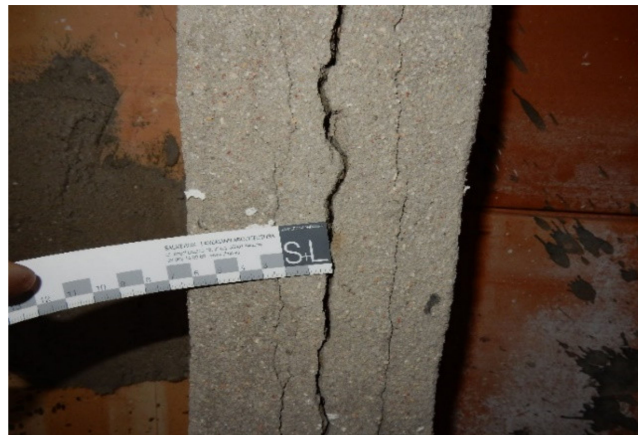
(a)

The building basement had undergone a series of previous repairs aimed at solving the corrosion problems of the lower steel rebars of the ceramic joists. Besides the original non-repaired joists, we found zones with two different types of repairs, which were distinguishable due to their different external appearance. These reparations had not succeeded in solving the problems (see Figure 4). Hence, we were faced with various degrees of

deterioration of the joists, all due to reinforcement corrosion [28], which pointed out the urgent need for an overall general intervention.

**Figure 4.** (a): Central crack on lower surface of a repaired joist. (b): A repaired joist in apparently good condition. (c): Reinforced joist with central crack. (d): Repaired joist with lateral cracks. (e): Repaired joist with badly corroded original reinforcement. (f): View of a corroded steel bar in a previously repaired joist. The exposed part of the rebar had been coated with a blue-grey passivating anti-corrosion product, but the repair was unsuccessful.

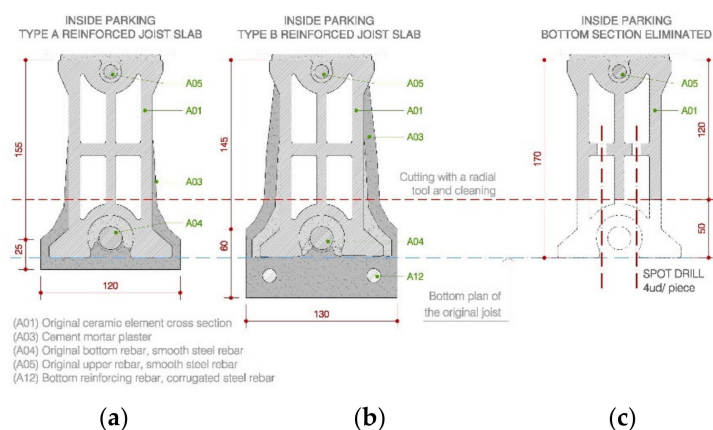
The general starting hypothesis was that if the affected part of the joist was one third of the lower section, the full functional replacement of the entire joist should be reconsidered. We therefore designed a prosthesis to replace this part without increasing its depth (see Figure 6c). Figure 6 also shows the typology of the previous (unsuccessful) reparations. Reparation type A consisted of only a partial cleaning of the corroded steel bar's surface and the application of a cement mortar (see Figure 6a), while reparation type B added two embedded corrugated carbon steel rebars (see Figure 6b).

**Figure 6.** Lower section of affected part (dimensions in mm): (a) Previous reparation type A; (b) Previous reparation type B; (c) Cut ceramic joist ready for application of the designed prosthesis, after elimination of the affected lower part of the section.

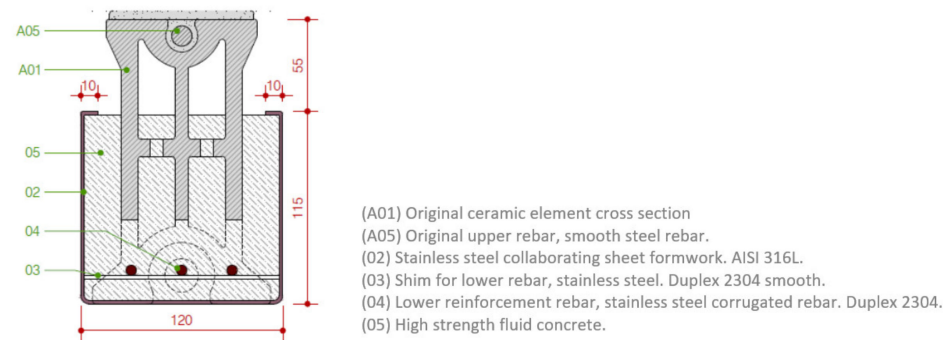
**Figure 10.** Proposed stainless steel solution (dimensions in mm).

The prosthesis was given an initial stainless-steel sheet box, with 3  $\varnothing$  6 mm internal stainless steel corrugated rebars (see Figure 10), so that the adherence between rebars and agglomerate would not be greatly affected by a thin covering, aiming to approach the conclusions reached by [36] of looking for the relation between the covering ( $r$ ) and the

steel bar diameter ( $d$ ), such that  $(r)/(d) > 4$  [36]. In addition, smooth stainless-steel rod wedges were designed for the cross section of the sheet steel box. This gave us good control of the actual thickness of the rebar covering and provided anchorage elements in addition to the frictional adherence forces.

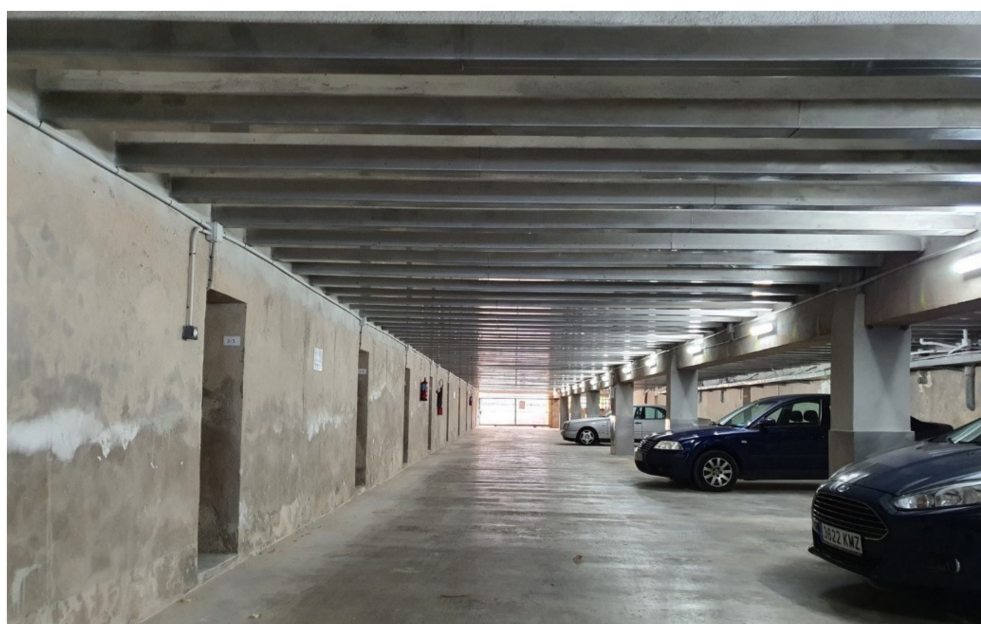
**Figure 21.** Final view of the finished repair work.

Considering the final image of the repairs in the design and structural analysis phase, the way in which construction and aesthetics collaborate in finding solutions to the problem is clearly one of the system's advantages (see Figure 21).
