**MULTITECHNICAL APPROACH FOR DAMAGE ASSESSMENT AND  
REINFORCEMENT OF BUILDINGS LOCATED ON SUBSIDING AREAS: STUDY  
CASE OF A 7-STORY RC BUILDING IN MURCIA (SE SPAIN)**

E. Díaz<sup>1</sup>, P. Robles<sup>2</sup>, R. Tomás<sup>3</sup>

The work presented herein proposes a multitechnical methodology for damage assessment and reinforcement of buildings located on areas affected by land subsidence induced by water withdrawal. The proposed methodology is illustrated by a comprehensive damage assessment and subsequent reinforcement of a 7-story reinforced concrete building located in the city of Murcia (SE Spain). Construction took place in the 1980's and the building was severely damaged by differential settlements caused by land subsidence throughout time. The building suffered an important tilting, presenting maximum settlement and tilt values of 260 and 177 mm, respectively, which considerably reduced its habitability and security conditions. Damage began to manifest in 1995, coinciding with an intense drought that affected the Murcia area between 1991 and 1995. Average piezometric level decreases of at least 8 m were verified, reaching 10 m in the nearby areas of the building. The

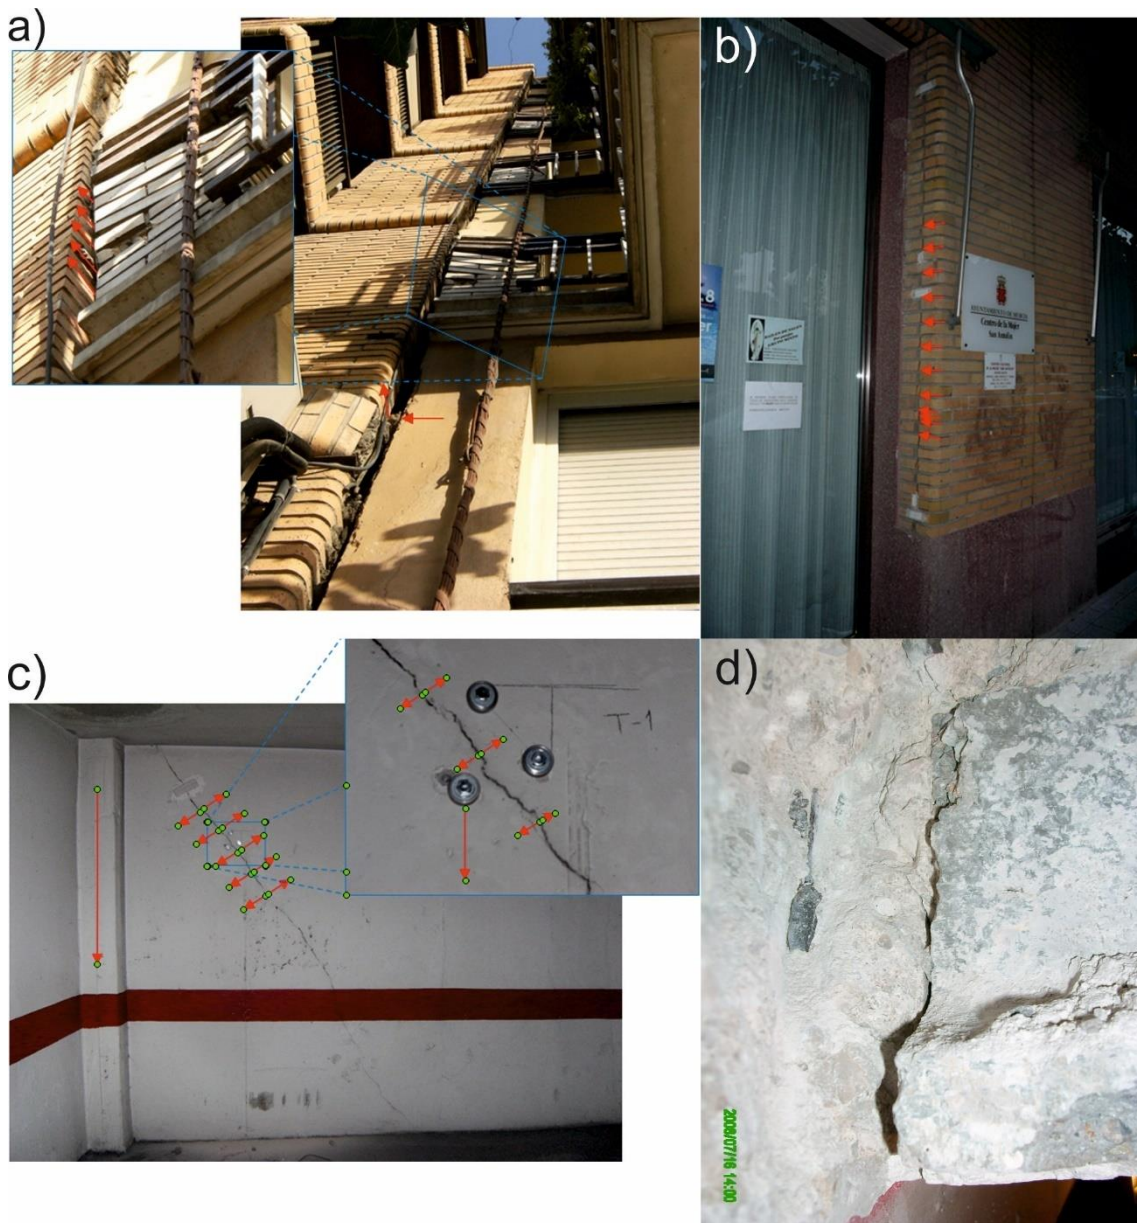
118 The tilt of the main façade is noticeable to the naked eye because, at the height of the rooftop  
119 floor, 115 and 177 mm displacements have been registered in the SW and SE directions  
120 respectively, with respect to the base. These displacements are also evident when comparing the  
121 adjacent façades vertically (Figure 2a).

124 *Figure 2. a) Details of the collapse of the study case building and of the mismatch with the adjacent building due to*  
 125 *interaction between buildings. b) Vertical cracking of façade bricks due to excessive compression stress. c) View of*  
 126 *the crack on the South end of the West wall and detail of the pins installed for crack control. d) Inspection opening on*  
 127 *the first-floor slab (code R-2), where it was verified that the semi resistant joist is suspended and therefore does not*  
 128 *fulfil its objective.*

130 Vertical cracks were verified in the façade bricks of some walls, which started at street level until  
 131 reaching the second-floor slab (Figure 2b).

134 In the basement, the walls perpendicular to the façades present 45° sloping cracks increasing in  
135 height and opening towards the main façade (Figure 2c). Still in the basement, large sections  
136 presented zigzagging cracks at the base of the first-floor slab, in the joist-beam embedment area  
137 (Figure 2d), as well as some fine rectilinear fissures (transverse lines) between the porticoes. The  
138 slab of the basement (parking) also presented generalized cracking, where longitudinal cracks can  
139 be highlighted, practically parallel to the main façade, running from one wall to the opposite,  
140 coinciding with the equidistant space between the different porticoes. Figure 3 shows a detailed  
141 map of the cracks observed in the basement. There are other less important cracks for which  
142 description is omitted due to the negligible contribution herein.

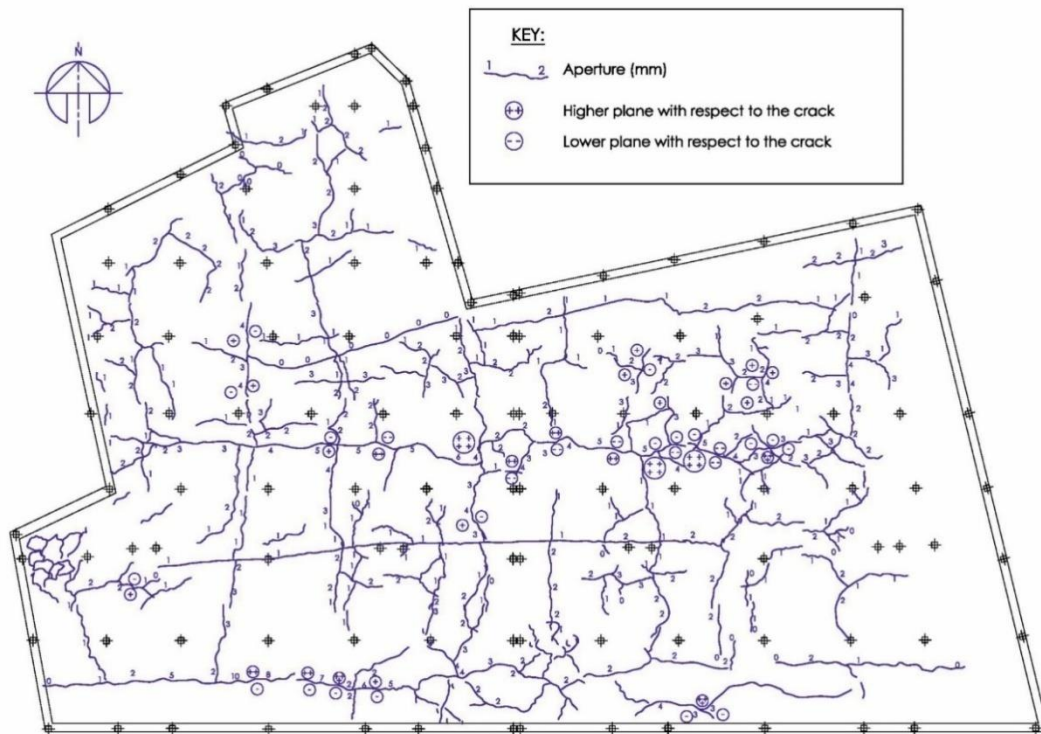
Figure 3. Map of the cracks detected on the basement floor.

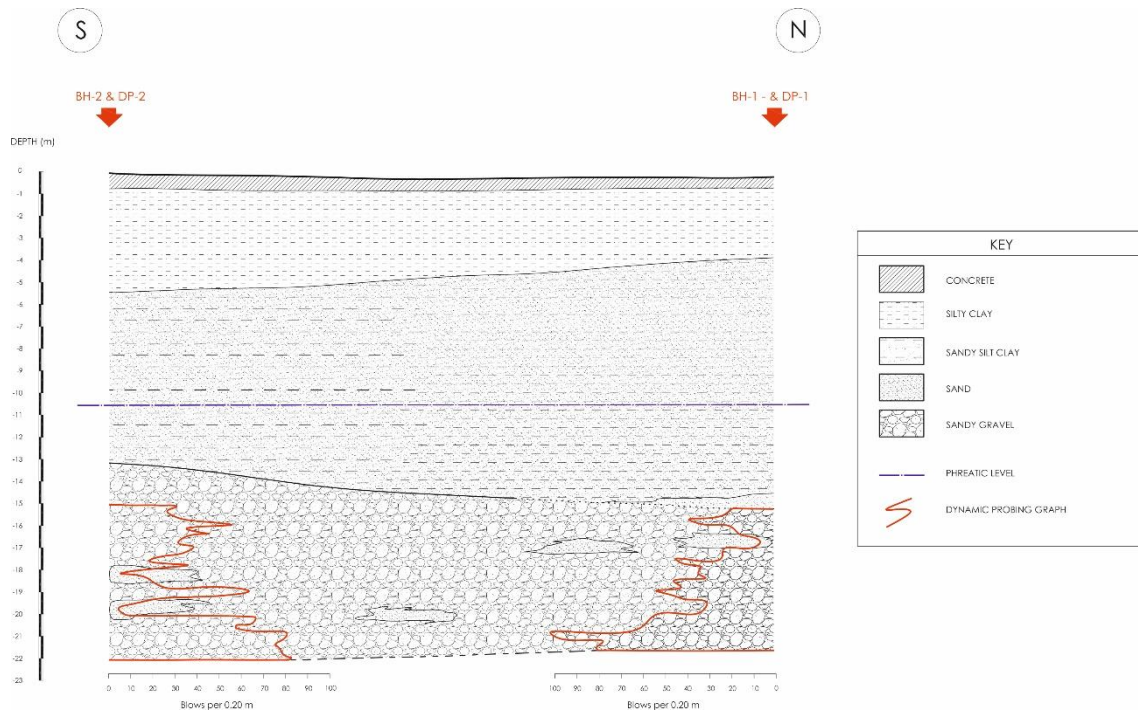
173 *Figure 4. Geotechnical profile of the subsoil under the study case building. The silty clay level presents a slight southward dip. The*  
 174 *location of boreholes is shown in Figure 1.*

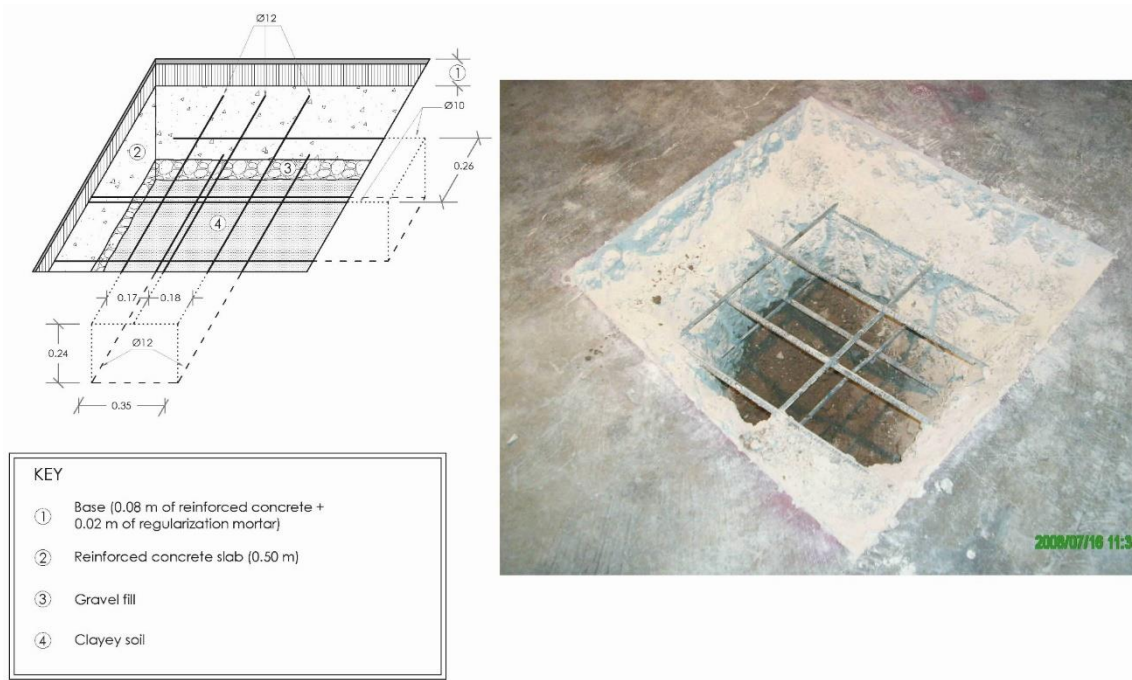
190 *Figure 5. Inspection opening performed in the slab foundation (code CC-3). See location of inspection openings in Figure 1.*

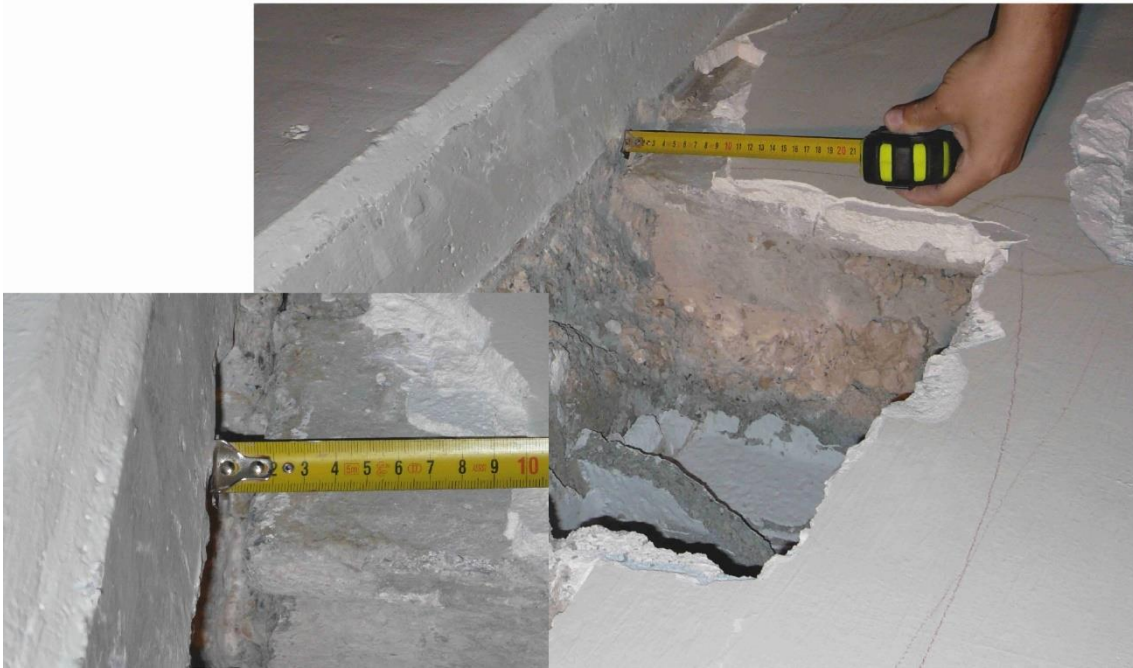
192 On the other hand, the cracks observed in the links of the joist of the first-floor slab with their  
 193 respective main beams (Figure 2d) as well as some open cracks between the floor tiles (near and  
 194 parallel to the main façade) indicate the existence of tension stresses as origin of its displacement.  
 195 Four inspection openings were made in the first-floor slab (see location in Figure 1) and it was  
 196 confirmed that the first-floor slab was built with prestressed joist. Regarding the joist-beam  
 197 embedment in the points investigated, unequal embedment measurements were obtained (shown  
 198 in Table 3). A detail of the inspection opening between pillars 89 and 90 is depicted in Figure 6.

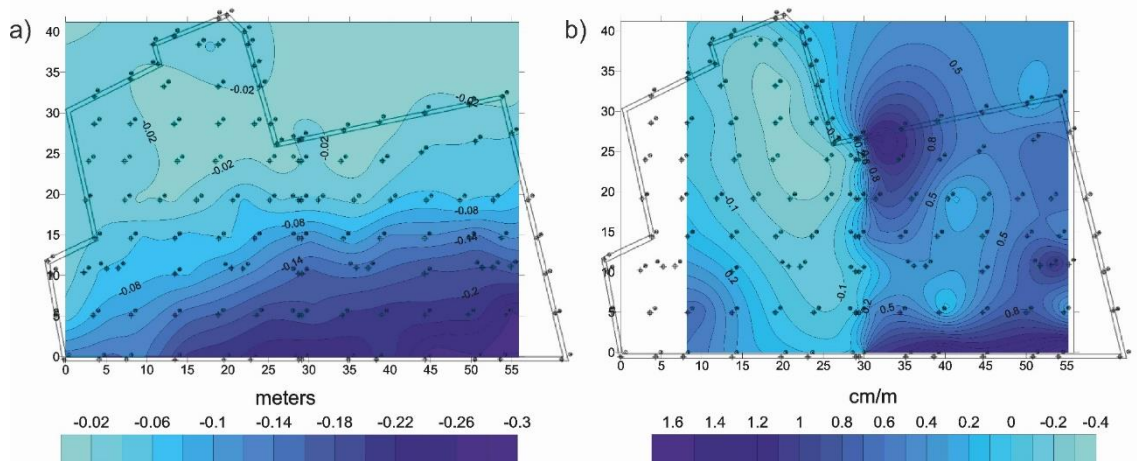
217 Precision levelling of the column bases and perimeter walls was carried out to establish the  
218 topography of the upper side of the foundation slab. These data were compared with planimetric  
219 data provided by the drawings of the project, enabling determination of the topography of the  
220 basement floor and deduction of the local descents of the analysed points. A representation of the  
221 analysis is shown in Figure 7a.

226 Tilt measurements were analysed in various elements of the structure to determine the type of  
227 turning movement and possible structural repercussions. The overall tilt of the columns in the  
228 basement floor was checked, and the results are represented in Figure 7b.

Figure 7. a) Topography of the upper side of the foundation slab. b) Tilt of columns in the basement floor.

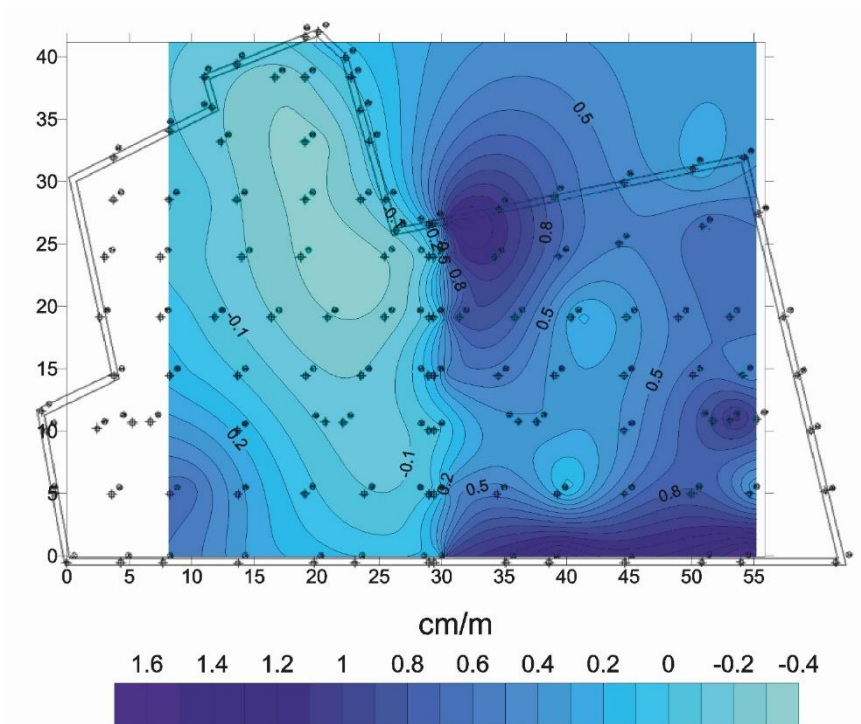
238 The structural system of the building presents porticoes parallel to the main façade (even the  
239 foundation slab is ribbed in that direction with greater height). Angular distortions were  
240 determined as the difference between the vertical displacements corresponding to contiguous  
241 columns in the direction of the frame and the separating distance. Seventy-one columns  
242 (considered as simple porticoes) were evaluated and grouped into four categories (shown in Table  
243 4). Figure 8 depicts the plant representation of the obtained values.

248 The results presented in Table 4 are congruent with the crack map of the building and it is

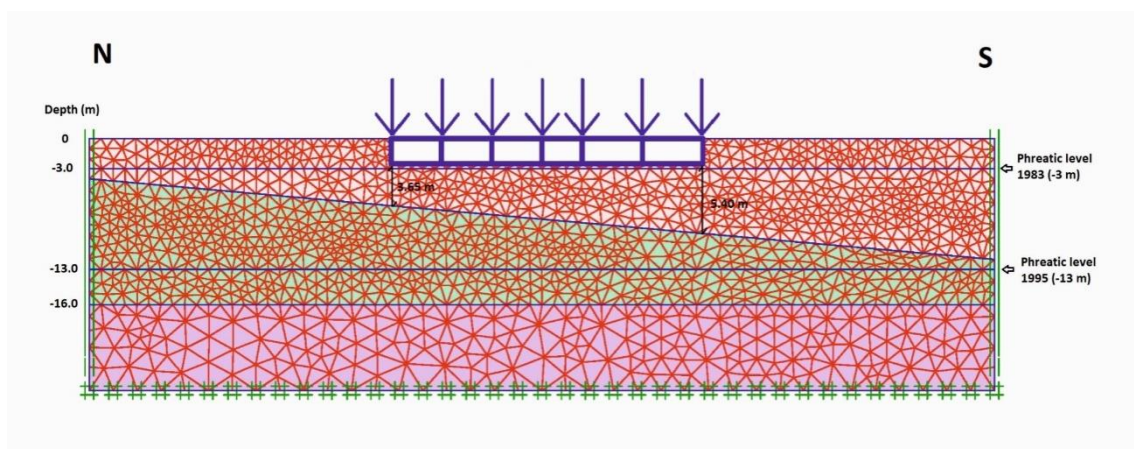
298 The obtained results provided a maximum settlement of 230.6 mm, located at the South zone of  
299 the building. This value is similar to those obtained via levelling at the upper side of the foundation  
300 slab of the building (Figure 7a), confirming the relative rotation of the building on the same

301 direction and magnitude as observed in situ. It can be concluded that the decrease of groundwater  
302 level registered across the valley was the main cause of the observed damage. Modelling of the  
303 first phase (i.e., 1983 groundwater level) did not explain the magnitude of the observed damage,  
304 although it revealed the beginning of the rotation of the building. Rotation was probably due to  
305 the concentration of stress on the area under the façade of the building, which increased the  
306 settlement of the area as the groundwater table decreased to its minimum value registered in 1995  
307 (modelled in the second phase).  
308

309  
310 *Figure 9. Finite Element Model of the studied building. The geotechnical properties of the different layers are described in detail in*  
311 *section 4.2.*

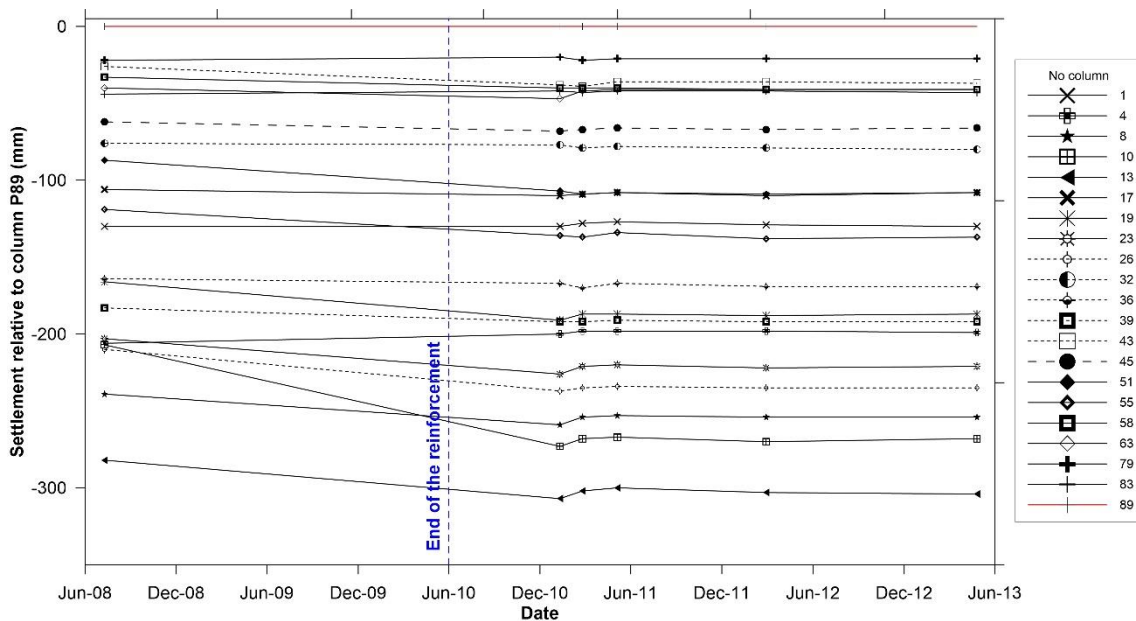
368 pattern was observed, with an average value of 2 mm (Figure 12). This order of magnitude is

373 *Figure 12. Evolution of the relative settlement of the base of the columns. The first data corresponds to July, 2008, when the*

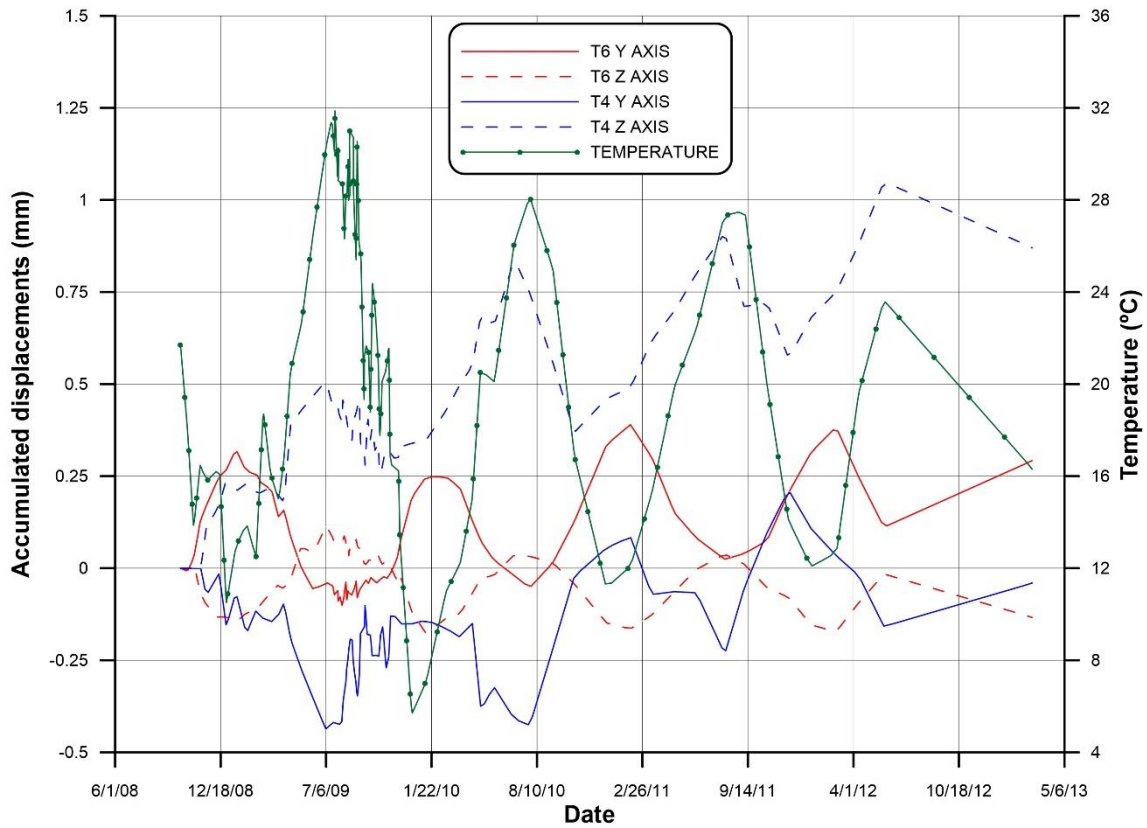
376 The crack monitors indicated the existence of oscillatory displacements that closed the fissures in

378 temperature variations, present a main horizontal component and millimetric amplitude.

382 *Figure 13. Accumulated displacements at crack monitor n° 4 (T4) and 6 (T6). Displacements along the X-axis were zero. The*  
 383 *temperature time-series has been also represented on the plot.*

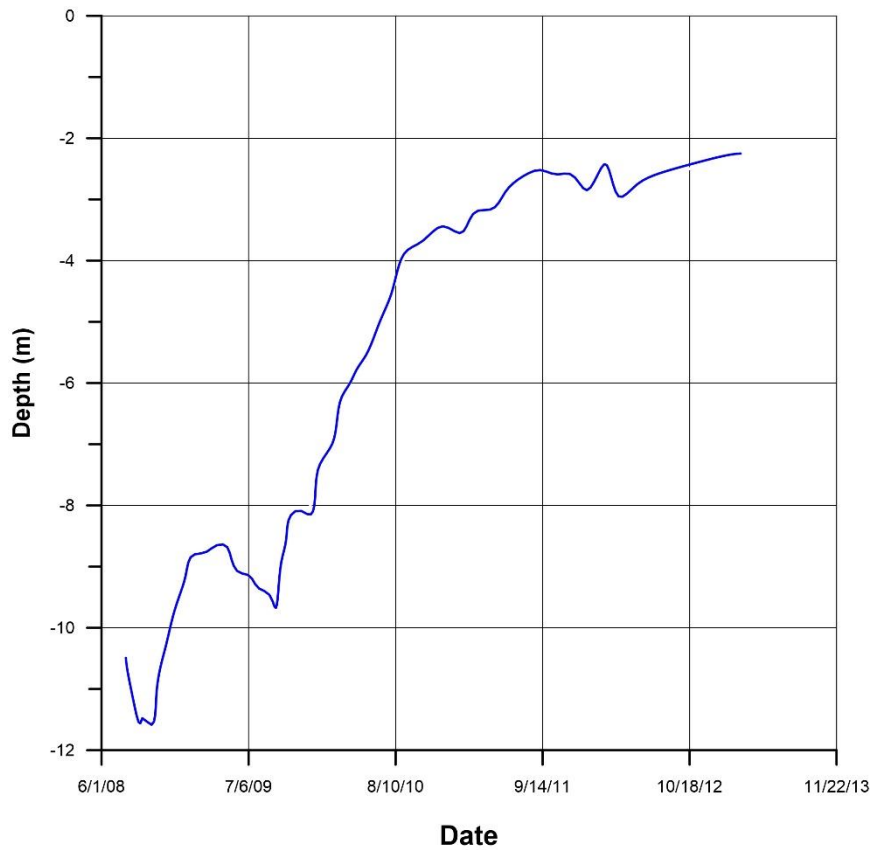
Figure 14. Time series of the groundwater level in borehole 1 (location shown in Figure 1).

394 Regarding the control of groundwater levels, analysis of the time series indicated the existence of  
 395 an asymptotic trend at -2.0 m depth, in accordance with pluviometry. Higher-than-average  
 396 precipitation caused fast groundwater level rise, over 8 m in 4.5 years (Figure 14). In September  
 397 2008 and 2009, two minimum precipitation records were reported (Figure 14), coinciding with  
 398 the respective annual dry seasons. Seasonal variations are not accidental and must be considered  
 399 at the time of designing the underpinning of the foundation, as occurred herein.
