Restoration of the facade of the church of San Pedro Apostol in Agost, Spain

This work describes the studies and the intervention carried out for the restoration of the facade of San Pedro Apostol in the parish church of Agost. This facade was made at the end of the 18th century in limestone. After an initial inspection and graphic survey of the facade, the lesions, their origin and the solution to them were identified by using advanced restoration techniques. The stone elements damaged or destroyed by the passage of time are composed of calcite, dolomite and silica, with plaster joints, and have been reconstructed either through the use of new elements or, for the most part, through systems of recovery of the initial volume with the use of a light core of polystyrene, lime mortars, expanded clay, fiberglass and carbon together with infiltrations of resins in the disintegrated areas. After a delicate intervention process using innovative techniques, the facade was completed in June 2023.

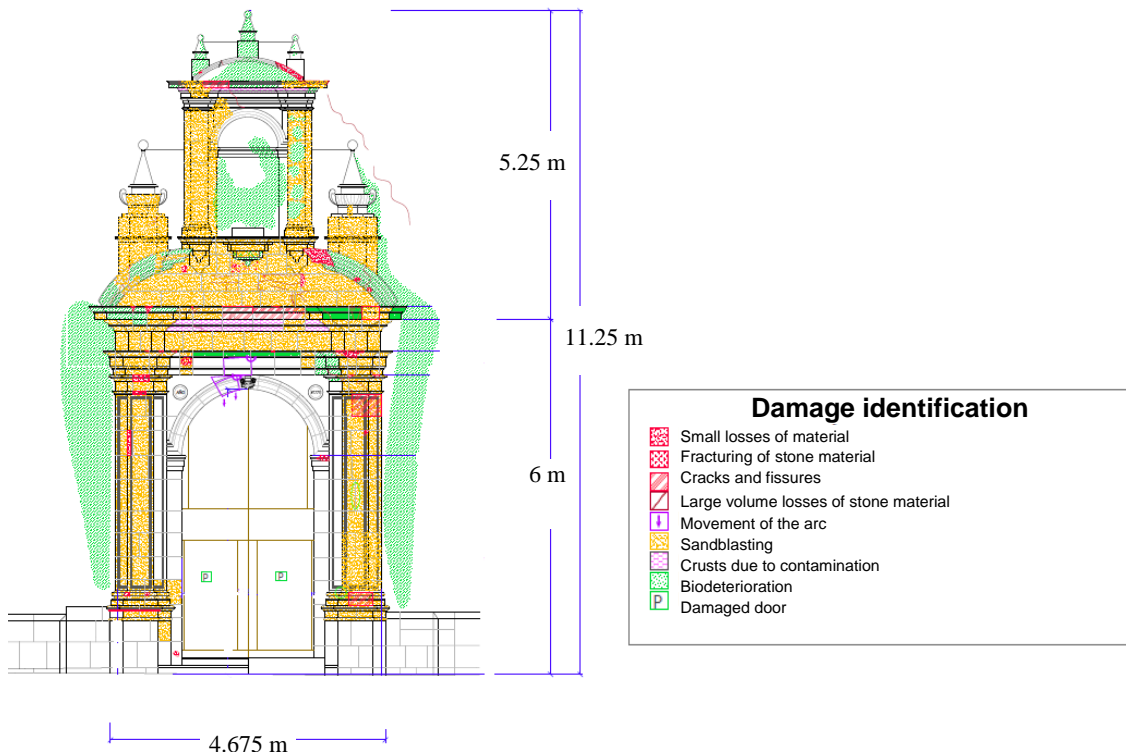
Based on the geometric information obtained, as well as the lesions observed, Figure 5 shows the situation of the doorway.

Figure 5. General geometry of the doorway. Damages observed.

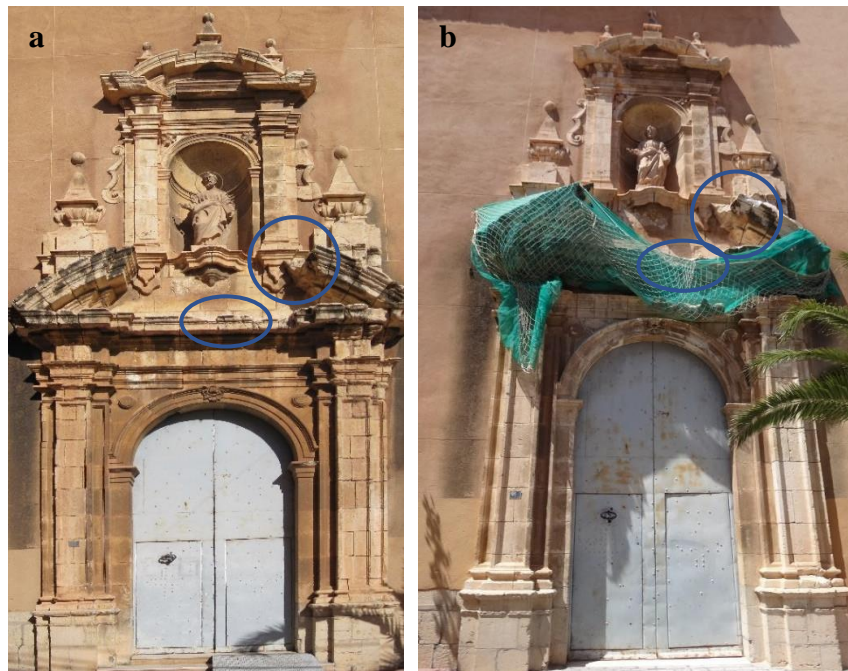
The façade of San Pedro Apóstol was much deteriorated, with stone elements missing, such as several fragments of the cornice that have come loose in recent years. If we compare the images of the façade in 2014 with those of 2021 (Figure 6), we can appreciate the increase in deterioration it has suffered. In 2014, it was recommended that protective nets be installed, as the façade was already showing a high degree of deterioration.

In January 2020, several large fragments fell off and were caught in the protective netting (Figure 6b). In other exposed areas of the portal, where water can be retained, further deterioration has also been observed.

Figure 6. a) Aspect of the doorway in 2014 (Author Javier García Galán; 2014) and b) 2021 (author Yolanda Spairani; own elaboration). The areas with the largest landslides are indicated.

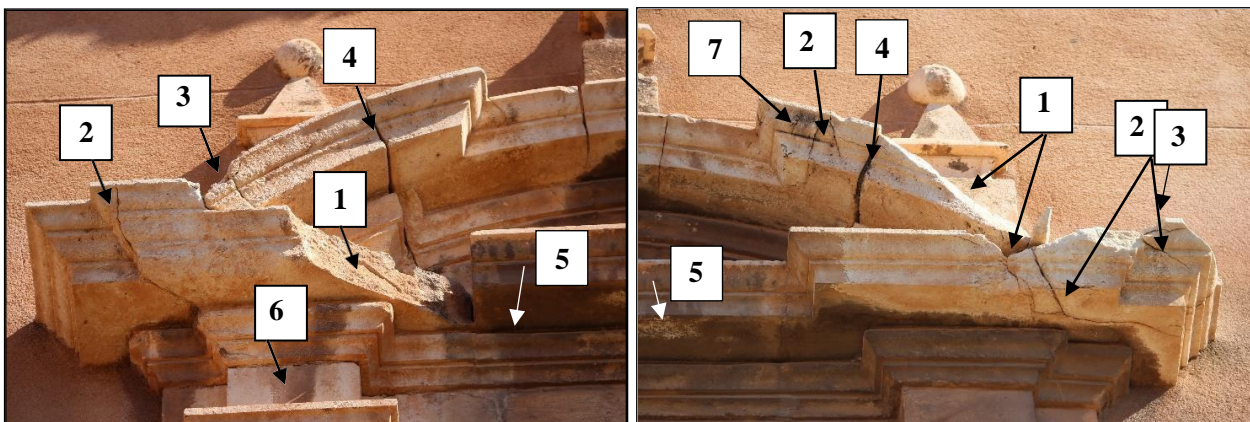
The different lesions observed on the doorway are listed below (Figure 7) in order of severity of the problem and photographs are attached to illustrate each of the different lesions:

1. Detachments of stone fragments
2. Fractures in the stone
3. Small losses of stone material.
4. Widespread loss of grouting material
5. Crusts due to contamination
6. Dirt deposits
7. Bio deterioration
8. Alteration of surface patina

Figure 7. Detail of the lesions in the upper area. Deposits of dirt can be seen in the areas protected from rain.

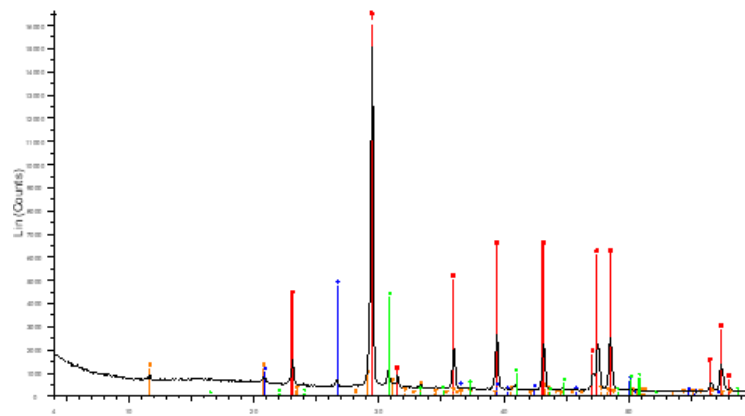
Figura 8. Diffractograms

The grout mortar, the calcarenitic stone and the grey limestone of the plinth have been analysed. The mortar was found to be gypsum as shown by the XRD results (Figures 8a and 8b). The stone is mainly composed of calcite (calcium carbonate CaCO_3), with some dolomite (Calcium magnesium carbonate $\text{CaMg}(\text{CO}_3)_2$), quartz (mineral composed of silica SiO_2) and gypsum (Calcium sulphate CaSO_4) as can be seen in the following diffractograms in their composition, where the orange peaks in the graph correspond to gypsum, limestone to red, siliceous to blue and dolomite to green.

a) Diffractogram of the mortar from the doorway of San Pedro in Agost.

b) Diffractogram of the calcarenite stone from the doorway of San Pedro in Agost.

These results indicate a significant presence of calcium sulphate (orange peaks) in existing mortars that are exposed to atmospheric agents (rainwater), and therefore its weakness and deterioration as a hygroscopic material (gains and losses of water in its molecular composition $\text{CaSO}_4 \cdot n(\text{H}_2\text{O})$) which makes it not very stable; but also this presence of sulphates can accelerate stone degradation as the stone contains the magnesium of the dolomite and very harmful salts such as magnesium sulphates can be produced (Grossi and Esbert, 1994), (Benavente, 2002, 2021). (Figure 9).

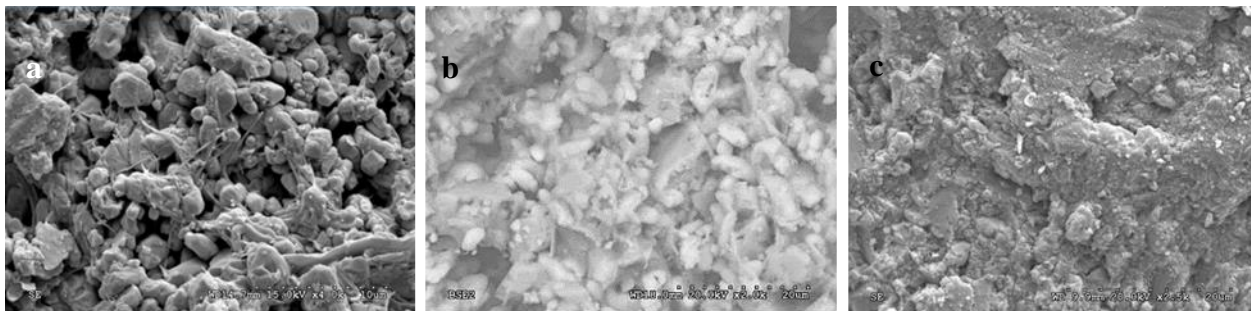
Figure 9. Microphotographs of the materials that make up the doorway of San Pedro de Agost. a) Calcarenitic stone, showing clays and abundant porosity. b) Gypsum mortar with signs of recrystallisation. c) Black limestone with occasional salts..
