Use of LiDAR Technology for the Study and Analysis of Construction Phases and Deformations in the Gothic Church of Biar (Spain)

Abstract: This work provides new data on the church of Nuestra Señora de la Asunción in Biar, combining the investigation of documentary sources with the analysis of the geometry obtained using LiDAR technology and the study of stone materials. This monument has a Proto-Renaissance façade of great architectural value, as it was the first building in the province of Alicante, in Spain, to use Renaissance decorations at the beginning of the 16th century. Its main façade reflects the four centuries of its construction from the 15th to the 18th centuries. The building has been digitised using LiDAR technology and photogrammetry. The graphic representation of the point cloud obtained from the aforementioned techniques makes it possible to study deformations in colour gradient with respect to a reference plane. The results obtained after the analysis of these data show that the method used in this work has served to detect and corroborate the constructive evolutions of the church obtained from the documentary sources investigated. This work serves as an example

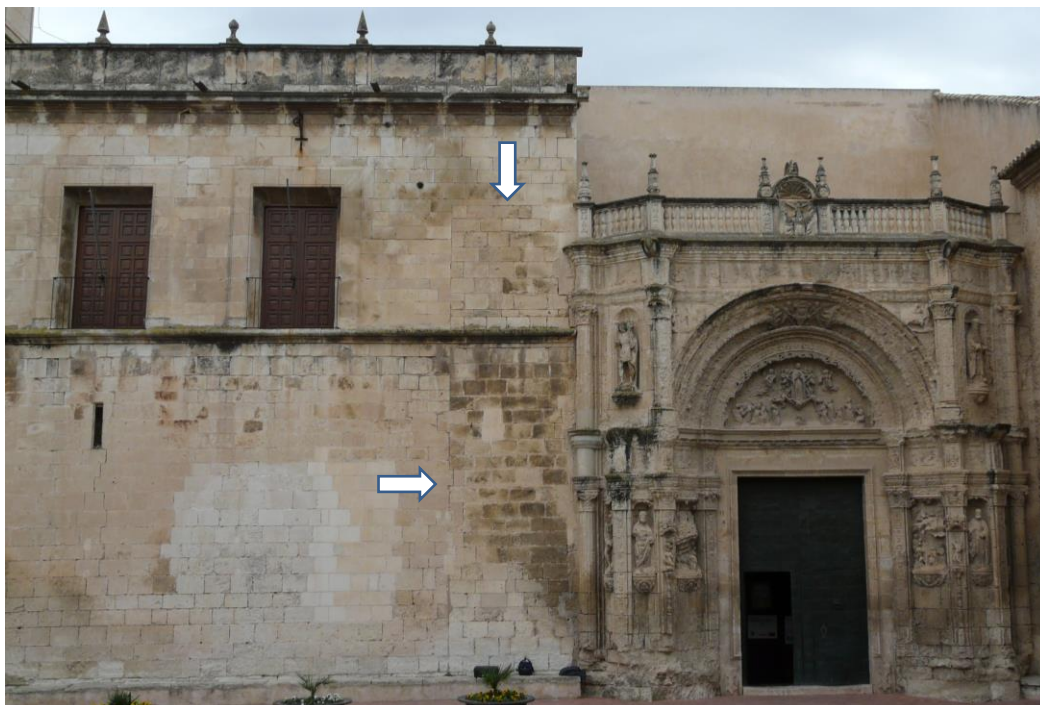
Figure 6. Northeast façade of the church.

The façade shows numerous constructive anomalies because of the sum of several masonries with different types of ashlar in terms of format and size. There are vertical and horizontal constructive joints typical of the construction of masonry in different stages of construction. This elevation of the building also shows numerous degradations due to the alteration of the stone materials of which it is composed. The areas affected by damp are the most altered. Some ashlar show a high loss of their original shape with multiple cavities, mainly due to alveolisation and sandblasting [35]. The most affected parts are the plinth in the lower part of the wall and the areas of incidence of rainwater runoff from the gargoyles on the vertical of the wall below its location (Figure 6).

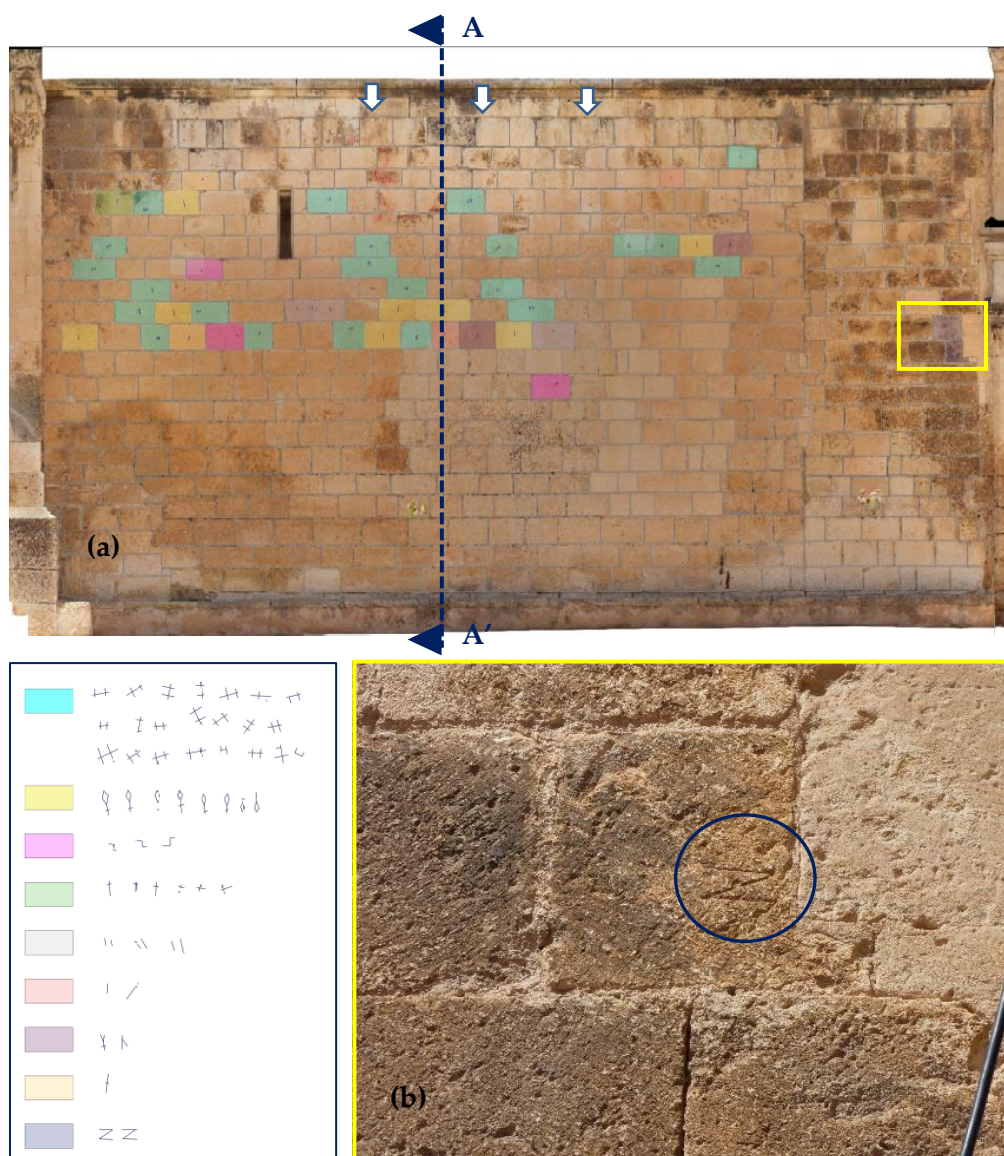
Figure 7. (a) Northeast façade of the church with ashlar coloured according to the type of stonemason marks, in the attached table. (b) Inside the circle detail of a mark that coincides with those of the Gothic church of Jávea (Alicante).

The Late Gothic façade, consisting of the walls of the old tower and the enclosure of the Gothic chapels, contains 49 stonemason marks typical of the 14th–15th centuries and which only appear in this area of the building (Figure 7). Previously, other studies had been carried out on Gothic buildings in the surrounding area, such as the church of the Assumption in Villajoyosa [35] and the church of San Bartolomé in Jávea [36], and in the latter, coincidences were found with some of the stonemason marks in the church of Biar (Figure 7b).

The ashlar of this part of the main façade were carefully observed and a row was detected, very altered with large ashlars, marked in (Figure 7a), which could have been the finishing touch of the façade of the chapels from the end of the 15th century until the 18th century, when the upper floor was built.

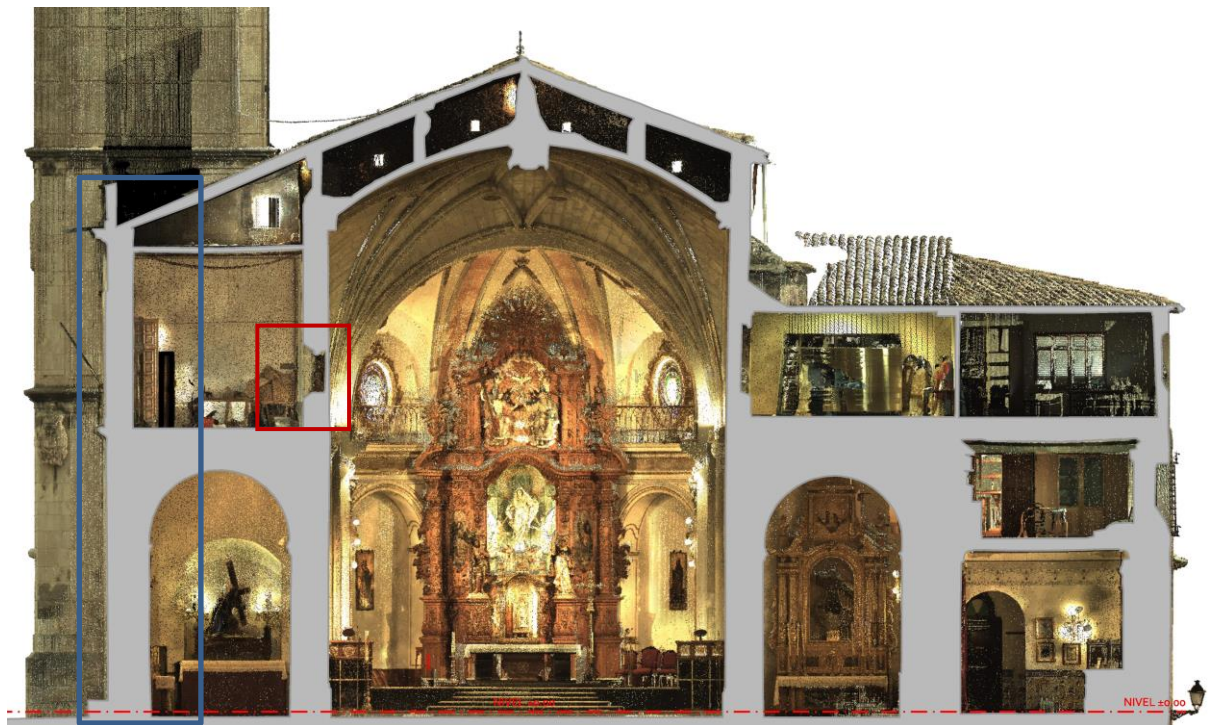
Figure 8. Church section, indicated in Figure 7a and 9c. The northeast façade under study is located inside the blue box. The Gothic rose window is located inside the red box.

There is a Gothic rose window (highlighted in red in Figure 8) which does not currently bring light into the interior of the church, as it is partitioned off and faces the chapter house. Originally, this circular window would have been located in a wall to the outside.

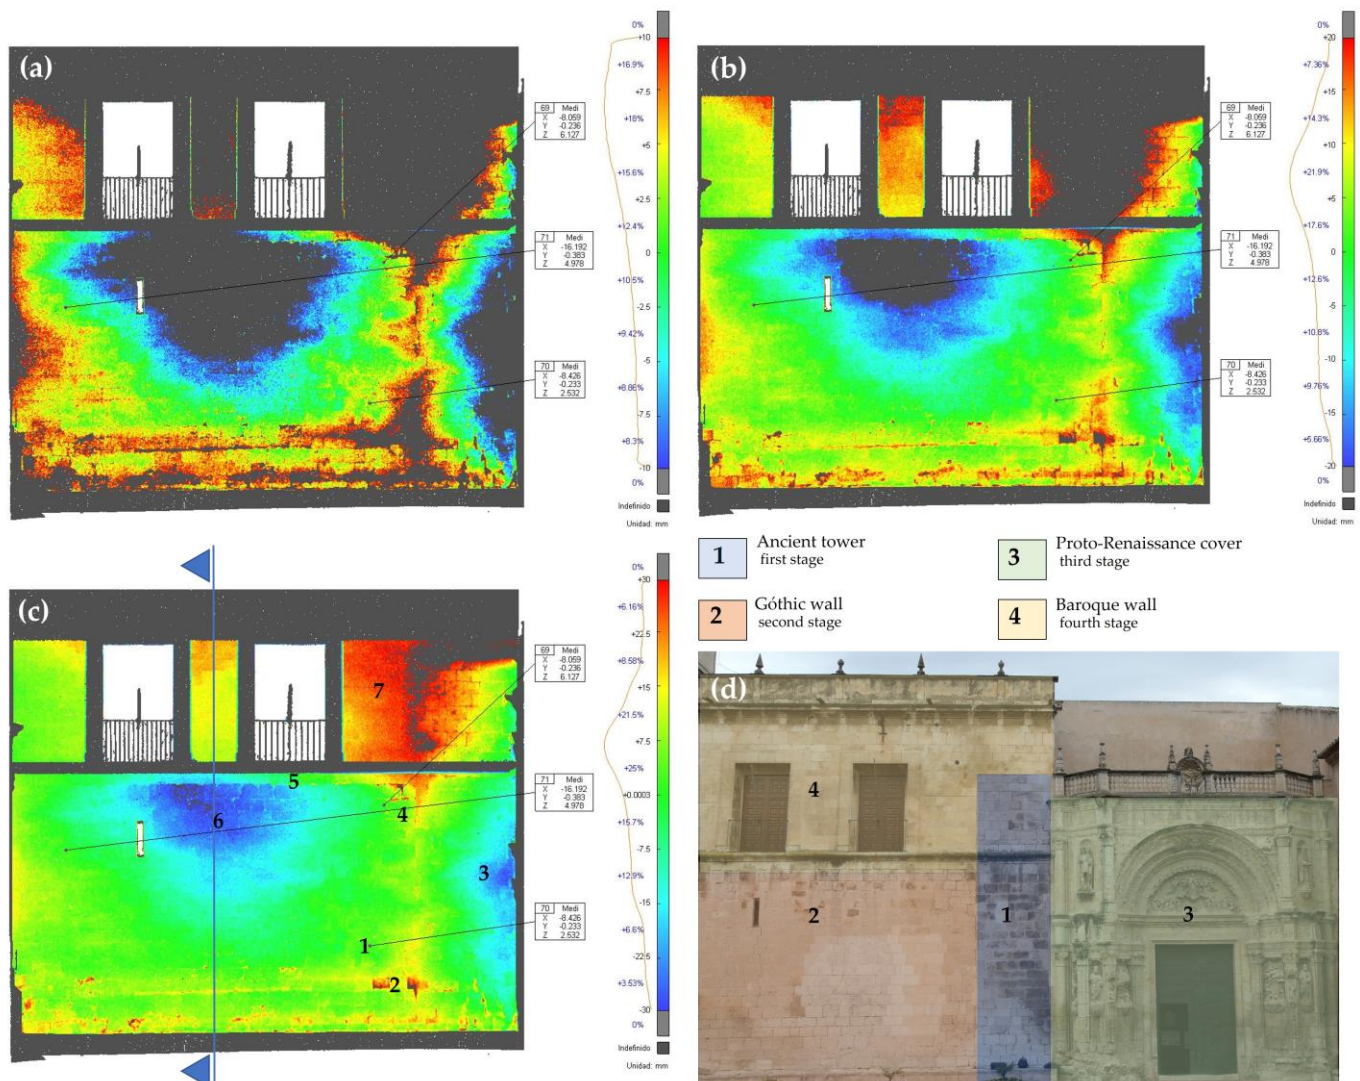
In the different images in Figure 9, the three points numbered “69, 70 and 71” that form the reference plane are indicated with their coordinates. The green points coincide with the plane. The red and blue colours indicate the distance from the reference plane (red towards the inside of the building and blue towards the outside). Surveys were carried out with three different ranges from (+10 mm) to (−10 mm) away from the plane

(Figure 9a), (+20 mm) to (−20 mm) away from the plane (Figure 9b) and (+30 mm) to (−30 mm) away from the plane (Figure 9c).

The areas shown in black in the figures are located outside the study range. If the part closest to the black area has red borders, it means that the black area is behind the reference plane. If the black area has blue borders, the black part is outside the building and ahead of the reference plane, e.g., the part indicated as “6” in Figure 9c.

It has been observed that the central area of the façade protrudes outwards by more than 3 cm. This part coincides with the horizontal thrust of the arch between the chapels that absorbs the loads of the vaults and transmits them to the wall, indicated as “6” in Figure 9c.

The row of ashlar below the current intermediate cornice, indicated as “5” in Figure 9c, is not built on the same plane as the lower masonry and corresponds to the Gothic façade. In addition, the row of ashlar just below shows much greater degradation, as indicated above. This could indicate that the Late Gothic masonry was finished off in the

deteriorated course with larger ashlar and therefore the Baroque masonry begins in the course indicated as “5”.

The plane that forms the façade of the original tower shows similar gradients of colours in vertical strips, which indicates that it is rotated with respect to the reference plane. The alignment of the plane of the chapel enclosure does not coincide exactly with the alignment of the former tower’s masonry, although it may appear so to the naked eye.

In the upper part of the old tower, coinciding with the wall that was rebuilt in the Baroque period, there are deformations in deep red (indicated as “7” in Figure 9c) and black areas, indicating that there are parts of this wall that go into the interior of the building with respect to the reference plane.

As for the degradations of the walls, the lower part of the façade shows multiple anomalies, as well as the encounter with the masonry belonging to the original tower, indicated as “2 and 4” in Figure 9c.

From the analysis of the geometric anomalies obtained using 3D LiDAR, it can be seen that the plane that forms the façade of the Gothic chapels is mostly green in colour, which belongs to the plane of the façade, but there are areas that appear in black, indicating that they are located outside the range of the study carried out, which goes from (+30 mm) to (-30 mm). Most likely, the deformations were produced by the thrusts of the interior vaults.

The reference plane (the façade of the chapels) does not coincide exactly with the plane of the tower masonry, as the tower is slightly rotated (+30 mm). There is an obvious interface between the original tower and the Gothic wall. In Figure 9a–c, there is a very marked vertical strip coinciding with this construction joint between elements.

The row of large ashlar, located under the one indicated as “5” in Figure 9c and which is highly degraded, must have finished off the Late Gothic façade completed in the

Regarding the degradations, as we have seen in Section 3, the materials used in the construction of this façade are very porous and mainly of a limestone nature. The lower part of the wall shows multiple areas of red or black colour in the study of colour gradients, depending on the distance from the reference plane. This indicates distances greater than 3 cm from the reference plane. In Figure 9c, the area affected by the effects of capillary rising damp has been indicated as “2”.

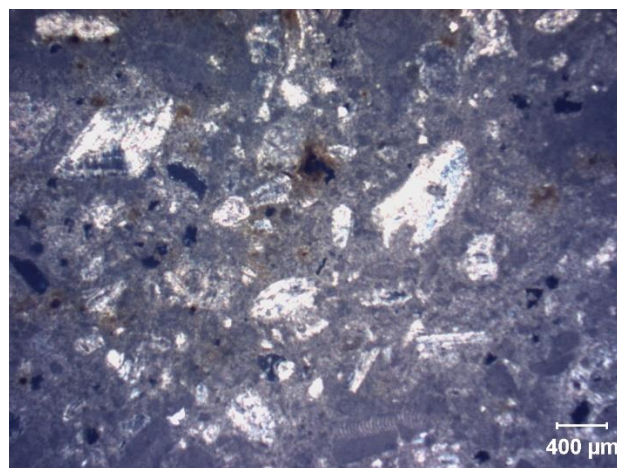
It is a white fine-grained biocalcarene with high matrix content (biomicrite limestone). Fossil content corresponds to foraminifera and fragments of shells and echinoderm plates (according to POM observations) (Figure 10). Terrigenous content is low (< 3%) and corresponds mainly to quartz, with trace contents of feldspar, opaque (dendritic structures) and clay minerals. According to XRD analysis, the mineralogical composition of this rock consisted of 95% calcite and 5% quartz.

Figure 10. Photomicrographs of the tower wall sample (Polarized Optical Microscope with crossed nicols). Biomicrite limestone.

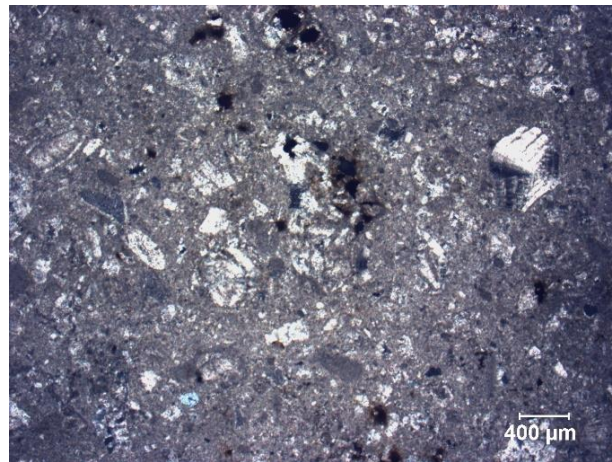
It corresponds to a white limestone similar to the rock used in the tower (fine-grained biocalcarene, biomicrite) (Figure 11). The fossils are foraminifera, mainly globigerinids, some fragments of bryozoans and mollusks. Small discontinuous venules of sparite are observed. Terrigenous content is low, corresponding mainly to quartz, opaque minerals and iron oxides. Other accessory minerals observed under SEM were apatite, zircon,

ilmenite and titanite. According to XRD analysis, the mineralogical composition of this stone consisted of 96% calcite and 4% quartz.

Figure 11. Photomicrographs of the central wall façade sample (Polarized Optical Microscope with crossed nicols). Biomicrite limestone.

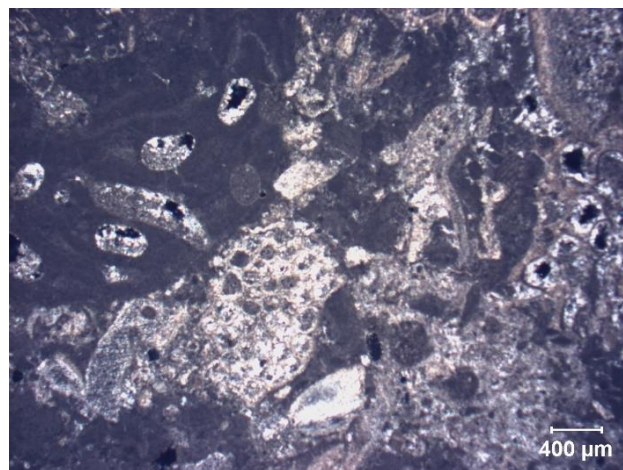
According to the observation carried out at POM, it is a fossiliferous limestone with high matrix content (biomicrite) and a certain reef character (colonies of red algae and bryozoans). It has abundant intraparticle porosity mainly associated with bryozoan components (Figure 12). Pores appear partially filled with a druse calcite cement (sparite). According to XRD analysis, the mineralogical composition of this rock consisted of 94% calcite, 3% quartz and 3% microcline.

Figure 12. Photomicrographs Proto-Renaissance doorway sample (Polarized Optical Microscope with crossed nicols). Fossiliferous limestone.

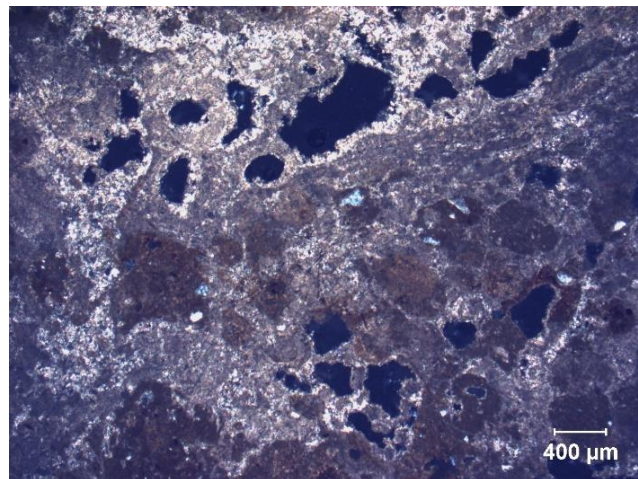
This rock corresponds to a white limestone with greyish and reddish chromatic variations. Terrigenous content is high (around 10%), corresponding mainly to quartz, opaque minerals and glauconite. The fossiliferous content corresponds to bryozoans, foraminifera and limeclasts (Figure 13). According to XRD analysis, the mineralogical composition of this stone consisted of 94% calcite and 6% quartz.

Figure 13. Photomicrographs at top wall façade sample (Polarized Optical Microscope with crossed nicols). Fossiliferous limestone.
