THE SOCIAL CLUB OF THE MANZANERA IN CALPE, ALICANTE (SPAIN) (WORK OF RICARDO BOFILL). STUDY OF THE ALTERATION OF HIS MATERIALS

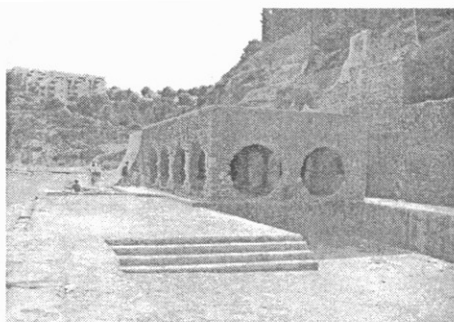
F1. General sight of the Social Club

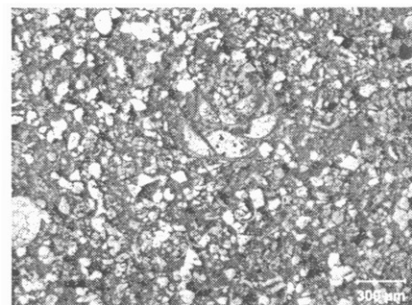
All the stony materials of the social club of the manzanera, Calpe, can come from the same area of quarry, since it would be the proper cliff where it is located, although for the content in detrital components his classification changes from a fossiliferous limestone (Biomicrite as Folk), to the sandy biocalcarens, being able to speak even about sandy limestones (F2). It is normal if there is born in mind the heterogeneity of materials that can be observed in the front of the cliff. In the optical microscope image is possible to see the texture of one of the observed samples.

F2. Optical microscope image of the sandy fossiliferous limestone.

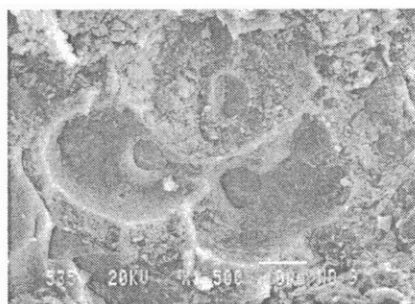
Observed to the S.E.M. (F3 and F4) the materials, both stone and mortar, show clearly the action of you goes out marine, with attack of chlorides for dissolution in the whole surface.

They appreciate abundant microfissures and intraparticle porosity.

F3. SEM image of the sandy limestone.

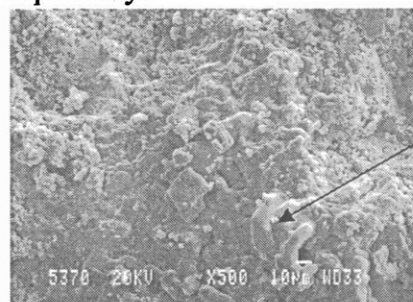
F4. SEM image of the stone surface showing sodium chloride.

- The cleanliness with papetas will be applied for the extraction of you works out soluble. In the zones affected by saline efflorescences one will proceed, after the cleanliness, to the application of an inhibitor of efflorescences type Tecosel or similar, applied to two hands by means of nebulizador on the stone.

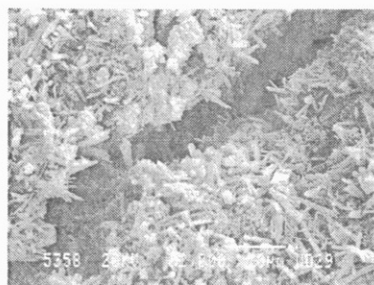
Also abundant crystals have been detected of ettringite very expansive, formed by reaction of the C3A of the cement by sulfates (F5).

F5. Needles of ettringite in a crack

- Accomplishment of concretes of discharge compacidad for the repair of the deeply depressed zones of the crossbeams, using arid of crushing which maximum size is of 20mm, 1 clean of powder and a cement type II/B-S 42,5 N/SR resistant to sulfates and to the water of sea, with minimal dosing of 350 Kg for m3.

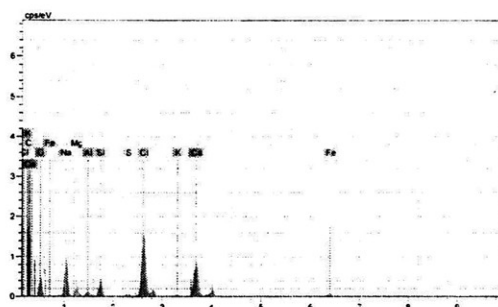
The attack verifies for the analysis for fluorescence of X rays (F6). In this case the saline compounds (sodium + 36 %) has substituted largely the originals of the concrete (calcium + oxygen 50 %) demonstrating the attack for sea water.

F6. Graph and results of the concrete analysis for fluorescence of X rays.

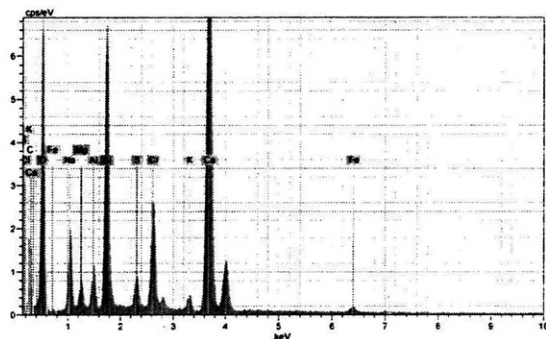
F7. Graph and results of the stone analysis for fluorescence of X rays.

Also in the stony materials the same phenomenon is detected. The stone of the building, defined as a sandy biocalcarenita, (calcio+oxígeno 79 %) but with high place contained in

fillosilicates (silica 10,8 %) and with white of egg he/she attends of you go out (sodio+cloro 10 %) that demonstrate the assault for water of sea, since they are not own percentages of these stones (F7).

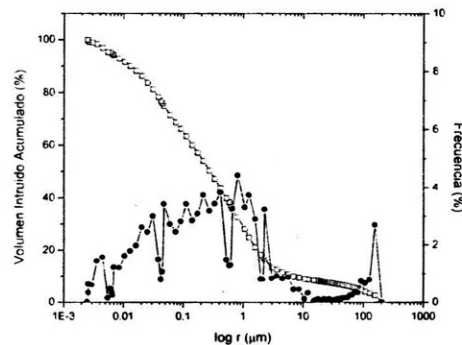
The porosimeter allows to quantify the entire porosity and in different status as his diameter (F8 & 9). In case of the concrete there is observed a high percentage of porosity connected to the status of the average diameter of the pores much down, for what the water can climb more easily for capillarity. The conditions are suitable so that the water crosses the material for his capillary network. The thickness is normal.

F8. Piled up curve and distribution of radioes of pores obtained with of intrusion of mercury porosimetry of a sample of concrete.

Connected porosity, P(Hg) [%]	19.01
Removed way, r_m (Hg) [μm]	0.28
Superficial area, S(Hg) [m ² /g]	5.14
Thickness combined, ρ_c (He) [g/cm ³]	2.72

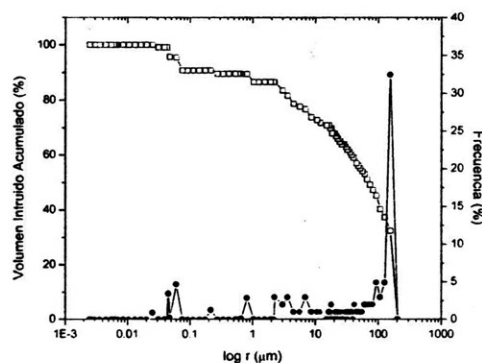
Connected porosity, P(Hg) [%]	2.01
Removed way, r_m (Hg) [μm]	70.36
Superficial area, S(Hg) [m ² /g]	0.03
Thickness combined, ρ_c (He) [g/cm ³]	2.71

F9. Accumulated curve and distribution of radioes of pores obtained with intrusion of mercury porosimetry of a sample of concrete.

The porosity connected of stony this one is very low, and the average very high radius of the pores, which he supposes that it he does not have capillary net. The density is the normal one in calcareous stones.
