Current Problems Involving the Dismantle of Asbestos-Cement Sheets in Buildings. The Case of Central Market in Alicante

Cesar Daniel Sirvent Pérez¹
Beatriz Piedecausa García²
Mónica Mateo García³
Carlos Pérez Carramiñana⁴

The project and the works described in this article mainly deal with the removal of the current asbestos-cement covering of the roof of the Central Market in Alicante and its replacement with zinc diamond-shaped scales, similar to the originals which were implemented in 1921 when the building was put into service.

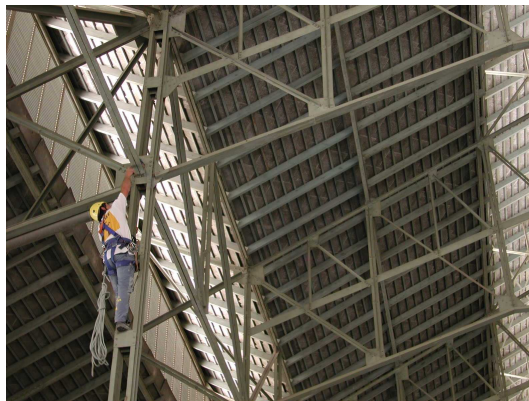
Figure 2. Partial view of the inside of the cover (photos taken during the inspection work "in situ" for drafting the injury report, 2006).

The steel, although relatively acceptable, had at various points begun to corrode, which manifested itself in the form of surface pitting (the profiles had not lost structural integrity).

Many of the wooden items remained undamaged, but we found some specific elements that had become unusable due to them having broken, or because they had begun to show symptoms of decay.

Finally, the main problem that we found with the topcoat was that it contained leaks in various locations. Before the renovation, a large surface of asbestos-cement square plates had received several additional layers of waterproofing paint with a base of chlorinated rubber and fiberglass mesh.

As a result of this study, we concluded that the most technically viable solution would involve the deconstruction of the existing roof, finished in asbestos-cement boards to proceed with the implementation of a new deck that guarantees a certain level of durability and waterproofing.

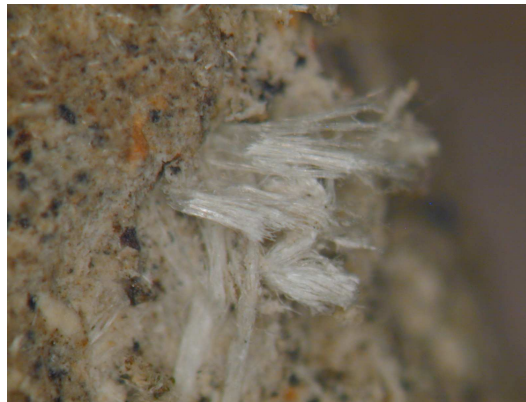
In order to unequivocally characterize the material composition of the sheets of Alicante Central Market roof, we obtained a sample from each type (thicknesses of 3 mm and 6 mm). They were transported to the laboratory at the Department of Building Materials at the University of Alicante, where they underwent analysis by optical microscopy. The presence of chrysotile (white asbestos) was discovered in each sample (Fig. 3).

Figure 3. Chrysotile (micrograph of a sample of the roof of the Central Market, corresponding to a square plate of thickness 3 mm).

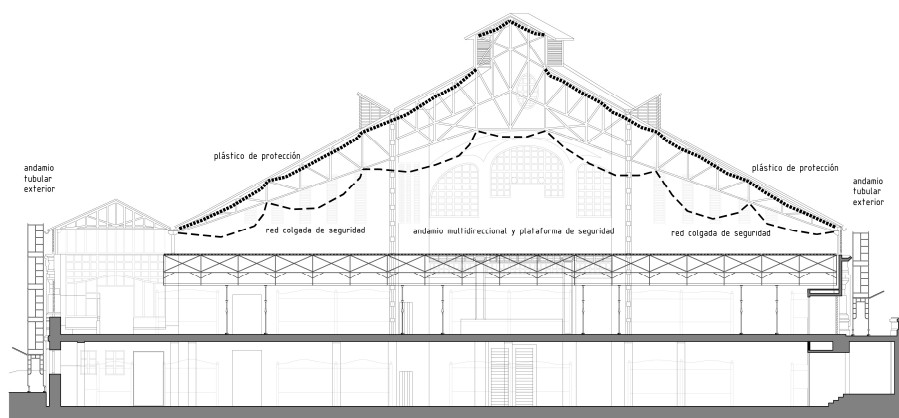
Figure 4. Section Deconstruction Project (2007).

The first phase involved installing guards on the exterior of the building (a perimeter of tubular scaffolding) and on the interior a system of multidirectional scaffolding that created a platform for ongoing security and lifeline nets anchored to the trusses (Fig. 4).

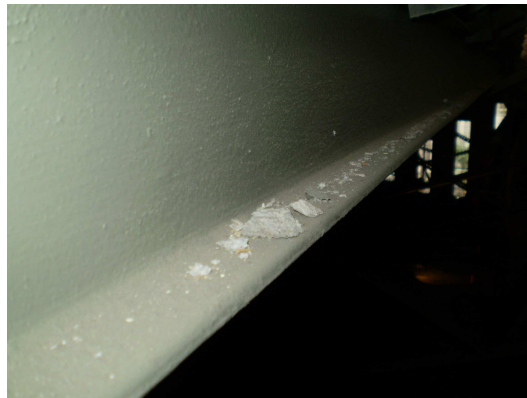
Another change to the plans was the elimination of the dual plastic membrane system under the current cover (*Section 6*) due to the difficulty of removal of asbestos collected in the plastic. It was replaced by a different extraction system (allowed by law). However, practice showed that this new system would not allow the removal of small and medium asbestos pieces, which were deposited on plastic or metal sections of the trusses (Fig. 5). We subsequently needed to measure fiber concentration in accordance with regulations.

Figure 5. Chunks of asbestos is not removed by exhaust systems deposited on the metal structure.

Finally, we should say that the capture of fibers in the vicinity of the emitting source with extraction systems is suitable only for very tiny particulates, but does not remove pieces of small and medium size. Thus, deconstruction by breaking of pieces should be avoided, or, at the very least, an additional means of collecting these pieces (eg, encapsulated by plastic) should be provided to prevent fibre deposition in other parts of the jobsite.

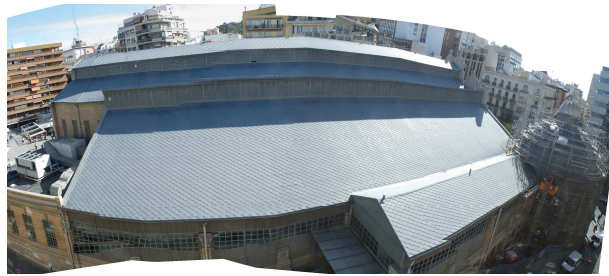
Figure 6. Final appearance of the new cover of zinc pieces (March 2010).
