# 1           **Subsidence damage assessment of a gothic church using** 2                           **Differential Interferometry and field data**

13    The Santas Justa and Rufina gothic church (XIV century) has suffered several physical,  
14    mechanical, chemical and biochemical types of pathologies along its history: rock alveolization,  
15    efflorescences, biologic activity and capillary ascent of ground water. However, during last  
16    two decades a new phenomenon has seriously affected the church, the ground subsidence  
17    caused by aquifer overexploitation. Subsidence is a process that affects the whole Vega Baja of  
18    the Segura River basin and consists on the gradual sinking of ground surface caused by soil  
19    consolidation due to a pore pressure decrease. This phenomenon has been studied by means  
20    of Differential SAR Interferometry (DInSAR) techniques providing settlements up to 100 mm for  
21    the 1993-2009 period for the whole Orihuela city. Although no DInSAR information is available  
22    for the church due to the loss of interferometric coherence, a spatial analysis of the

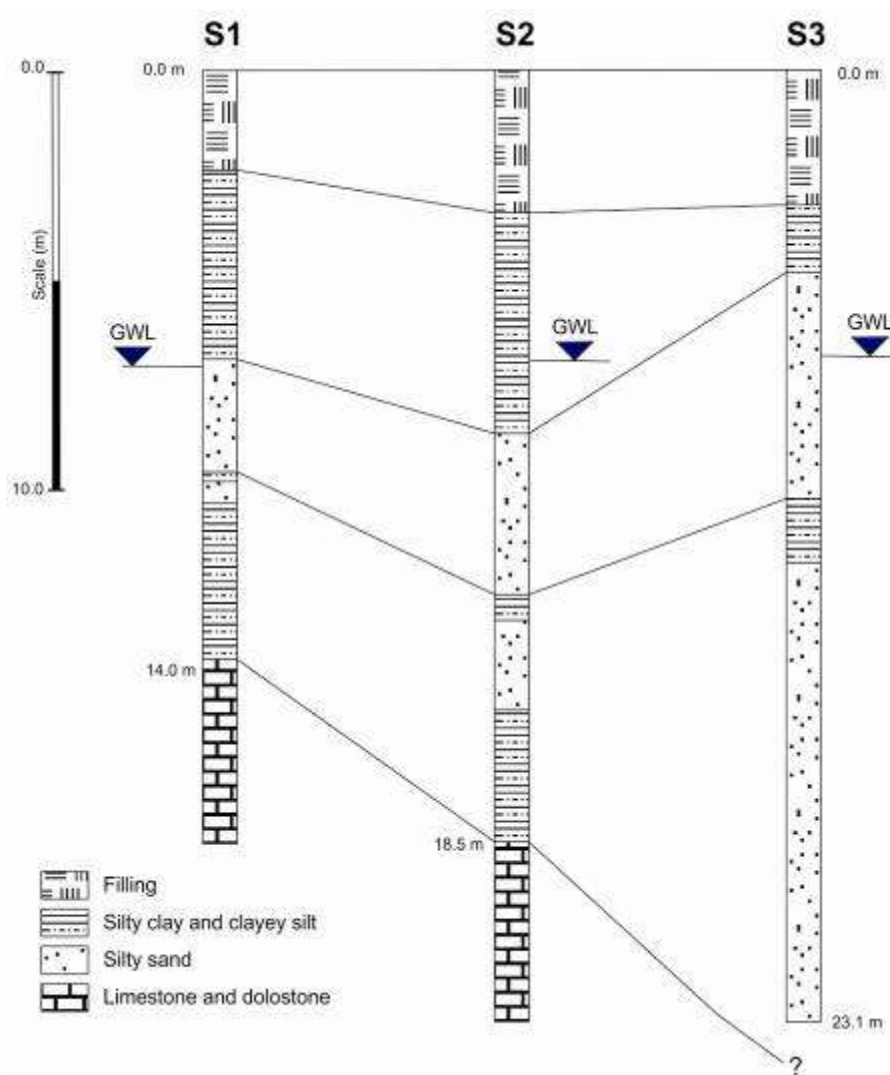
153 Figure 4. Geotechnical boreholes performed in the Santos Justa and Rufina gothic church.

156 Three geotechnical boreholes have been drilled in the proximities of the church (Figure 4) in  
157 order to better know the substrate properties and the geometry under the church. Four different  
158 lithologies have been recognized (from top to bottom): a) Fillings; b) Silty clays and clayey silts;  
159 c) Silty sand; and d) Limestones and dolostones.

160 The fillings have up to 2 m depth and present a low relative density with standard penetration  
161 test results lower than 5 blow counts. Next layer is composed by silty clays and clayey silts that  
162 present a slight improvement of the properties (standard penetration test up to 6 blow counts).  
163 The penetration values of this lithology increase notably with depth, reaching maximum values  
164 up to 15 blow counts on standard penetration test. Silty sands are intercalated among  
165 previously described layer. These sands have a higher penetration resistance than fillings and  
166 more surficial silty clays layer (11 blow counts). The geotechnical substrate is constituted by  
167 carbonatic rocks (Figure 4), limestones and dolostones with refusal values on standard  
168 penetration test and uniaxial compressive strength higher than 30 MPa. This layer appears at a  
169 depth higher than 16.0 m and is usually used for founding deep foundations due to the

170 considerable improvement of its geotechnical properties. Notice that the depth of this layer  
171 changes in a few meters with slopes higher than 0.19 m per meter ( $>11^\circ$ ) in the church area.

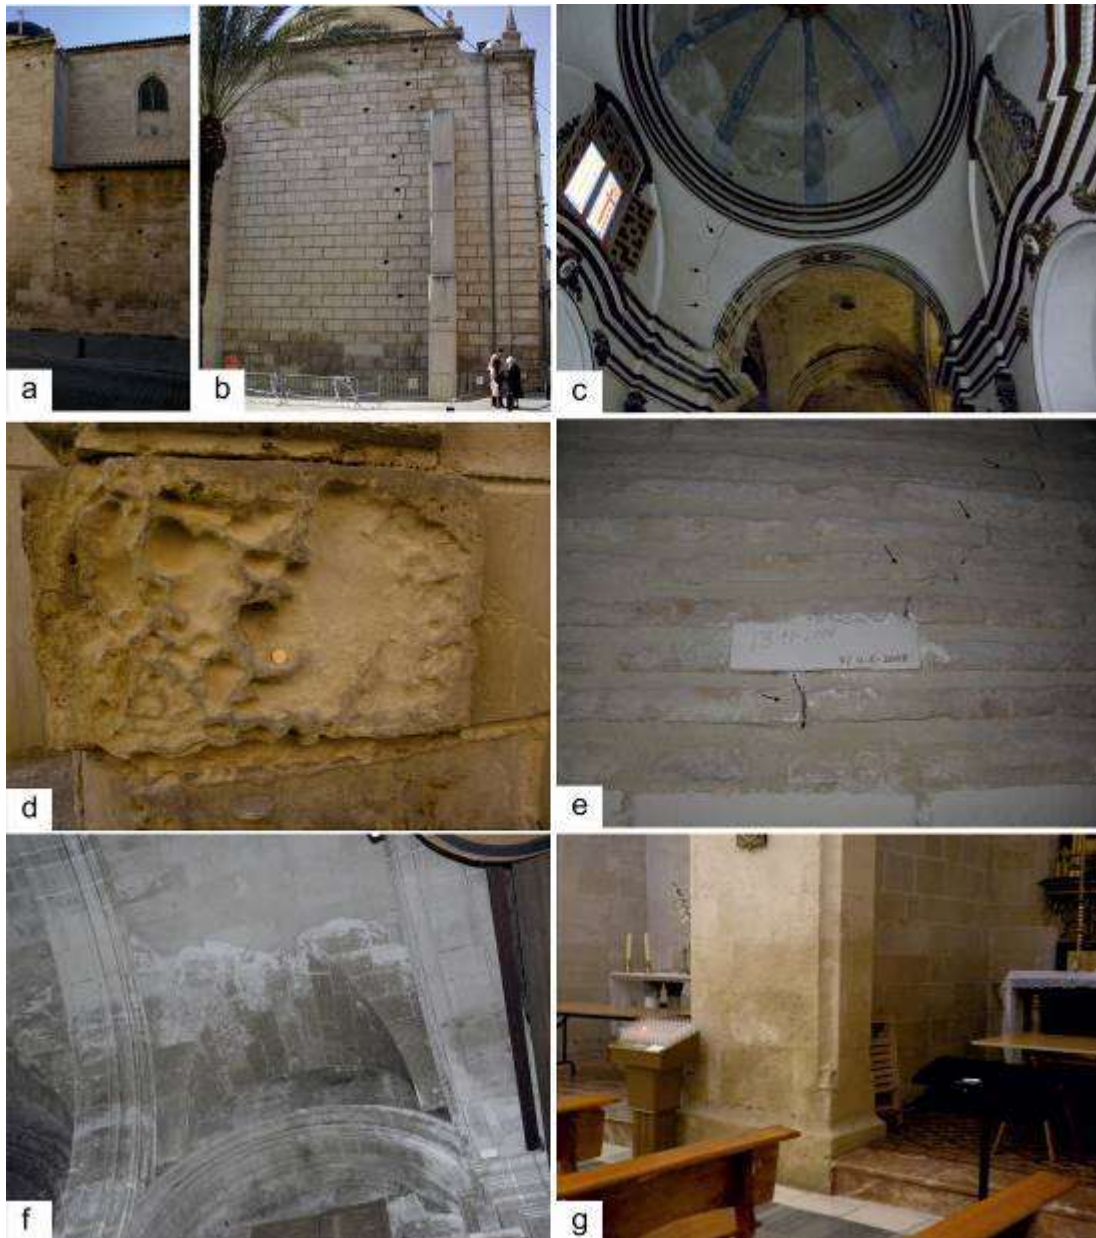
180 Rock alveolization is observed in sandstones blocks of several elements of the church causing  
181 cluster of small cavities and an evident loss of resistance (Figure 5d). These holes can be the  
182 result of the stonework (stacking), biological activity (pits) or the action of salt in the irregular  
183 porous network of the marble (alveoli) (Chabas and Jeannette, 2001). The salts form  
184 efflorescence growing on rock surface (Figure 5c and f) composed of small crystals that can  
185 influence both weathering and disintegration (alveolization) of the rocks. Microorganisms (fungi,  
186 moho, lichens, etc.) and other organisms (birds, plants, etc.) can cause a wide range of  
187 pathologies that are out of the scope of this work. Due to the high water level and the proximity  
188 to the Segura River, capillarity ascent affects the lower part of the elements that are in contact  
189 with soil although humidity can affect higher elements (cupules, columns heads, etc.) when rain

190 access through preexisting cracks (Figure 5f). Salts from ground water can be transported by

191 capillarity through the rock pore system causing salt crystallization, which is the origin of the  
192 previously mentioned efflorescence and alveolization processes.

195 Figure 5. Pathologies observed in the Santos Justa y Rufina church: a) vertical cracks related  
196 with a rigidity change; b) cracks due to local effects of counterfort; c) cupola cracks due to  
197 differential movements of the base; d) Cluster of small cavities (alveoli); e) masonry cracks  
198 induced by differential movements. Notice, the installed plaster markers for crack monitoring f)  
199 Efflorescences due to rain infiltration; g) Capillary ascent of water.

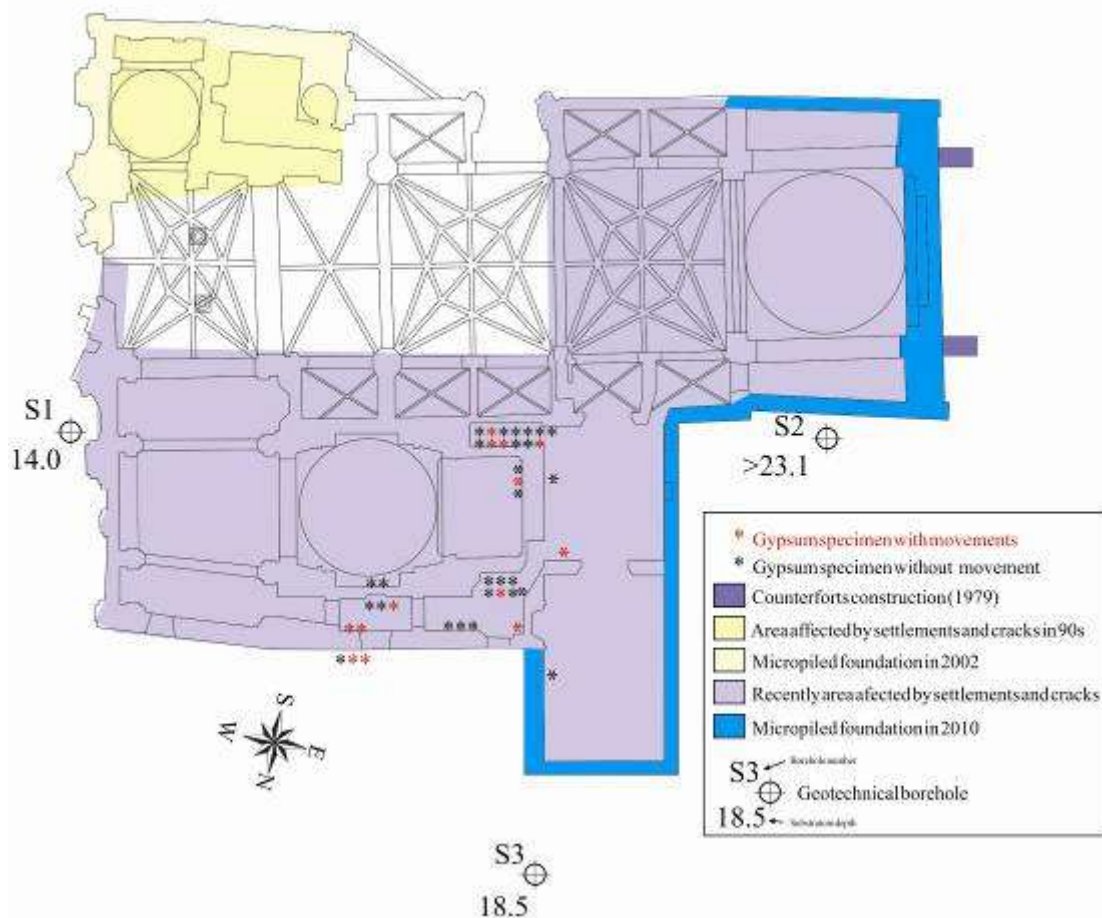
208  
209 Figure 6. Gypsum plaster markers, geotechnical boreholes location and structural improvement  
210 actions performed on the church. Notice that the plaster markers control period was November  
211 2006-June 2008. See geotechnical boreholes lithological description on Figure 4.

212  
213 The eastern wall that closes the principal chapel suffered an important tilt in 70s decade. The  
214 problem was solved by means of the construction of two reinforced concrete counterforts  
215 (Figures 5b a 6). After that, deformations affecting the church have occurred in two different  
216 phases. In the ninety decade of the last century, important settlements affected the San José  
217 chapel zone (Southwest area of the church, Figure 6). Unfortunately no in situ observations are

218 available for this period. As a consequence, the foundation was reinforced in 2002 with  
219 micropiles. On a second stage (first decade of present century), deformations affected the  
220 whole north zone of the church and the principal chapel area. Ground settlements were visible  
221 at the floor of the antesacristy, the sacristy and La Comunción chapel. Multiple cracks where  
222 identified in the north, west and east walls, affecting as well La Comunción cupola (Figures 5b, c  
223 and e), the sacristy and the antesacristy. Several plaster markers were placed in the cracks in  
224 2006 and controlled in 2008 coinciding with the higher piezometric level fall never known in the  
225 Vega Baja of the Segura River basin (Figure 7). Figure 6 shows that multiple cracks grew up for  
226 this period as a consequence of the sinking of the walls foundation caused by ground  
227 subsidence. This affected zone of the church has been recently repaired in 2010 using

228 micropiles (Figure 6).

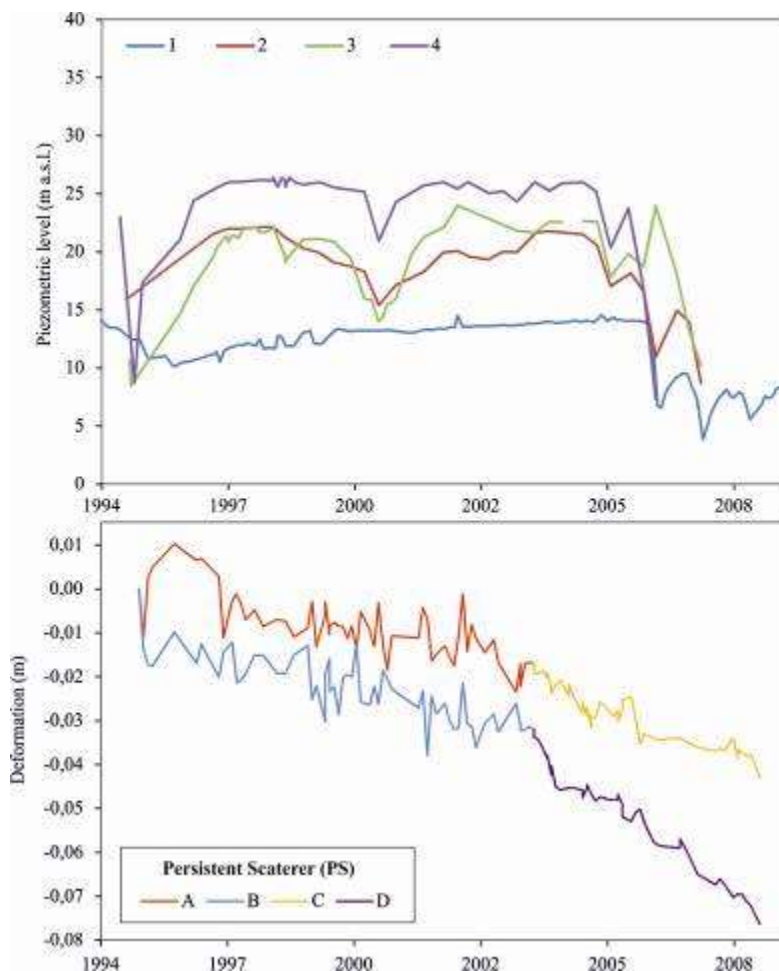
232 Figure 7. Piezometric level evolution of several piezometers located in the Vega Baja of the  
233 Segura river superposed to DInSAR deformation time series of 2 PSs located in the vicinity of  
234 the Santos Justa and Rufina church (see A, B, C and D PSs location in Figure 9 and 1, 2, 3 and

320 been proved to be closely related with piezometric level changes (Figure 7) suffering an  
321 important acceleration when the piezometric level dropped drastically from 2004 to 2008.  
322 Although no PSs are available for the Santas Justa and Rufina church due to the loss of  
323 coherence derived from the maintenance works performed in its cover, subsidence rate values  
324 up to -21 and -95 mm per year have been measured for 1995-2006 and 2004-2008 periods,  
325 respectively, in the nearby areas of the church (Figures 7 and 9). Computed differential  
326 settlements using interpolated maps provide maximum differential settlements affecting the  
327 church of 12.5 and 24.5 mm for 1995-2006 and 2004-2008 periods, respectively. As it can be  
328 notice, these values are lower than the general rule of 25.4 mm (equals to 1"; Terzaghi et al.,  
329 1996) of acceptable maximum differential settlement, although during the second period

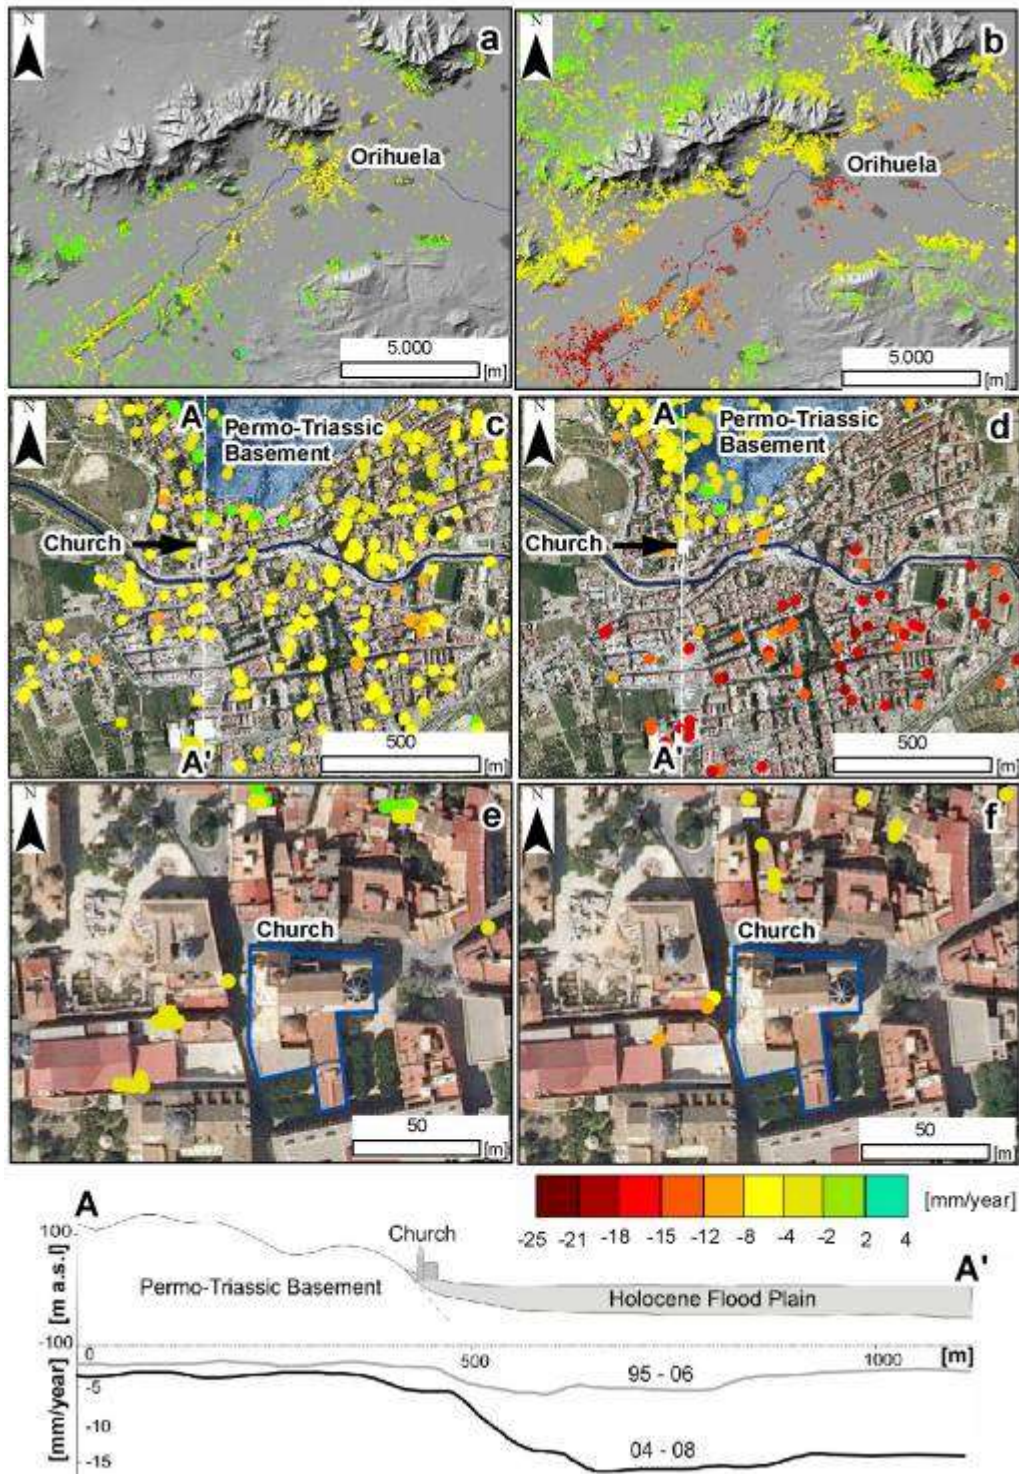
265 Results of subsidence in the city of Orihuela for both periods (1995-2005 and 2004-2008) are  
266 shown in Figure 8. As it can be seen in figure 8a and b, the higher density of PSs corresponds  
267 to the urban area of Orihuela. In the Santas Justa y Rufina church neighborhood deformation  
268 rates up to -2.1 and -9.5 mm/year for 1995-2005 and 2004-2008 periods respectively have been  
269 measured by means of DInSAR (Figure 8a to 8d). Notice that subsidence measured for 2004-  
270 2008 period in the vicinity of the church is higher than the measured deformation for the

271 previous period (1995-2005) due to the previously mentioned high piezometric level drop that  
272 affected the area because of the aquifer overexploitation. Unfortunately, no PSs are available  
273 for both periods for Santas Justa and Rufina church. This is due to the loss of coherence, which  
274 is associated to the reforms performed in the cover and façades of the church in 1998 and  
275 2002, just during the period comprised by processing. However, several PSs are available for  
276 the nearby areas of the church.

277 Figure 8g represents N-S cross section of the study area. As it can be noticed, Holocene  
278 sediments from the flood plain of the Segura River increase their thickness from the north  
279 towards south (from the Sierra de Orihuela relief towards the center of the basin). Subsidence  
280 follows a similar trend. The Santas Justa and Rufina church is just located near the Sierra de  
281 Orihuela that is composed of carbonatic rocks (dolostones and limestones). This relief deepens  
282 under Holocene sediments with high slopes causing important changes in substratum depth as  
283 it has been observed in the available boreholes performed in the church perimeter (Figure 4).  
284 These substratum changes favor differential settlements occurrence. Differential settlements  
285 affecting the church have been computed interpolating the available data for both study periods  
286 (Figure 9). The maximum differential settlements have been calculated considering the highest

287 and the lowest subsidence values contained in an area composed by the church and a buffer  
288 ring of 14 m providing 12.5 and 24.46 mm for 95-06 and 04-08 periods respectively. The  
289 angular distortion has been obtained dividing differential settlement by the distance between the  
290 two points that provides the maximum and minimum subsidence value. Computed distortion  
291 values for both periods are  $1.5 \times 10^{-4}$  m/m and  $3.4 \times 10^{-4}$  m/m.

294 Figure 8. Subsidence measured by means of DInSAR for 1995–2005 and 2004–2008 periods:

295 a) and b) for the whole study area; c) and d) in Orihuela city; e) and f) in the vicinity of the

296 church; g) Geological simplified and subsidence N-S cross section along Orihuela city.

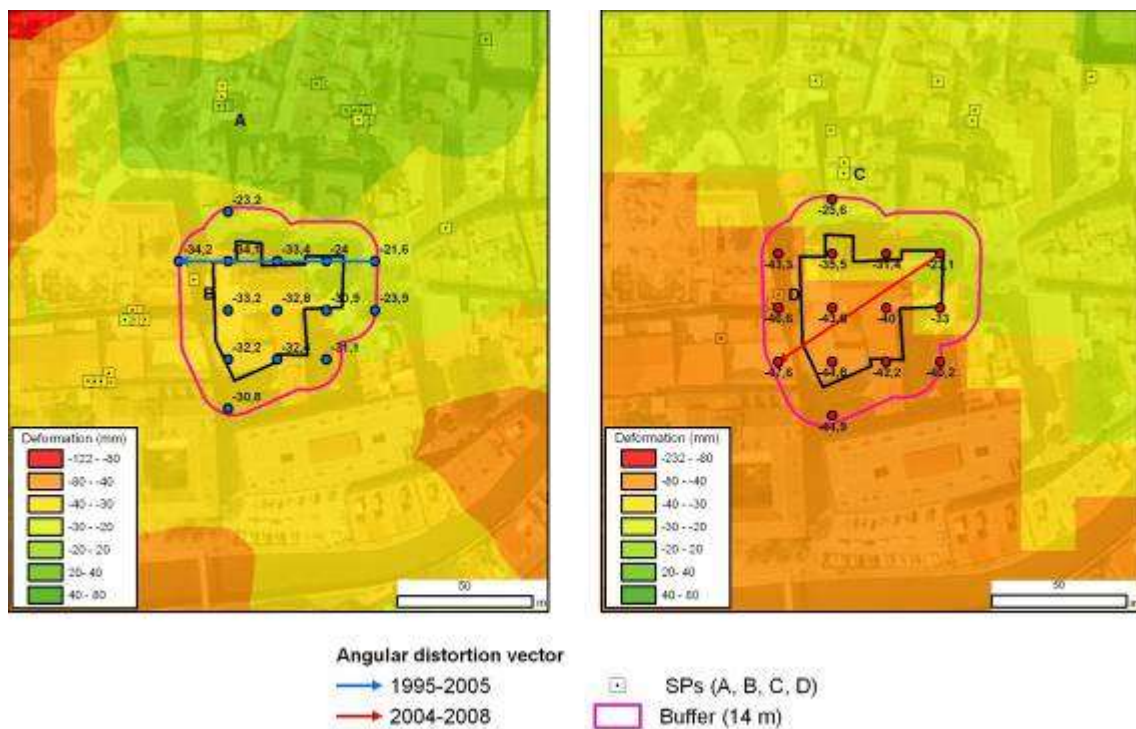
313 Figure 9. Interpolated DInSAR subsidence in the vicinity of the Santas Justa and Rufina church  
314 and computation of differential settlements and maximum deformation gradients for 1995-2006  
315 and 2004-08 periods. Notice that the arrow indicates the direction of maximum deformation  
316 gradient.

330 deformations are very close to it. Computed angular distortions reached values of  $1.5 \times 10^{-4}$   
331 m/m and  $3.4 \times 10^{-4}$  m/m that are also lower than the ones generally accepted of (1/1000  
332 m/m). However, the 1995-2008 differential settlement probably got over this value.

333 The interpolated subsidence values of subsidence also allow interpreting the deformational  
334 evolution of the church. As it was explained in section 5, in the ninety decade, high settlements  
335 affected the San José chapel zone. Figure 9a shows that the maximum settlements for 1995-  
336 2006 period were concentrated on the NW corner of the church, just coinciding with the  
337 mentioned area. Also notice that the computed angular distortion (blue arrow) is oriented from E  
338 towards W coinciding with the San José chapel zone. The foundation was repaired in 2002  
339 using micropiles. More recent damages are concentrated in the SE zones (La Comunción  
340 chapel, antesacristy and sacristy; Figures 6). As it was explained in section 5 field work has  
341 been performed in order to identify the damages affecting this area. Observed damages consist  
342 principally on floor settlements (pavement irregularities are easily recognized) and wall cracks

343 that can affect other elements. Figure 9b shows that maximum interpolated settlements for the  
344 2004-2008 period are concentrated on the SW corner of the church with a maximum angular  
345 distortion direction NE-SW (the church has undergone a tilt towards the SW) in agreement with  
346 field observations.
