EURODYN 2020

AN INTEGRATED VIBRATION-IMAGE PROCEDURE FOR DAMAGE IDENTIFICATION IN STEEL TRUSSES

The Quisi Bridge located in Benissa (Alicante) is an historic steel truss railway bridge, which is investigated with different techniques to assess the presence of fatigue damages. It is a XX century steel Bridge and it is part of the 9th FGV Railway Line. The structure consists in a top-bearing Pratt type truss. It is 170 m long with six spans of different length (Figure 3).

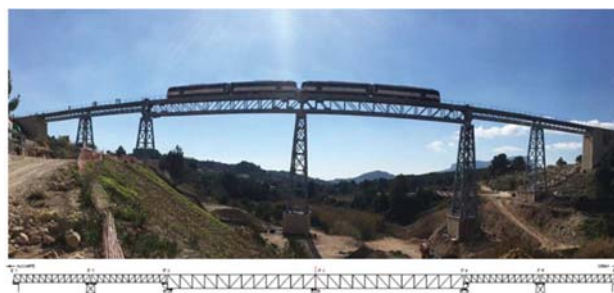
Figure 3: Quisi Bridge.

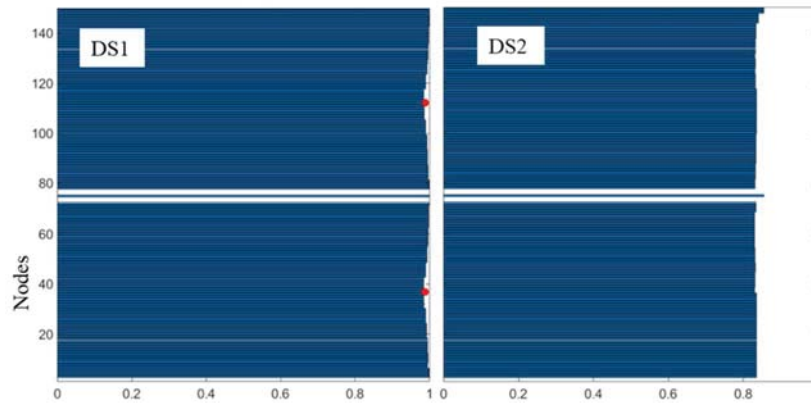
Figure 4: CoMAC comparing modes obtained by numerical model of the main span.

The CoMAC between the mode shapes of the damaged and corresponding undamaged scenarios, can be calculated as presented in Figure 4. Although CoMAC is often taken as damage locator for its space information, it might sometimes be affected by its low sensitivity to damage, (as in DS2), and from confusing localization, (as in DS1).

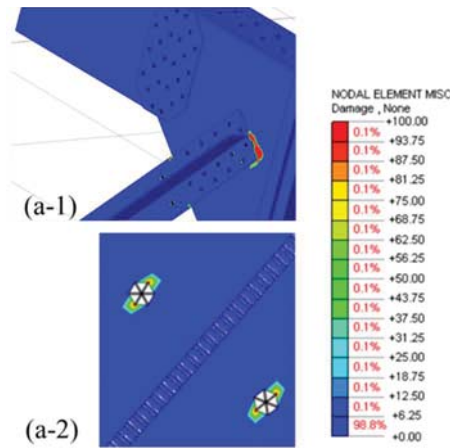
Figure 12: Fatigue analysis results in terms of damage: (a-1) - (a-2) detail views of damage contour.

Results of fatigue analysis performed using MIDAS-FEA are reported in Figures 12 and 13. From the second fatigue result, it is noticed that there is no remaining fatigue life for elements in blue colour, it had expired 4 years before the year in which this assessment was undertaken. The member chosen for the analysis cannot be considered safe anymore. It should be noted that each specific structural element has a different fatigue life.

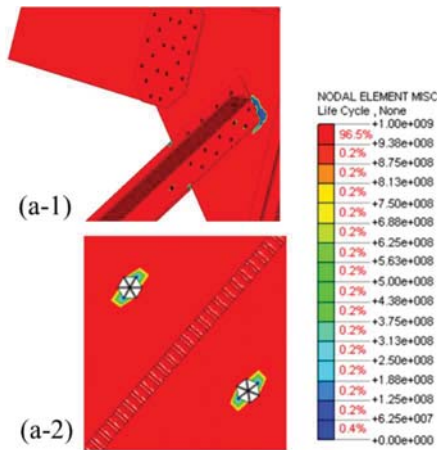
Figure 13: Fatigue analysis results in terms of fatigue life: (a-1) fatigue life of the joint; (a-2) detail of the holes in the diagonal element.
