DEFENSIVE ARCHITECTURE OF THE MEDITERRANEAN
XV TO XVIII CENTURIES
Vol. V

PROCEEDINGS of the International Conference on Modern Age Fortifications of the Mediterranean Coast
FORTMED 2017

Mapping building materials and alteration forms to diagnosis, conservation and restore: a Norman castle in Sicily

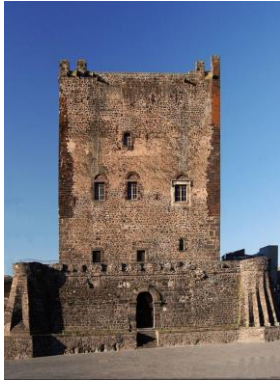
Fig. 1 – The Adrano Castle; courtesy of Arch. Marcellino (Superintendence for Cultural Heritage of Catania).

All the aforementioned fields of interests, *i.e.* the archeological, the scientific and the conservation fields, are reasons behind the researches performed on the construction materials of the Adrano Castle (Catania, Sicily) (Fig. 1), a watchtower whose foundation is attributed to the Norman leader Roger I, around 1070. According to the scholars, the tower was probably part of a wider system of fortification established by Normans to control the Sicilian island (Maurici et al., 2008), as testified by the geographic position of the neighboring Paternò and Motta Sant'Anastasia Castles built along the Simeto river valley.
