CMMoST 2019

Mechanical Models in Structural Engineering

On the vulnerability of an irregular reinforced concrete bell tower

ABSTRACT

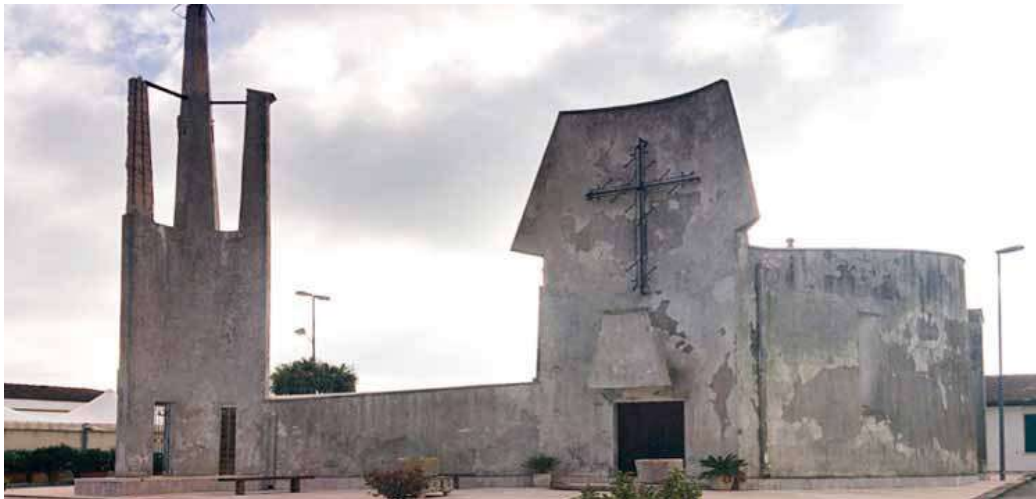
Figure 1. Church and bell tower of Santa Maria Assunta of Lamadacqua in Noci (Bari, Italy).

The roof is pitched and made in reinforced concrete (r.c.) with a double strut scheme. The bell tower to the left of the building, instead, is a structure entirely in r.c. with section septa varying from bottom to top. In the space between the church and the bell tower there is a small room in load-bearing masonry and a horizontal floor in r.c. simply leaning on the main structures (Figure 1).

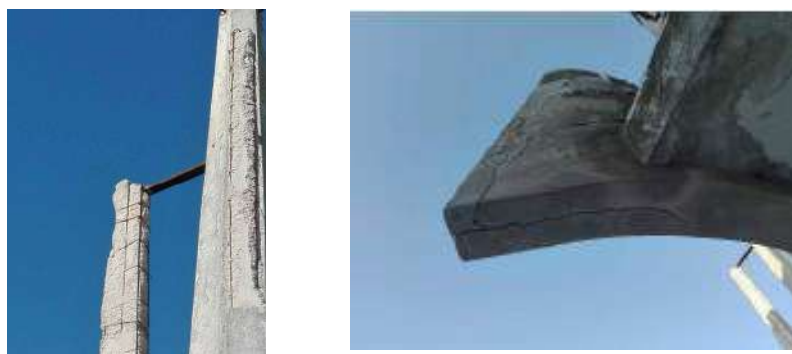
Figure 3. Detail of damages observed on the r.c. structures on the Church of Santa Maria Assunta bell tower.

The bell tower is affected by cracks and injuries partly caused by problems of capillary rising and, in part, by the scarce mechanical characteristics of the materials utilised. In this regard, the detailed survey of degradation and instability was able to confirm the important cracks patterns. In particular, the shape of the cracks on the three spiers of the bell tower is caused by a concomitance of actions and reactions to which the structure is subject (Figure 3). In particular, the exogenous degradation, that is the alteration of the characteristics of the materials constituting the structure, was caused by external agents such as wind. The area in which the structure rises, in fact, can be considered without obstacles and this causes an increase in the kinetic pressure that the wind exerts on the structures it meets. Moreover, in the case of a cantilever structure, the action of the wind causes particularly critical bending moment stresses at the base with tensile stresses to which the concrete is not able to resist. Among the three spiers at the top of the bell tower, the one adjacent to the remaining part of the structure is damaged to a lesser degree; this could be caused by the holding reaction that the remaining structure exerts on it, with a consequent reduction of the tensile stresses.

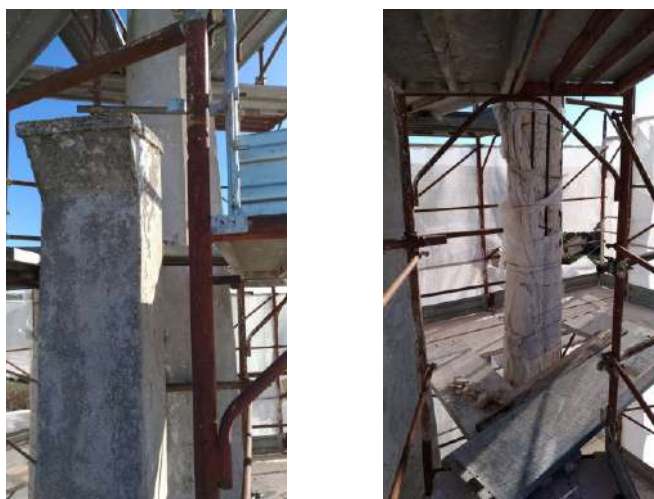
Figure 4. Details of coatings and scaffoldings before the retrofitting intervention.

On 22th January 2018 while the structure was made safe by means of coatings and scaffoldings were placed for repairing the structure (as shown in Fig. 4), the first experimental campaign was carried out. The tower was instrumented with seventeen 393B31 uniaxial piezo-accelerometers with a sensitivity of 10.000 mV/g, placed at three different levels on the tower. The accelerometers were connected to a centralized data acquisition system National Instruments DAQ model NI 9232 mounted on a NI cDAQ-9188 Chasis CompactDAQ. To guarantee the recordings in two perfectly orthogonal directions in each acquisition point, a cubic metallic device has been utilized as shown in Fig. 5. Due to the situation, several blocks containing the accelerometers were only placed on the pillars where it was possible.

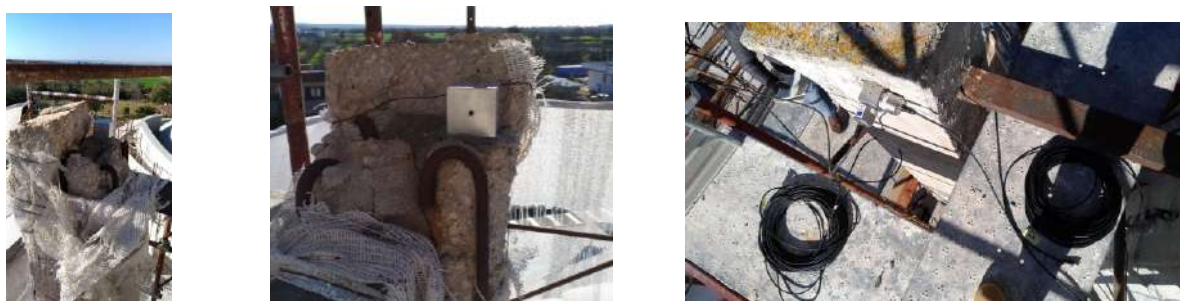
Figure 5. Details of the blocks placement and accelerometers connection
