Review

Effects of Wildfire on Rockfall Occurrence: A Review through Actual Cases in Spain

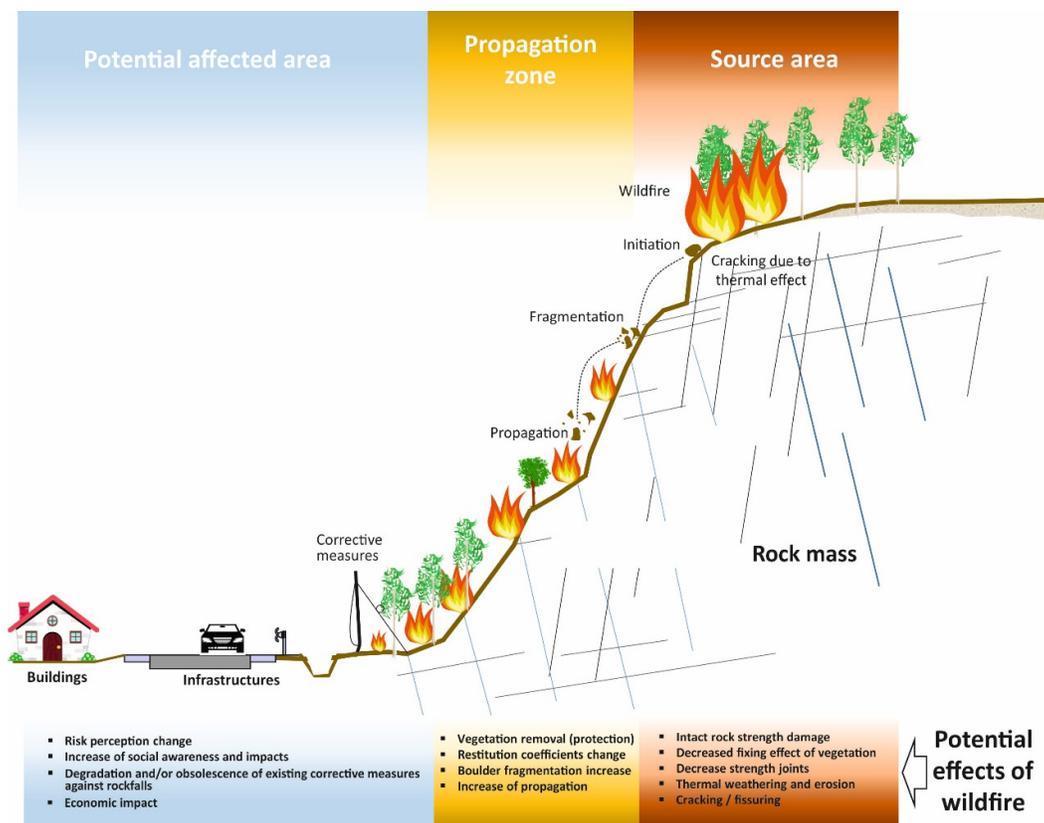
Figure 1. Diagram of potential wildfire effects on rockfall occurrence that frames the structure of this work.

In this work, the review of the effect of wildfires on rockfall occurrence is divided into three parts (Figure 1): (i) the detached zone or source area; (ii) the propagation rockfall area, and (iii) the affected zone, where the majority of the boulders and fragments stops. Regarding the source areas, we present the effects of wildfires on the rock mass and its properties: thermal weathering and erosion, degradation of rocks, crack initiation and strength damage. The propagation area comprises the loss of vegetation by the fire and their consequences on the slope. It is difficult to predict when the protective function of a

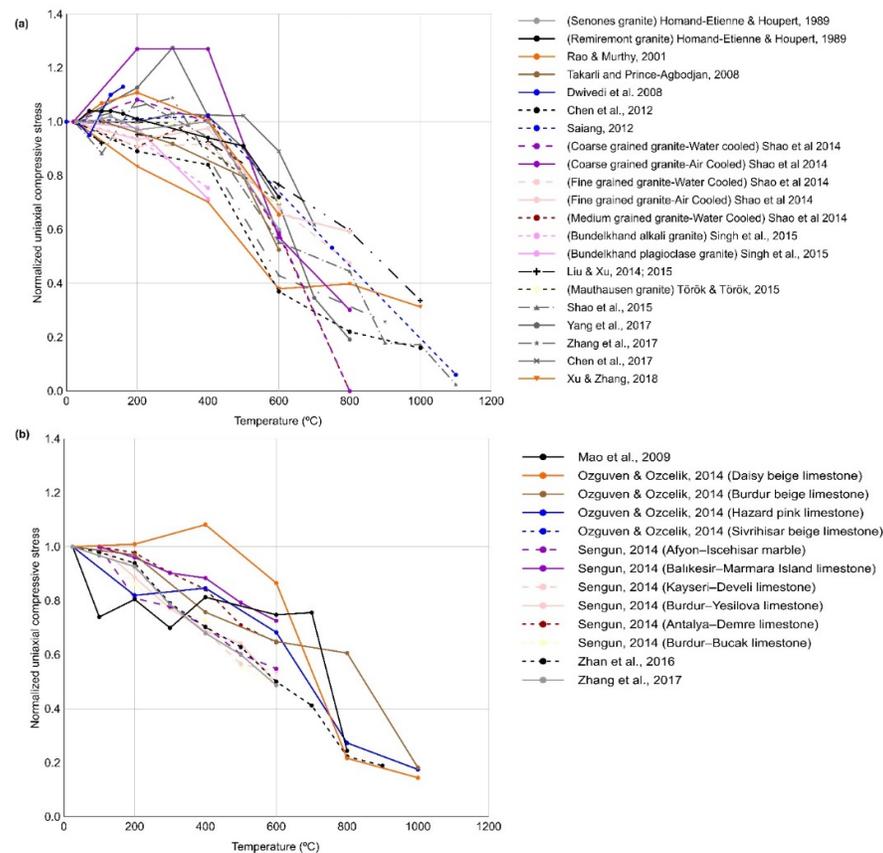
Figure 2. Variation of normalized uniaxial compressive strength of (a) granites and (b) limestones after thermal treatment. The plotted cases were compiled from scientific literature [47,50,53,56,61–75].

changes and mechanical properties of rocks [40,42]. Thermo–minero–chemical changes also cause polymorphic transformations, melting, and even the disappearance of certain minerals [40,43–45]. These processes are behind the development of new microcracks and the coalescence and enlargement of existing ones that are responsible for the important changes in the physical and mechanical properties of rocks after a fire [39,41,42,46–49] (Figure 2).

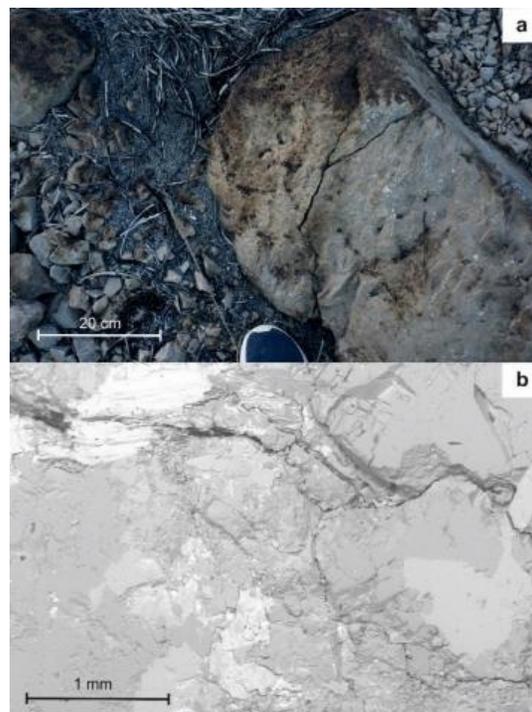
Figure 3. (a) Fractures appearing on a limestone boulder (35 cm across) affected by a forest fire in the Foncalent mountain range located on a dry arid region of Alicante, SE Spain, with a low thermal load. (b) Scanning electron microscope image of microcracks affecting a granite specimen from near Vila Real, N Portugal heated in the laboratory up to 600 °C and cooled by immersion in water in the Laboratory of Rock Mechanics of the University of Alicante.

Wildfires mainly affect rock masses, expanding the outer parts, causing internal stresses that exceed the tensile strength of the rock-forming fractures (Figure 3a,b). These fractures are more or less parallel to the surface or influenced by various lines of weakness, such as stratification, “blind joints”, rift, veins, and schistosity yielding fragments of many shapes and sizes [81,82]. Thus, the presence of matrix in detritic rocks causes a dampening effect of mineral crystal dilations; however, in massive rocks, the absence of matrix and the greater packing of the crystals increase the efforts between them as they dilate, and cracking occurs (Figure 4). Considering massive rocks with similar porosities and mineral packing, those of carbonate composition are less sensitive to the action of fire than those of siliceous composition [26].

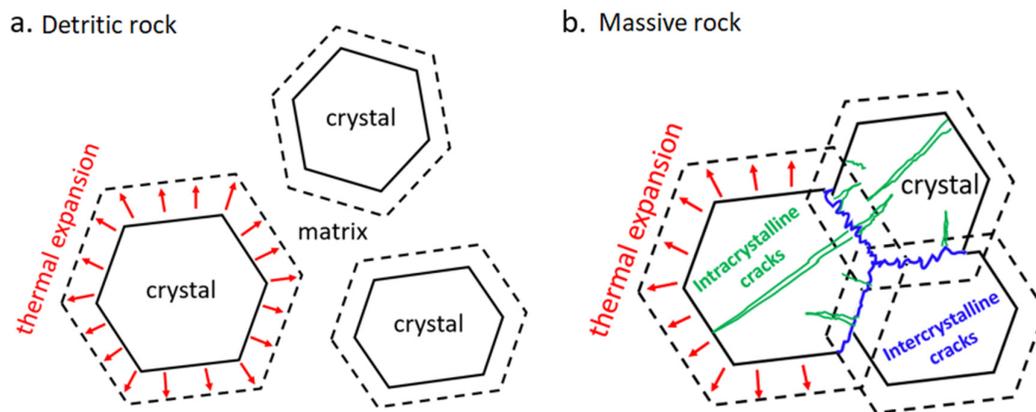
Figure 4. Effects produced by thermal expansion in detritic rocks (a) and massive rocks (b).

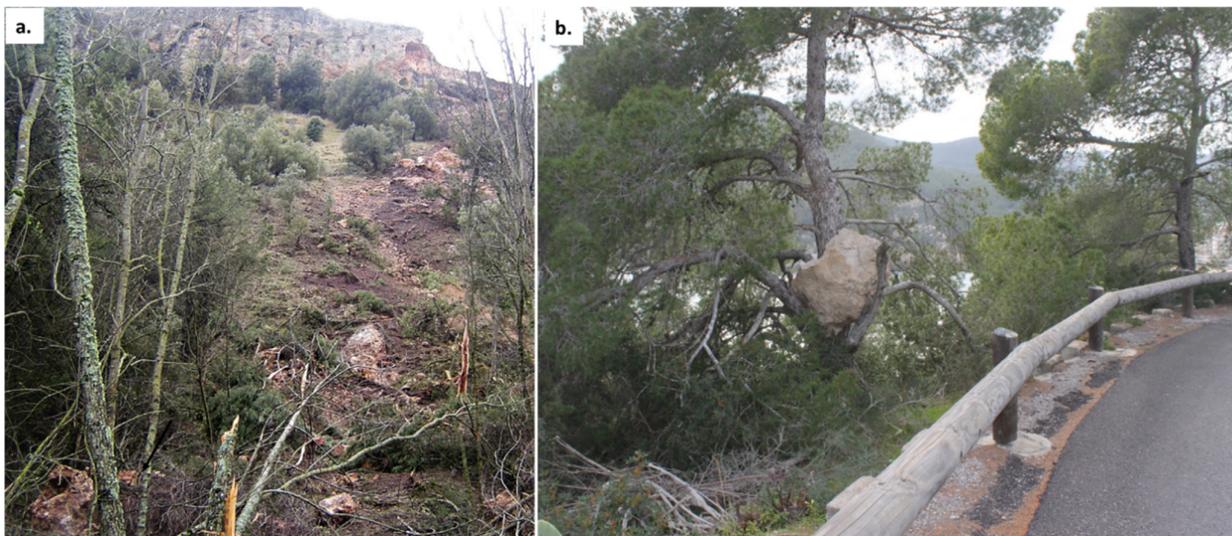
Figure 5. Examples of the protective effect of forests against rockfalls; (a) rockfall in Covarrubias (Burgos), where trees reduced the velocity and the rebound heights of the falling rocks, and (b) rockfall boulder “hanging” from pine in Cala Sant Vincent (Ibiza).

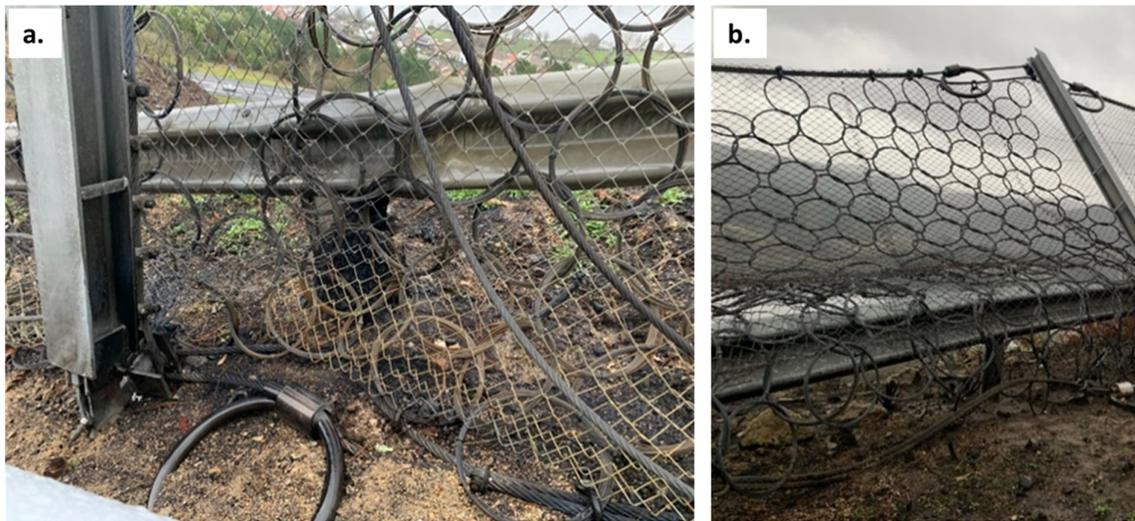
Figure 6. (a) Degradation of the cables and energy dissipators after a wildfire. (b) Dynamic barrier for protection against rockfalls affected by a wildfire.

However, when a fire occurs, these protective measures can be seriously affected by the high temperatures (Figure 6b). One of the main effects of wildfire on rockfall protection barriers is the degradation of the cables and energy dissipators, changing their properties of friction/tightening with cable ties (Figure 6a). In this case, cables, energy dissipators and nets would be replaced. High temperatures can also destroy nets and bolts, which become brittle and weak depending on the composition of these elements and the temperature reached during the fire.

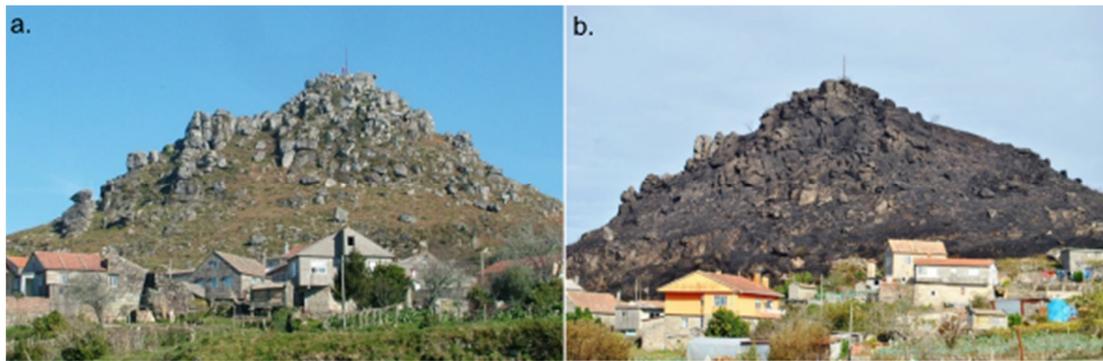
Figure 8. Two views of the study area: (a) before and (b) after the occurrence of the wildfire in 2017 (photos taken by the authors).

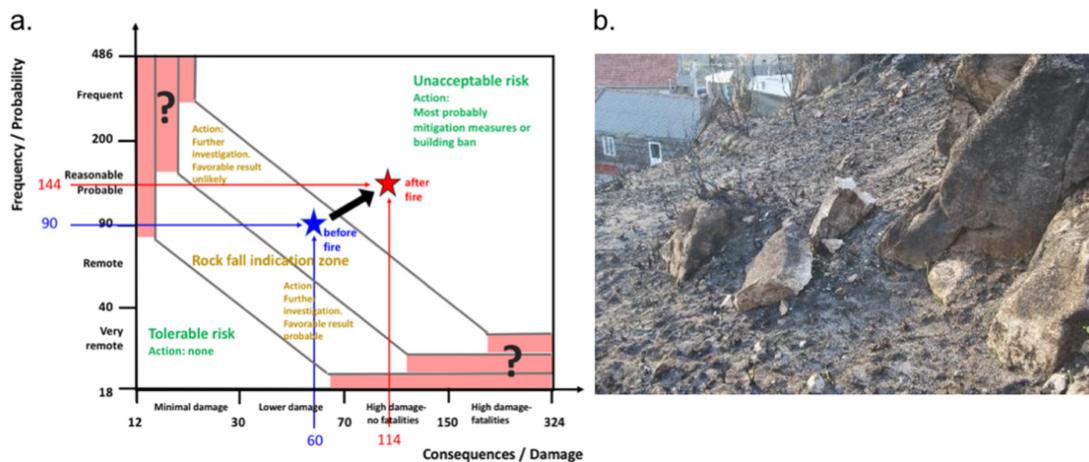
Figure 9. (a) Diagram proposed by Mlk et al. [120] for analyzing frequency/probability vs. consequence/damage. (b) Freshly fragmented block in the lower part of the slope after the fire.

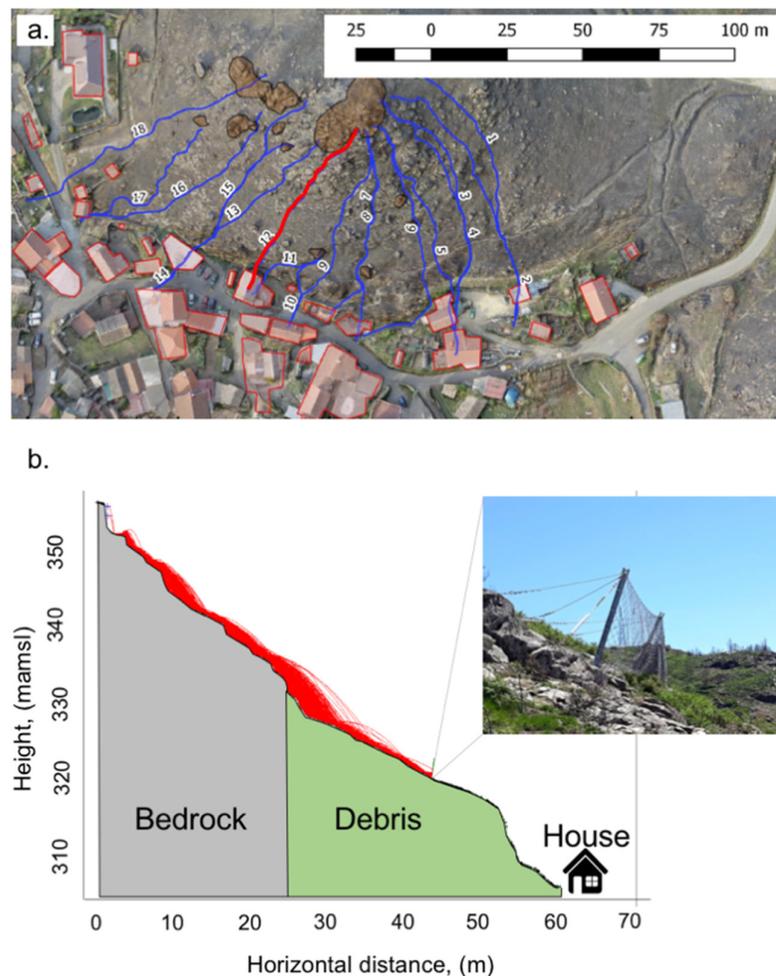
Figure 10. Modeling of rockfall paths for the study in Galicia. (a) Selection of maximum slope trajectories or rockfall-paths based on the 3D point cloud. Profile 12 is highlighted in red color. (b) Geometry of profile 12 input in RocFall code, including different materials and simulation of profile 12 with the designed flexible barrier. A picture of this barrier once installed is also provided.

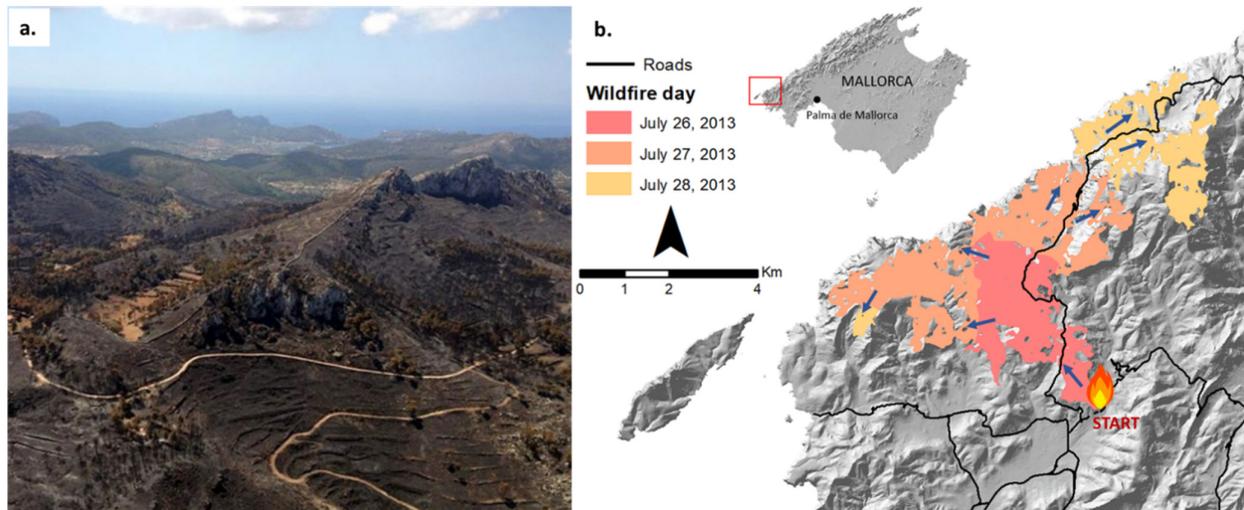
Figure 11. (a) The 2013 forest fire in Mallorca. A total of 2400 hectares were burned in the southwestern part of the Tramuntana range (Photo © El País). (b) The right map shows the spread of the fire over time.

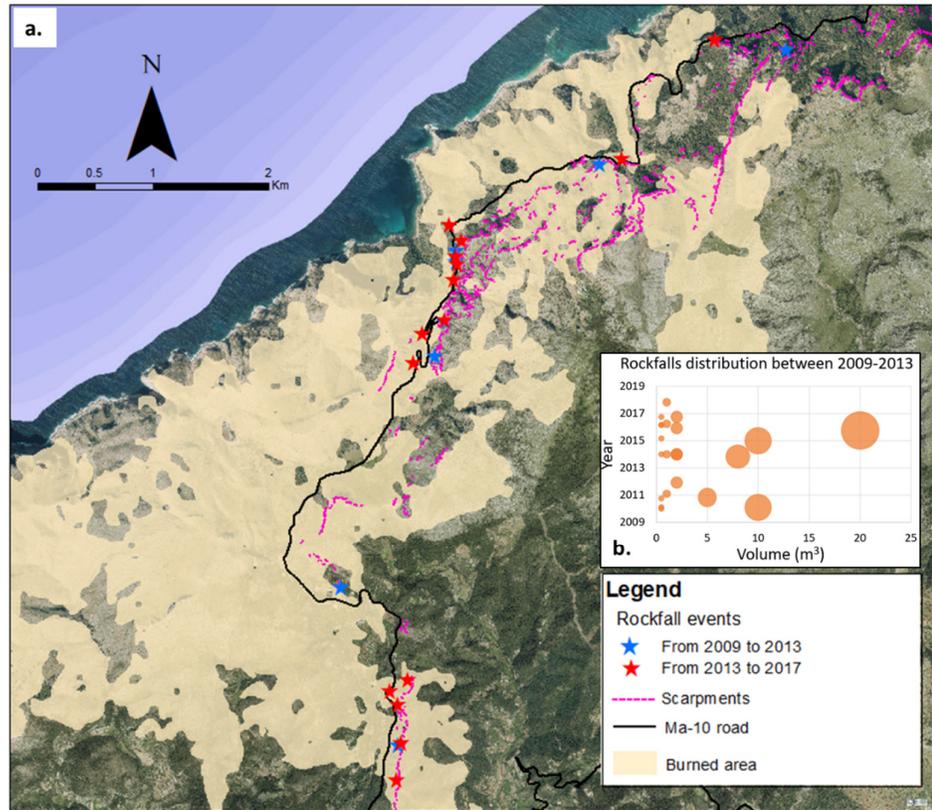
Figure 12. (a) Rockfalls occurred before and after the wildfire in the Tramuntana range (Mallorca) in 2013. We considered the rockfalls in the Ma-10 road reported by the road maintenance service of Mallorca. (b) Rockfall distribution according to the volume of the boulders and considering the year of occurrence.

In this case, the effect produced by the loss of vegetation was important. During the spanning period 2009–2017, the rockfall inventory collected by the Road Maintenance Service of Mallorca showed a total of 22 significant rockfalls in the area where the wildfire took place (Figure 12). Before the wildfire in 2013, 7 rockfalls were recorded in the burned section of the road between 2009 and 2013; 4 of them took place in 2010 when the island of Mallorca experienced the coldest and wettest winters of the last 40 years [126]. After the 2013 wildfire, between 2013 and 2017, a considerable increase in rockfalls was observed in the same section; a total of 15 rockfalls, which double the number of events for the pre-fire period (2009–2013). Nevertheless, the number of rockfalls could be higher because some fences were installed along the road after the wildfire. Regarding the intensity of the events, a greater heterogeneity of block-sizes was observed after the wildfire. The volume varied from 0.5 m³ to 20 m³ after the wildfire, while in the previous period, they range between 2 m³ and 10 m³.

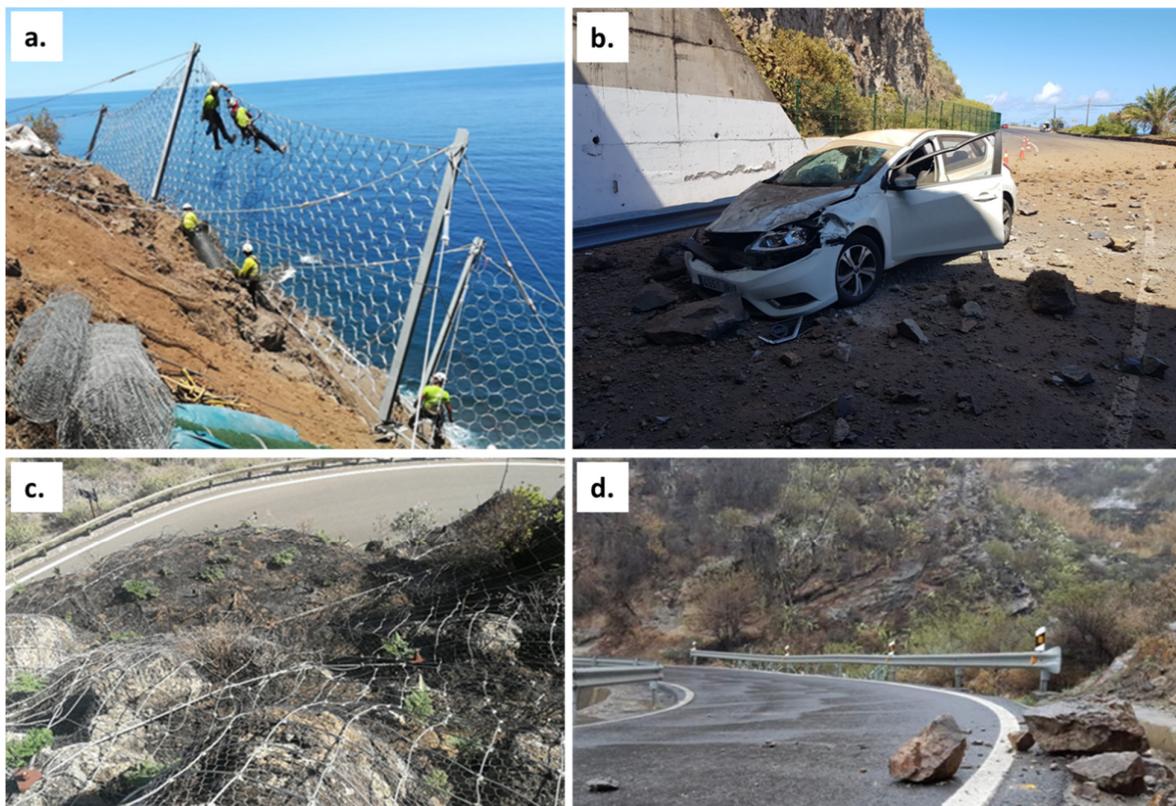
Figure 14. (a) Installation of dynamic barriers on the slope affected by rockfalls in Tenerife test site; (b) vehicle affected by rock impact at km 43 of the TF-5 highway (photos courtesy of V-Traverca). (c) Fence and barrier affected by the wildfire in GC-210 (courtesy of V-Traverca). (d) Rockfall triggered by wildfire in Tejada (courtesy of Road Service of the Canary Islands).

The second case in the Canary Islands occurred on 17 August 2019 on the island of Gran Canaria. The fire started near the town of Tejeda and spread to Tamadaba Natural Park, driven by prolonged high temperatures, strong winds and low humidity. According to the authorities' information, over 700 firefighters and 16 aircraft helped to tackle the blaze, with some flames reaching over 50 m in height. The Copernicus Emergency Mapping Service (CEMS) was activated. The products offered by CEMS were based on comparing pre- and post-event Sentinel satellite images [129]. The Tejeda-Artenara wildfire affected a land surface of 104.5 km², 26.2 km² of forest, forcing the evacuation of 13,000 inhabitants. In addition, fences and barriers against rockfalls were affected by the high temperatures (Figure 14c), and the road maintenance service noted an increase in the number of rockfalls during the months following the fire. (Figure 14d).
