Experimental Damage Identification in Masonry Structures by OMA

Abstract—This paper presents a study carried out in different types of masonry structures to identify existing damage through dynamic identification techniques using operational modal analysis. A cross vault, a masonry wall and a simple clay brick construction have been analyzed. The three cases have been tested on a full scale in the laboratory. The cross vault has been subjected to a settlement of one of its supports, the damage has occurred and then it has been repaired by using Textile Reinforced Mortars (TRM). In the case of the wall and the simple construction, the damage has been generalized by means of horizontal loads simulating a seismic action by a cyclic incremental load, after the generation of the damage, it has been repaired using TRM. In all cases, a dynamic identification has been carried out prior to the generation of the damage, after the generation of the damage and later after its repair, finally after a new process of damage the structural health changes have been monitored. In the four phases, an identification of the dynamic characteristics of the structures has been carried out, both main freq

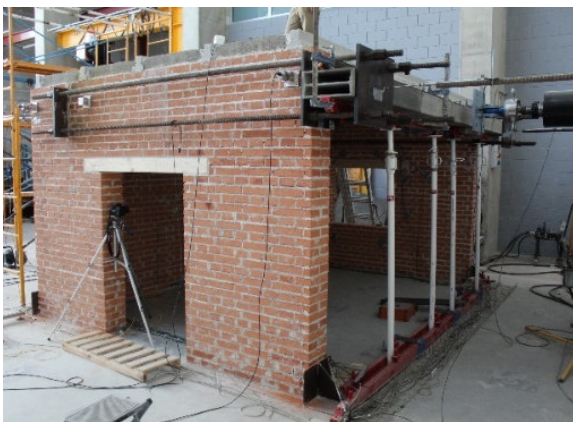
Fig. 2. Accelerometers configuration during dynamic test of simple clay brick construction.

Regarding the third structural typology, the damage introduced on the simple masonry wall construction was generated in the same way as described in the previous paragraph. The main difference between them lies in the fact that the load was applied punctually on the upper ends of the two lateral walls of the construction, and no vertical prestressed load was applied except for the weight of the roof slab itself, Figure 2.

Regarding the third structural typology, Figure 2, the cracking pattern observed varied slightly with respect to the two previous structures. In this case, the most damaged walls correspond to the exterior walls, which present cracking at 45° following the mortar zone and starting at the corners of the door and window openings, respectively. However, the wall transversal to the lateral walls did not present cracking or overturning problems around its longitudinal axis. On the other hand, regarding the dynamic results, Figure 10 show the normalized energy density spectra for the first two phases on the test. The results show the same trend as for the previous cases in relation to frequencies and damping, both with respect to the effect of damage. For the unreinforced case, the effect of cracking causes an average decrease in the vibration frequencies for the first four modes of 28.7%. Likewise, an average increase of the damping factor by 117% is also observed with initial values prior to cracking of 2.41%, 1.53%, 0.74% and 0.50% for the first four modes, respectively. In the case of the reinforced structure, the damage pattern was very similar to that observed in the case of the unreinforced structure. However, in this case, less important cracks were observed in the window zone than in the unreinforced case.

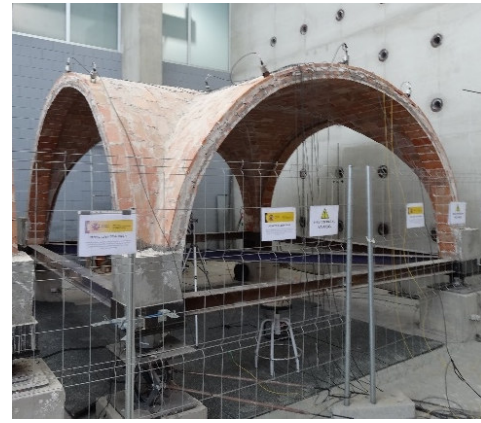
Fig. 4. Accelerometers configuration during dynamic test of the cross vault.

Regarding the generation of the damage, it has been introduced in a different way for each of the analyzed structures. In the case of the cross vault, the damage was introduced by the controlled displacement of one of the four supports of the structure to a total depth of 40 mm. This settlement was generated manually by the use of two mechanical jacks under one of the supports. Specifically, the structure rests on four supports facing each other two by two. Supports 2 and 4 have freedom of movement in the horizontal plane, but are restricted from moving in the vertical direction. On the other hand, support 3 is restricted from both horizontal and vertical displacements. In addition, support 1 also has freedom of horizontal displacement by resting the system as metal steel rollers, freedom of controlled movement in the vertical direction by resting on the displacement control jacks. Finally, it should be noted that all the supports are connected to a horizontal frame of steel beams to avoid the relative horizontal displacement of some supports with respect to the others, Figure 4.

For data acquisition, 11 piezoelectric accelerometers of sensitivity equal to 10 V/g were employed for the cross vault structure and 8 for the simple wall structure and simple construction formed by three brick walls. They were located according to Figure 4, Figure 5 and Figure 6. Signals have been registered using a data acquisition device model Kyowa PCD-320 and signal conditioner model PCB 482A22. The sampling frequency for the three typologies were 200 Hz, 1000 Hz and 1000 Hz, respectively. The source of excitation for the first and third structural typology consisted of ambient noise. However, for the second typology, a white noise signal was used by means of an exciter placed in the central area of the wall.

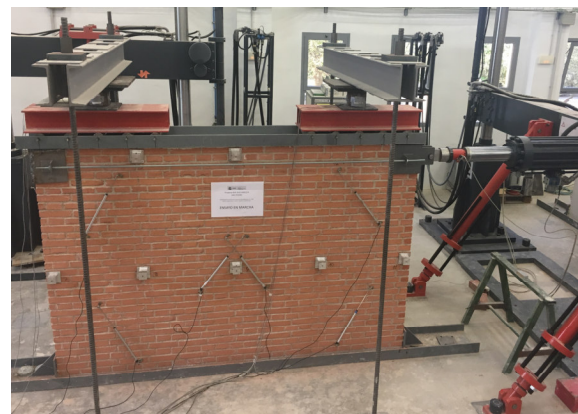
Fig. 5. Accelerometers configuration during dynamic test of the masonry wall.

In relation to the second structural typology, the damage introduced in the simple brick masonry wall was generated by the application of a point load at the top of the wall and arranged parallel to the plane of the wall. This load consisted of a cyclic displacement that varied between 0.2 mm and 12 mm in amplitude, and was applied by means of a hydraulic jack with displacement control. In this regard, it should be noted that the test configuration took into account the restriction to horizontal movement of the support points of the wall with the base. In addition, the previous stress state associated with the weight of the rest of the structure that would be arranged above the structure was also taken into consideration by applying a vertical prestressing load of 300 kN, Figure 5.

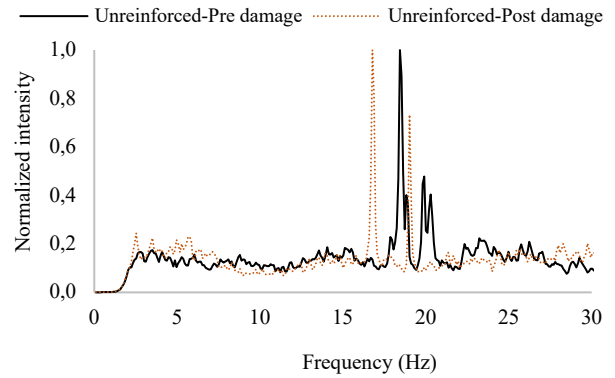
Fig. 7. Normalized frequency spectrum pre-reinforcement before and after cross vault damage.

First, in relation to the cracks observed in the cross vault, two types of damage were detected. On the one hand, cracking of the perimeter arches in the position of approximately 30% of the length of the arch measured from the start of the arch. On the other hand, cracks were detected along the major diagonals in plan of the vault body. It is important to note that although the application of the reinforcement and repair of the structure increased the maximum displacements during the test, no significant variations were noted with respect to the cracking pattern observed for the unreinforced structure. Secondly, in relation to the variation of frequencies and damping during the test, it was observed that when comparing the unreinforced-uncracked state with the unreinforced-cracked state that negative variations of frequencies between 7% and 5% have been detected after damage generation. Likewise, positive increases in the damping factor between 15% and 25% have been evaluated, with values of 0.61% and 0.357% for the first two vibration modes of the undamaged structure and values of 0.76% and 0.41% for the damaged structure, respectively, Figure 7. On the other hand, in relation to the reinforced structure, comparing the results between the unreinforced and undamaged structure versus the repaired and reinforced structure after the second phase of the test, then the results show that the type of reinforcement applied allows recovering the initial dynamic properties prior to the application of the damage, increasing the vibration frequencies and reducing the damping factor. In addition, the results obtained after comparing the reinforced structure after the new damage versus the damaged structure without reinforcement showed a similar dynamic behavior for similar damage levels, Figure 8.

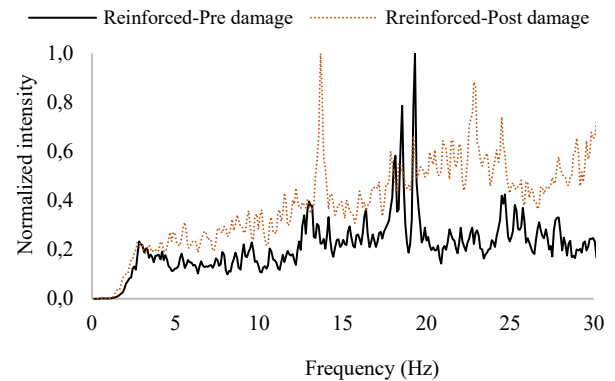
Fig. 8. Normalized frequency spectrum post-reinforcement before and after cross vault damage.

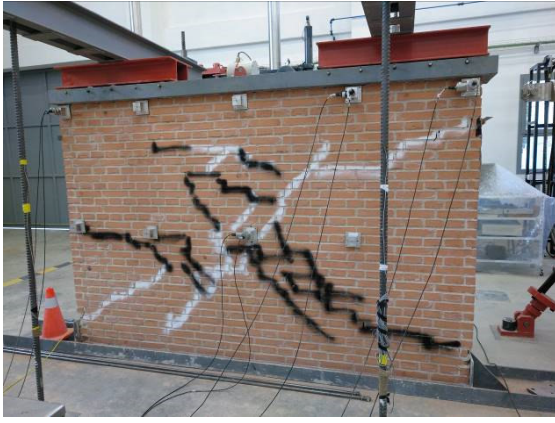
Fig. 9. Damage pattern during the test of masonry wall.

Regarding the second structural typology, masonry wall with and without reinforcement, in relation to the cracking pattern observed, a classic pattern was evaluated with diagonal cracks arranged along the mortar joints with low cracking in the brick units, Figure 9. On the other hand, regarding the dynamic results, Table I and Table II summarize these results for each of the test phases. In general terms, a behavior similar to that detected in the cross vault can be observed. That is, for unreinforced structure, vibration frequencies decrease with

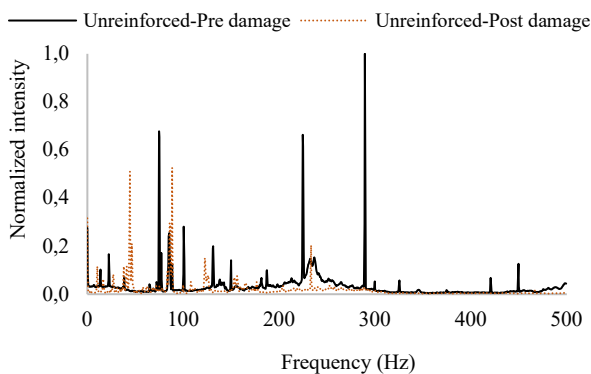
Fig. 10. Normalized frequency spectrum pre-strengthening before and after simple clay brick construction damage.

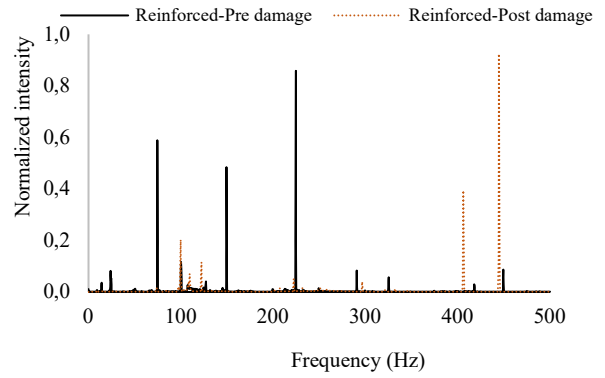
Fig. 11. Normalized frequency spectrum post-strengthening before and after simple clay brick construction damage.

On the other hand, with respect to the dynamic results, similar patterns are maintained to those defined for the case of the unreinforced structure, Figure 11. Specifically, the reinforced structure prior to damage showed frequencies significantly higher than those of the original structure with an average increase of the first four modes of 157%. However, after the application of the last phase of the test, the values of the frequencies of the reinforced model returned to values very close to the frequencies of the damaged and unreinforced structure, with an average relative error of 10%. Likewise, after cracking of the reinforced model, an average increase of the damping factor by 200%, with respect to the values of the reinforced structure, was also observed. The final damping factor values at the end of the test were 4.26%, 3.46%, 2.19% and 0.86% for the first four modes, respectively.
