DEFORMATION AND DEGRADATION STUDY USING POINT CLOUDS IN NATATIO OF THE WESTERN BATHS AT LA ALCUDIA IN ELCHE (ALICANTE)

This paper deals with the study of construction and geometry, as well as with the analysis of deformations and active degradations of the *natatio* belonging to the Western Baths in La Alcudia archaeological site. Its location in Elche-Alicante, Spain (Colonia *Iulia Ilici Augusta*), is widely known for the discovery of The Lady of Elche in 1897. The dimensions of this *natatio* in the *frigidarium* are 6.60 x 9.30 m (22 x 31 Roman feet) and 1.50 m deep, making it one of the largest Roman swimming pools documented to date on the Iberian Peninsula. The *natatio* has several cracks sealed with materials used in earlier interventions at the end of the third century. Its comparison with the hypothetical original form allowed the researchers to quantify the current deformations. A damage evolution study has been made comparing the 2016 point cloud with the 2022 cloud, both obtained by light detection and ranging (LIDAR). There is evidence that an active process of degradation and deformation is gradually increasing damage to the pool. By studying the geometry and const

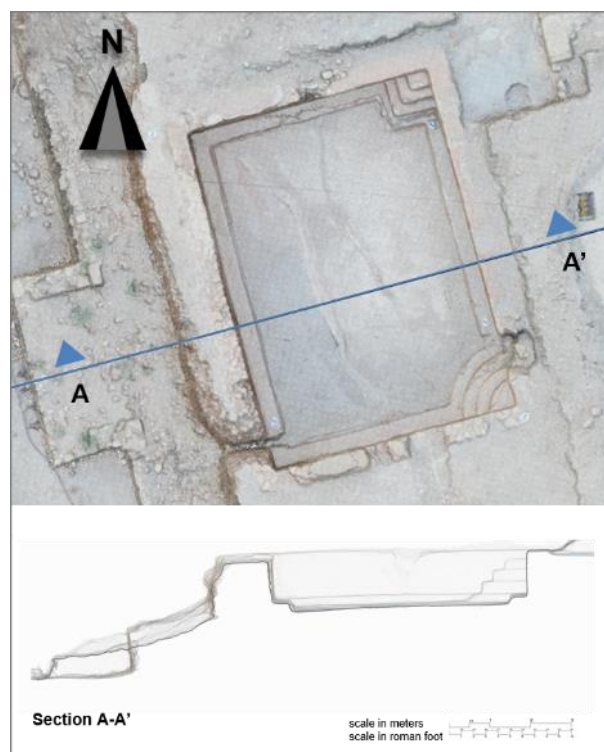
Figure 3: Orthophoto of the *natatio* at the Western Baths, the remains of the buttress of the rectangular wall can be seen on the left. A cross section is included.

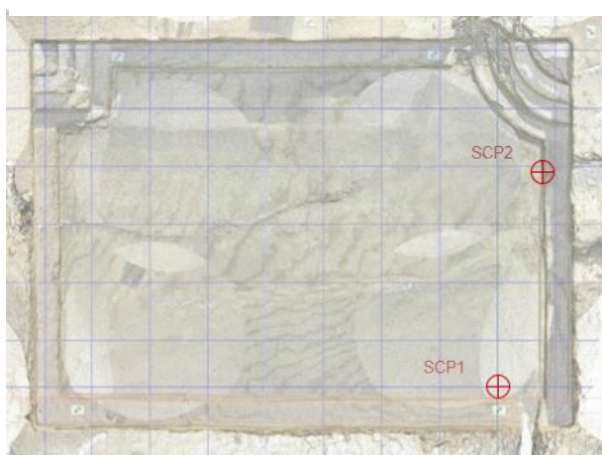
Figure 5: Point cloud of the plan natatio with reference points.

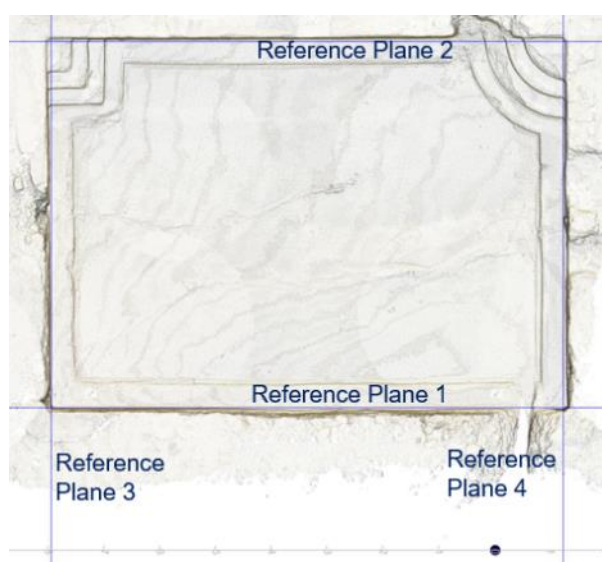
Figure 6: Point cloud of the natatio in plan with lines with the reference plane in blue.

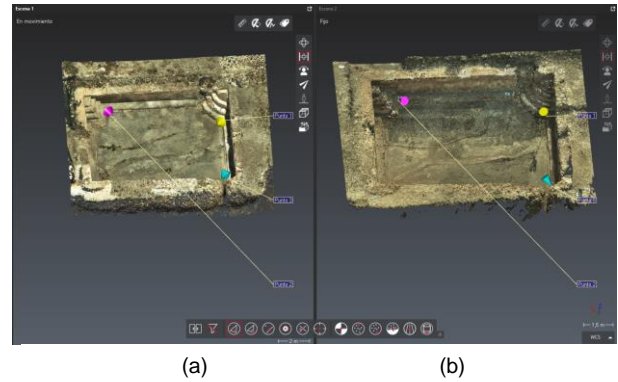
Figure 8: Points for the alignment of the point clouds: a) performed at the end of 2016; b) performed in 2022.

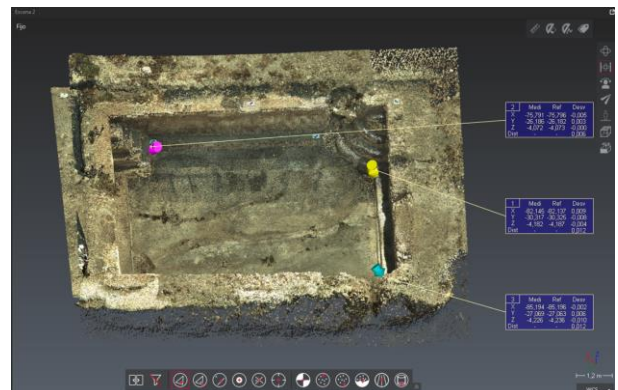
Figure 9: Cloud alignment with Cyclone 3DR.

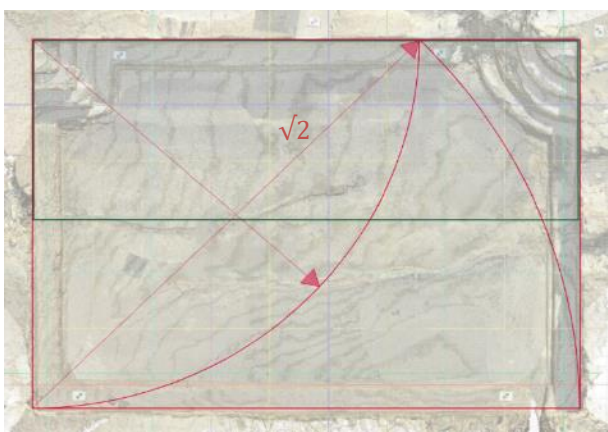
The proportions of the sides of the rectangle of the *natatio* correspond to $\sqrt{2}$, as seen in Fig. 11, a typical design in some Roman constructions (Vitruvio, 2000; Esteban, 2001). The hypothetical shape of the original *natatio* is also shown in Fig. 11 in green.

Figure 11: Proportion study. The green line corresponds to the dimensions of the hypothetical original *natatio* area and the red lines to the current *natatio*.

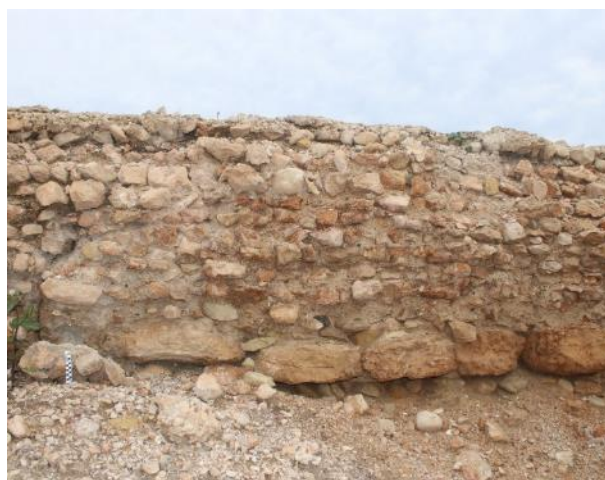
The exterior of the west wall has been exposed due to landslides from the filling of the expanded space. This has allowed us to obtain more accurate data and to observe the differences both in the structure and in the materials used in its construction with regard to the eastern half (Fig. 13).

Figure 13: Photography of the back of the East wall. The rudus, the calcarenite blocks and the masonry of the wall are observed.

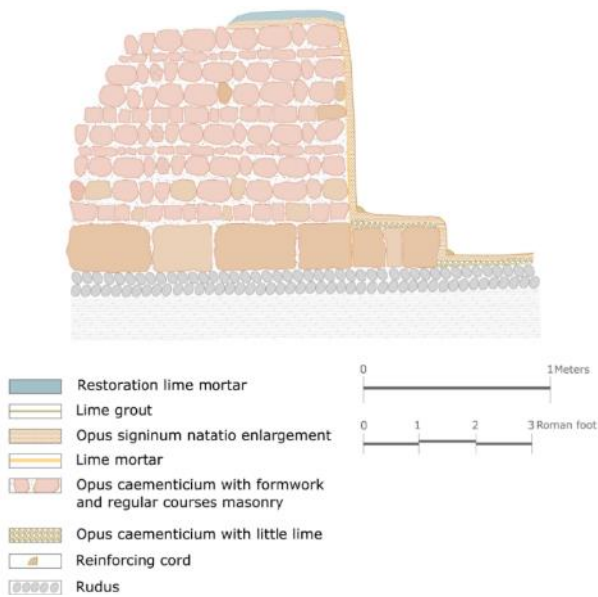
Figure 14: East *natatio* wall section drawing.

The archaeological sequence indicates that in the part of the filling that fills the space between the old wall line and the new work that delimited the baths to the west, there is a *rudus* or foundation preparation, consisting of pebbles of fluvial origin arranged mostly inclined (Fig. 14).

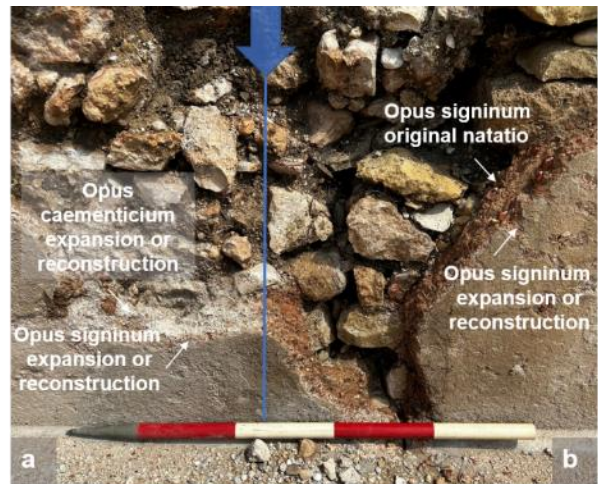
Figure 15: Photo of the north wall. The difference between coating mortars is observed: a) Extended *natatio*. b) Original *natatio*.

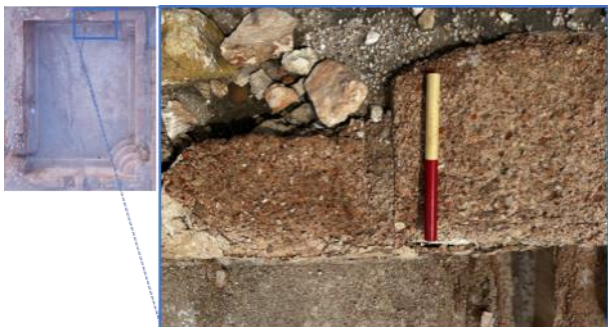
Lastly, various elements are related to the collection and outlet of the water in the *natatio*. On the northern parapet, an interruption of the *opus signinum* of the coating can be detected, forming a channel 6 cm wide (1/5 Roman foot) (Fig. 16). It is possible that a pipe was housed in this crevice through which water was supplied to the basin. Subsequently, the channel is filled with a different mortar, blocking this supposed water entrance. At the base of the southern wall, in front of the aforementioned channel, there is a circular drain, 12 cm in diameter (2/5 Roman feet), where a lead pipe is housed. Its position suggests that it communicated with a section of the internal sewage pipes of the city excavated a little further to the south.

Figure 16: Photo of the north wall parapet. Semi-cylindrical hole 6cm in diameter filled with mortar is observed.

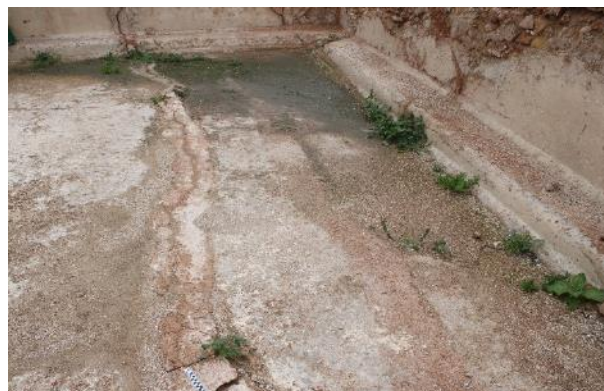
This building has several deformations and fractures. Some cracks were repaired with *opus signinum* as early as the Roman period. These cracks were sealed by slightly protruding from the surface of the bottom of the *natatio* (Fig. 17). In order to determine the possible causes of the movements, which in turn led to the cracks,

Figure 17: Appearance of the bottom of the *natatio* with cracks sealed with *Opus Signinum* creating a curved ledge. Photo taken in December 2022.

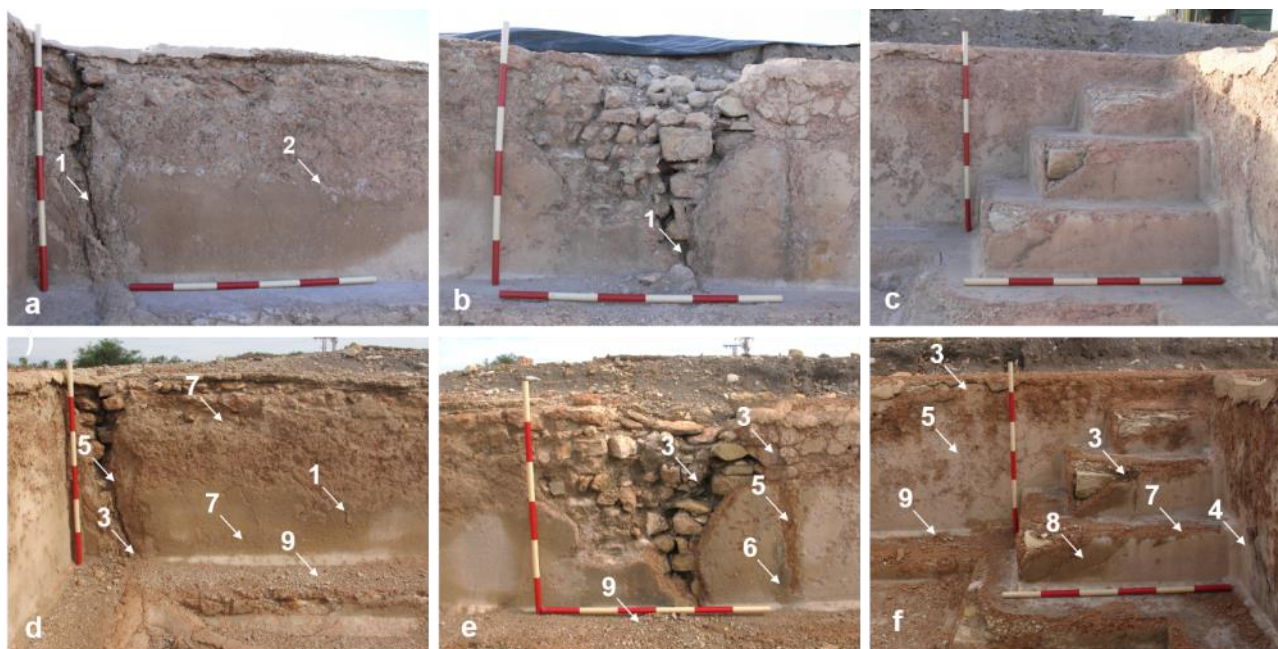
Figure 19: Different aspects of the north wall. Pictures a), b) and c) from the year 2016, photos d), e) and f) are from 2022. The following damages are indicated: 1.- Crack, 2.- Efflorescence, 3.- Detachment, 4.- Exfoliation, 5.- Erosion, 6.- Biological colonization, 7.- Granular disintegration, 8.- Discolouration, 9.- Stone and mortar detritus.

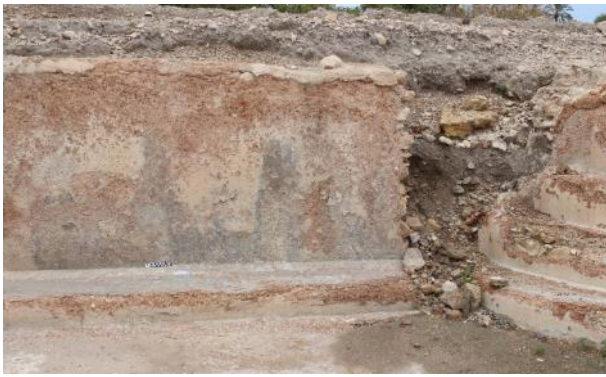
Figure 22: Appearance of the east wall next to the staircase in the southeast corner in 2022.

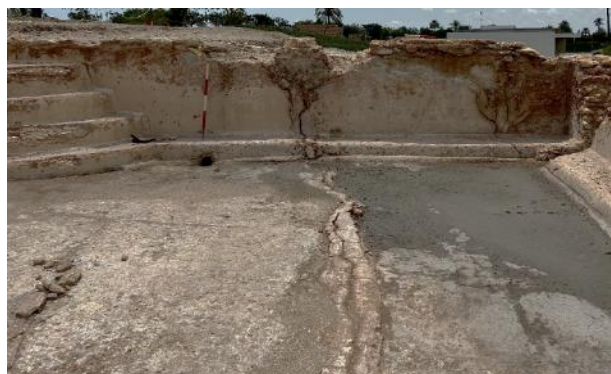
Figure 25: Appearance of the southern face in the year 2022.

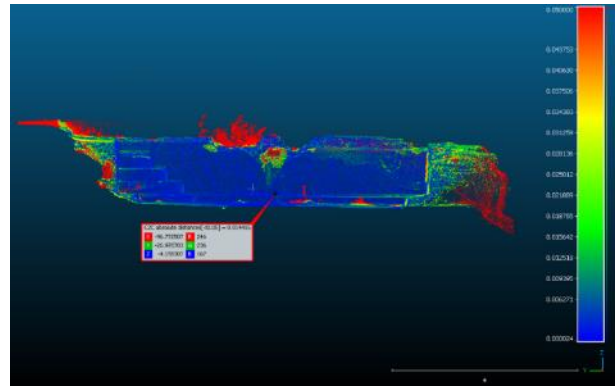
Figure 27: Point cloud overlay of the south wall in 2016 and 2022.

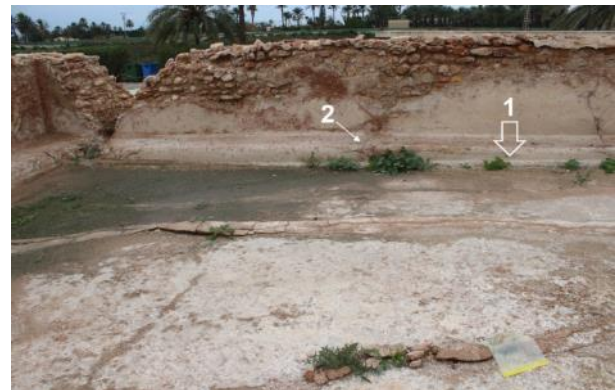
This wall shows numerous deformations and degradations. There is a high loss of part of the wall in the southern corner with a fracture that cuts through to the base of the wall (Fig. 28).

Figure 28: Appearance of the west face in the year 2022. Indicated as "1" is the arch-shaped discharge saddle. A recent crack is indicated as "2".

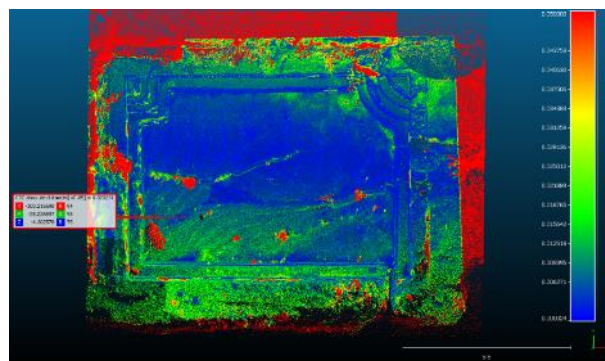
Figure 31: Comparison of point clouds for the year 2016 and 2022 of the bottom of the *natatio*. Matching points are shown in blue, all other colours imply changes in the geometry of the *natatio*. The red colour indicates differences greater than 5 cm.
