THE USAGE OF TLS AND PHOTOGRAMMETRY DURING THE RESTORATION PROCESS OF SPANISH NATIONAL MONUMENT

Yolanda Spairani-Berrio^{1*}, Pascual Saura Gómez¹, J. Antonio Huesca-Tortosa¹, Silvia Spairani Berrio¹, David Torregrosa Fuentes¹

¹ Department of Architectural Constructions, Alicante University, Alicante, Spain. yolanda.spairani@ua.es; pascual.saura@ua.es; jahuescat@gmail.com; silvia.spairani@ua.es; dtfuentes@hotmail.com

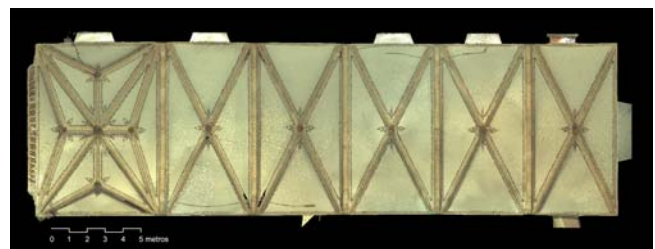
Figure 1: Zenith view of the vaults

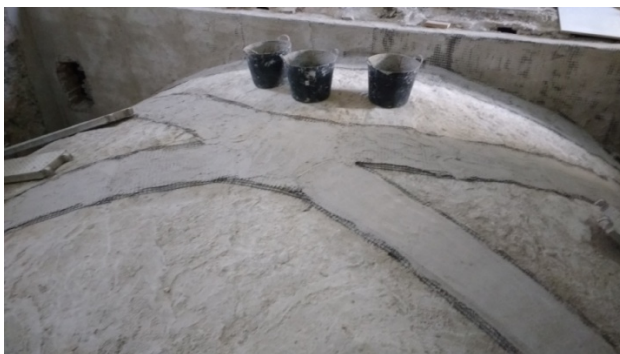
Figure 2: Reinforcement with Planitop HDM and fiberglass Mapei

2.3. The outside wall has been stabilized and consolidated by injecting fluid lime mortar. The existing cracks in vaults and arches have been sealed with special lime mortars, and some stitching with fiberglass rods has been made. For the purpose of binding the walls closing the refectory, steel braces system has been prepared. The vaults extrados has been reinforced using rendering with two-component mortar fiber-reinforced PLANITOP HDM, restoration reinforced with fiberglass mesh from the Mapei brand.

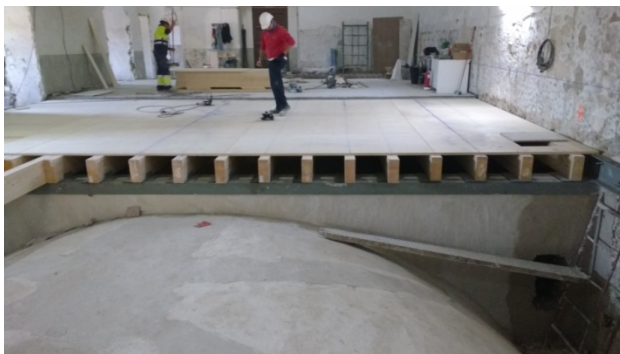
Figure 3: Reinforcement on wall ribs

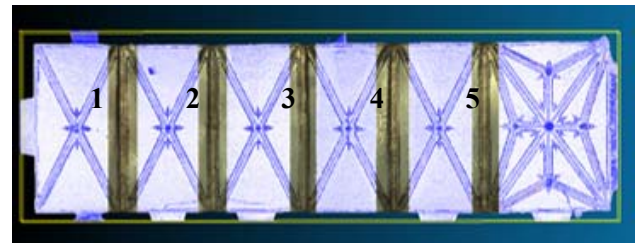
Figure 4: Part of vaulted structure: numbers of archs

sections that allow us to analyze both the dimensions of the different construction systems as deformations and displacements produced, both the arches-nerves and the vaults. Of all the results obtained and in order to generate a valid criterion to analyze the behavior of the vaulted structure of the Refectory, has been considered in each of the nerves (archs 1, 2, 3 and 4) points A, B and C in the intrados of the arch, corresponding to 1/4, 1/2 and 3/4 of the light, and that approximately concur with the kidneys and key of the archs.

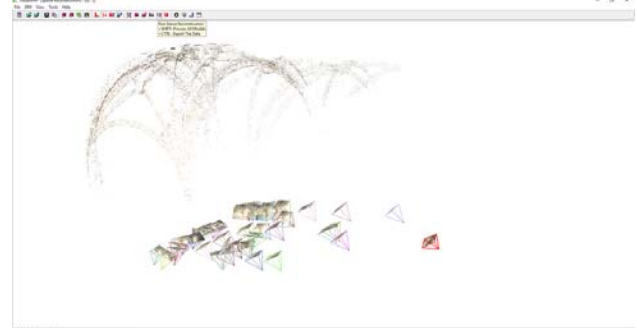
Figure 5: location of photographs in Visual SfM

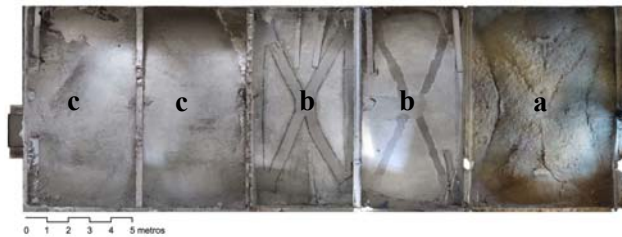
Figure 8: Vaults extrados on its different restoration stages (a): original, (b): during restoration, (c) finished. Photogrammetric study by Agisoft Metashape

It has also been a great help to document the construction phases of the walls faithfully in order to carry out archaeological studies of them, currently in the drafting phase of the final archaeological and architectural report (e.g. figure 8 and 15)

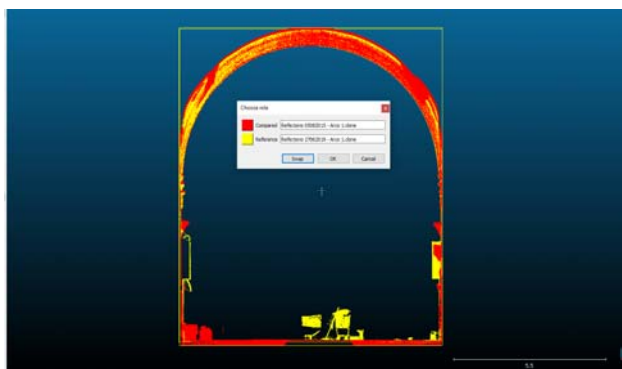
Figure 9: comparing cloud to cloud with Cloudcompare. Clouds data 2015 and 2019

The comparative studies carried out from the data collection with the techniques referred to in August 2015 and June 2019 (once the execution works of the new slabs have been completed, including the reinforcements in vaults and arches) reflect a null movement of the structures, no deformations have made compared with to the first state. The data obtained in the measurements reflect the point clouds and they contain absolute errors of the order in 1-3 mm, in such a way that the differences between the initial and final measurements are in the aforementioned interval of 1 mm.

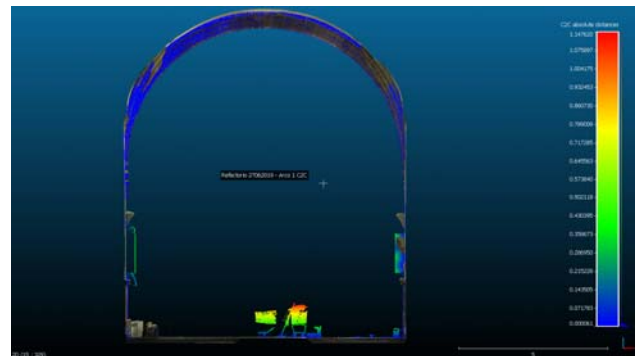
Figure 10: comparing cloud to cloud with Cloudcompare. Deformation study en arch 1

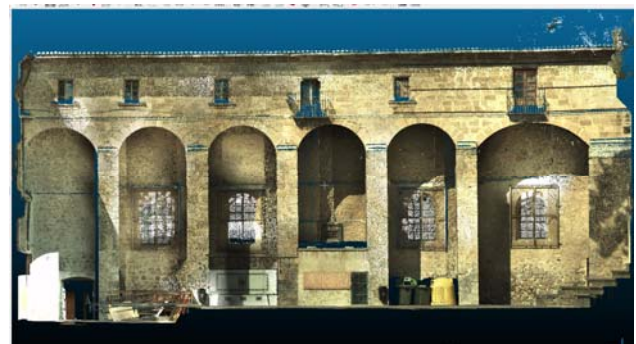
Figure 12: East facade with perceptible deformation

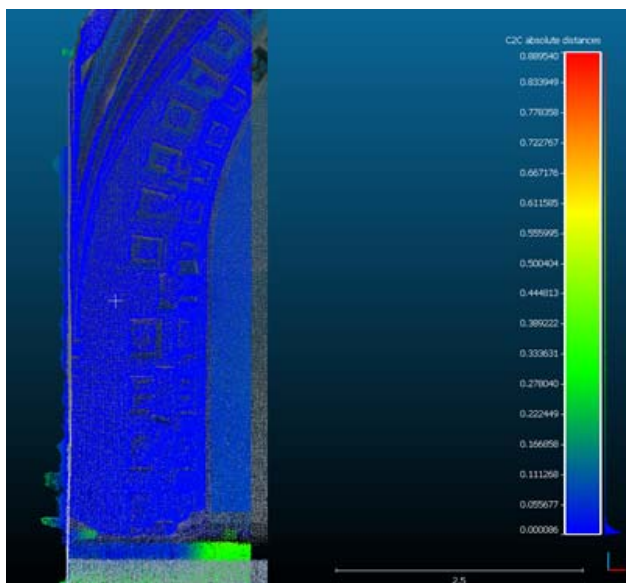
Figure 13: Crack location in wall: depth study and evaluation

With the comparison of point clouds (original-final) it has been possible to quantify the deformations of some elements, as well as their location. Specifically in relation to the areas affected by movements of the nerves of the vaults (difference of position in its initial state and its final final state, e.g. figure 13). And to quantify the depth of some of the most important cracks that the building presented (e.g. figure 12).

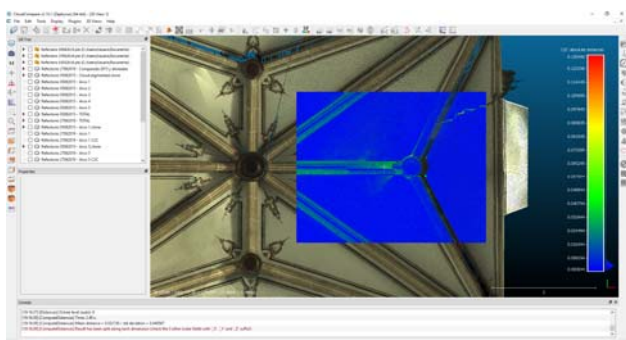
Figure 14: Deformation and descent of cross vault nerves moving evaluation

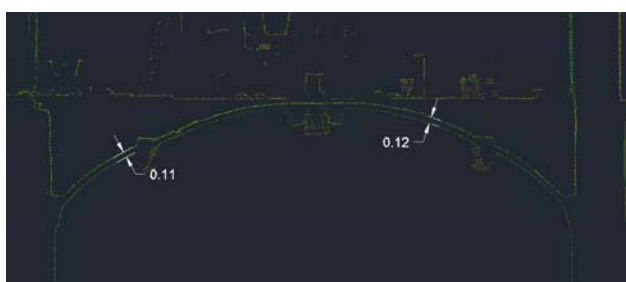
Figure 15: Point cloud section during the restoration works. The measure of the vault section can be obtained.

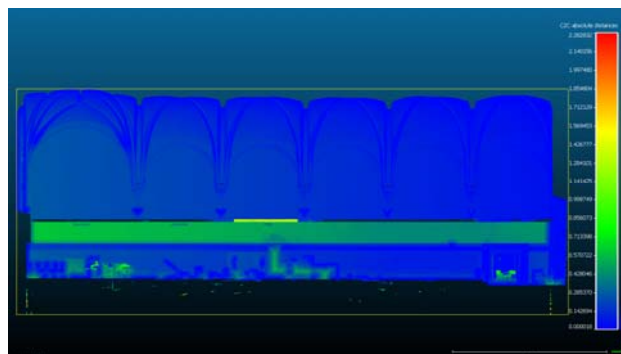
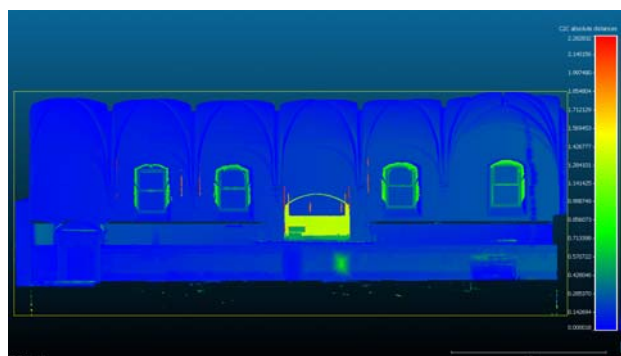
Figure 16: Cloud to cloud comparison (original state and final state) lateral east and west
