# Violin Ceramic Joist Slabs: Evaluation and Proposal for Intervention with Duplex-Type Stainless Steel

Antonio Salmerón <sup>1,\*</sup>, Miguel-Ángel Climent <sup>2,\*</sup>

**Citation:** Salmerón, A.; Climent, M.-Á.; Ivorra, S. Violin Ceramic Joist Slabs: Evaluation and Proposal for Intervention with Duplex-Type Stainless Steel. *Buildings* **2022**, *12*, 942. <https://doi.org/10.3390/buildings12070942>

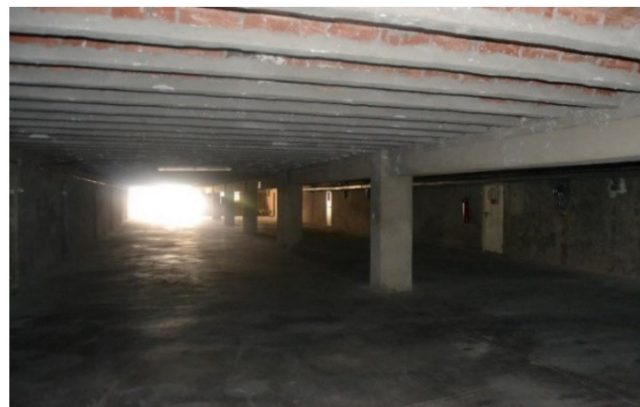
**Figure 3.** General view of building's basement.

The building basement had undergone a series of previous repairs aimed at solving the corrosion problems of the lower steel rebars of the ceramic joists. Besides the original non-repaired joists, we found zones with two different types of repairs, which were distinguishable due to their different external appearance. These reparations had not succeeded in solving the problems (see Figure 4). Hence, we were faced with various degrees of

deterioration of the joists, all due to reinforcement corrosion [28], which pointed out the urgent need for an overall general intervention.

After analysing the underlying causes, it was decided to perform a general intervention on the entire basement joist slab. This had direct consequences for defining the CTE requirements [22–24] that had to be satisfied by the repairs, since they had to comply with the existing legislation in aspects such as mechanical capacity, durability, fire-resistance, etc.

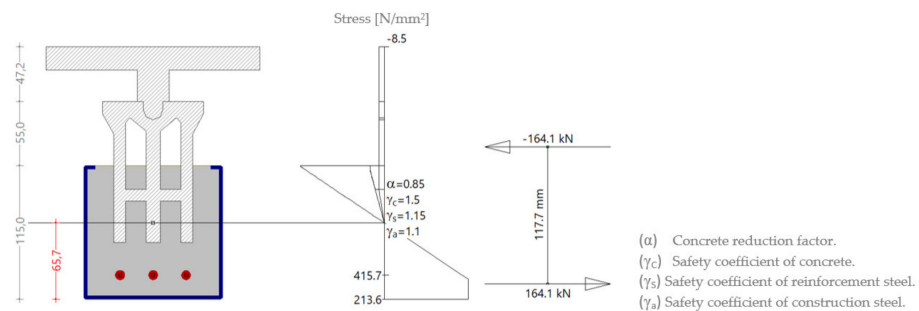
The bending moment load in this case for the larger span was 15.66 kN·m and the structural analysis obtained an efficiency coefficient of 0.81 in the reinforced section (see Figure 11).

**Figure 11.** Verification of 81% efficient reinforced cross section (dimensions in mm).

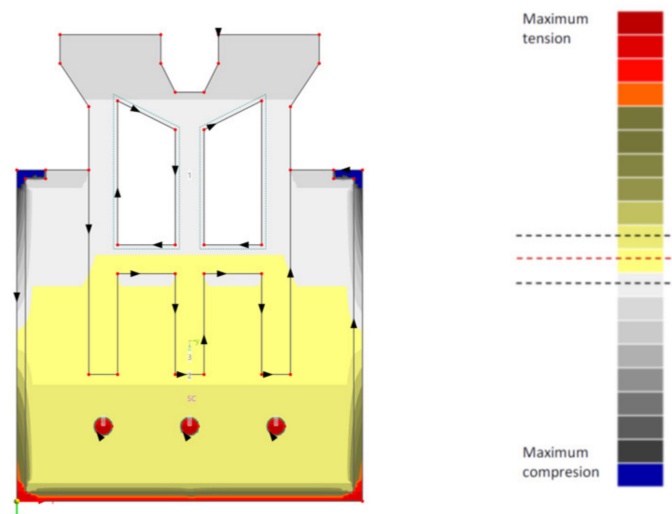
The results of this analysis indicated that most of the strengthening concrete remained in the tension zone so, should better efficiency be required, it would still be possible to use fibre-reinforced concretes and maintain the present geometry.

We could also predict the points with the highest compression forces in the upper surface of the sheet steel box of the prosthesis. As there was a high stress difference between the metal and the concrete cover, at near-breaking point both would become separated by deformation of the metal.

**Figure 12.** Finite element stress distribution diagram.

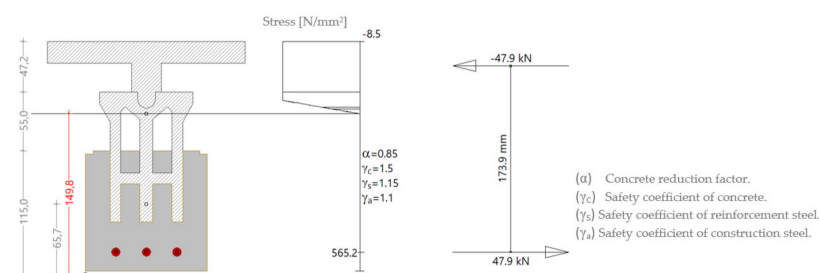
The bending moment loads for the largest span was thus 8.01 kN·m and the situation of an accidental fire gave us 96% efficiency for the strengthened section without the external stainless-steel mould (see Figure 13). Through this procedure, the capacity of the section to accidental actions is verified.

**Figure 13.** Verification of strengthened section without metal sheet at 96% efficiency (dimensions in mm).

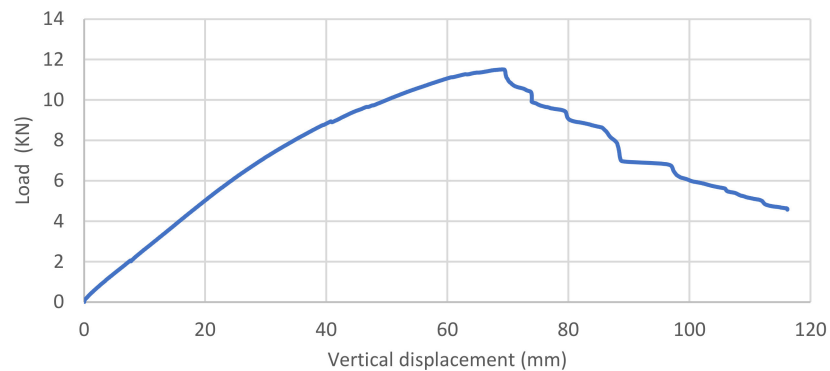
**Figure 16.** Stainless steel prosthesis third-point loading test. Applied load (kN) vs. vertical displacement (mm) in the centre of the span.

The first experimental results indicate that we reached a resistance capacity of 8.91 kN·m compared to a design bending of 15.66 kN·m at the centre of the span, that is, practically with the prosthesis (see Figure 17) we were able to achieve 57% of the requested mechanical design features, and 111% of the requests referred to in accidental fire situations.

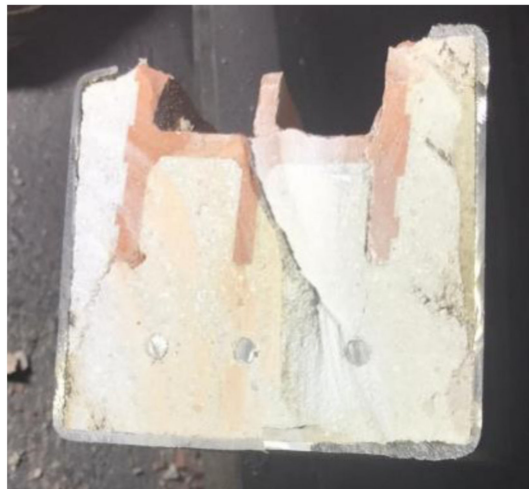
**Figure 17.** Test of prosthesis cross section.

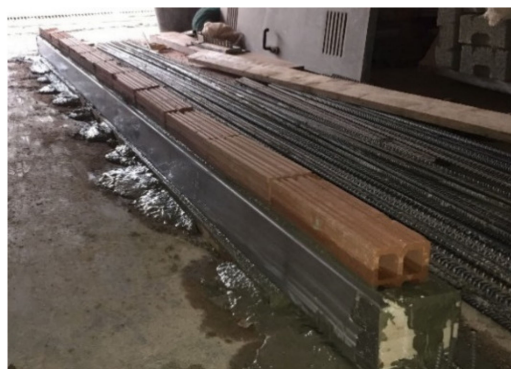
**Figure 18.** Specimen for the flexural test. Clay joist violin reinforced with a stainless-steel prosthesis.

This new model of joist was proceeded, under the same boundary conditions as the first specimen, to its test until failure (Figure 18). The second sample obtained a maximum failure moment of 23.80 kN·m, which practically tripled the behaviour of the mechanical capacity of the first model, prosthesis in isolation (see Figure 19), and was approximately 52% higher than the calculated design forces for the slab under study.

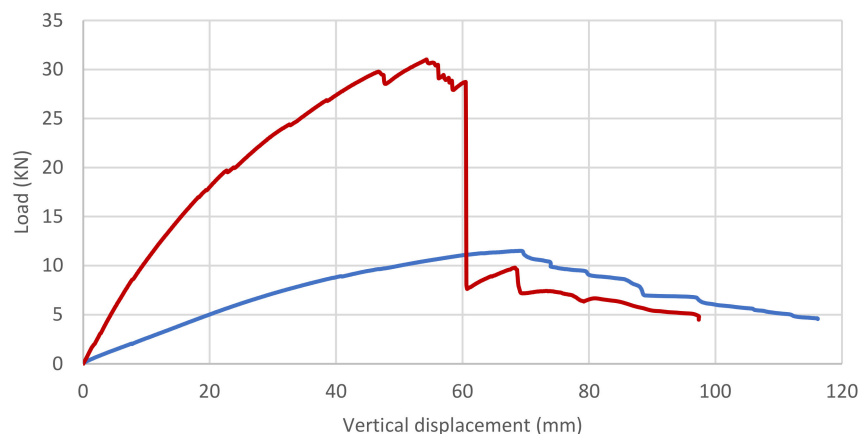
**Figure 19.** Flexural tests. Applied load (kN) vs. vertical displacement (mm) in the centre of the span. Blue line: Stainless steel prosthesis specimen. Red line: specimen of a clay joist violin reinforced with a stainless-steel prosthesis.

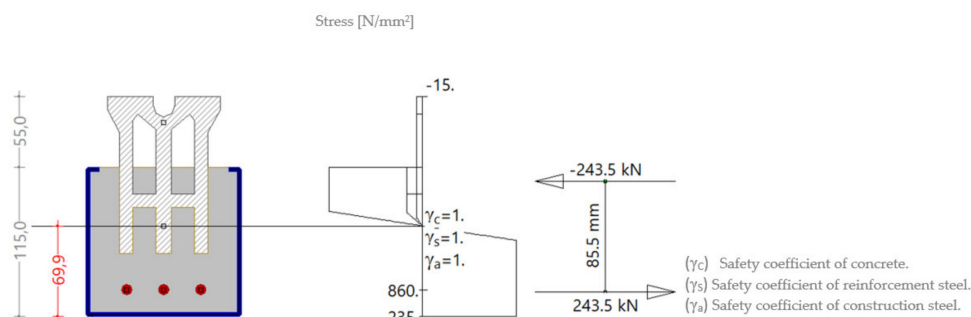
**Figure 20.** Structural analysis of isolated resistant section without safety coefficient  $M_f = 20.80$  kN·m (dimensions in mm).

In the prosthesis breakage test, the prototype reached a bending capacity of 23.80 kN·m, while that reached by the theoretical model without safety coefficients of the materials was 20.80 kN·m, i.e., a difference of 3 kN·m, indicating a residual value tolerance coefficient of approximately 1.14.

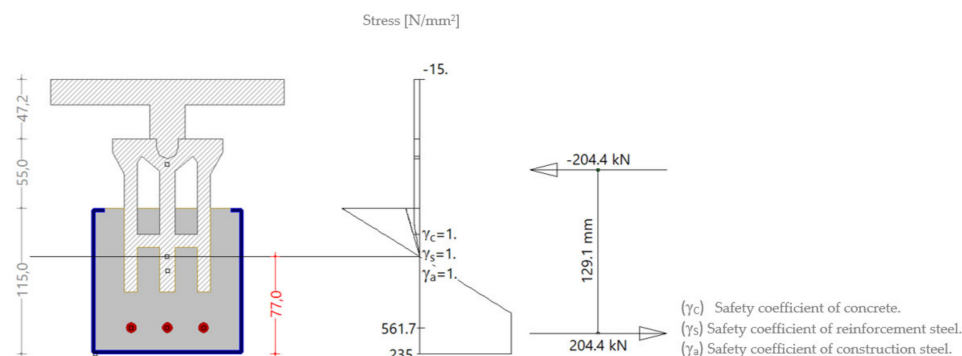
Finally, we must not forget that this intervention has to contend with a 50-year-old construction system with tolerances, quality, and homogeneity far-removed from modern systems. If we reproduce the design model in Figure 11, reducing the concrete and steel safety coefficients, we obtain a section efficiency of 60% (see Figure 22).

**Figure 22.** Structural analysis of reinforced section without coefficients with 60% efficiency (dimensions in mm).

This implies that the system provides a residual safety margin of 40%, even though it only acts on the lower third of the original section.
