**MULTITECHNICAL APPROACH FOR DAMAGE ASSESSMENT AND  
REINFORCEMENT OF BUILDINGS LOCATED ON SUBSIDING AREAS: STUDY  
CASE OF A 7-STORY RC BUILDING IN MURCIA (SE SPAIN)**

E. Díaz<sup>1</sup>, P. Robles<sup>2</sup>, R. Tomás<sup>3</sup>

The work presented herein proposes a multitechnical methodology for damage assessment and reinforcement of buildings located on areas affected by land subsidence induced by water withdrawal. The proposed methodology is illustrated by a comprehensive damage assessment and subsequent reinforcement of a 7-story reinforced concrete building located in the city of Murcia (SE Spain). Construction took place in the 1980's and the building was severely damaged by differential settlements caused by land subsidence throughout time. The building suffered an important tilting, presenting maximum settlement and tilt values of 260 and 177 mm, respectively, which considerably reduced its habitability and security conditions. Damage began to manifest in 1995, coinciding with an intense drought that affected the Murcia area between 1991 and 1995. Average piezometric level decreases of at least 8 m were verified, reaching 10 m in the nearby areas of the building. The

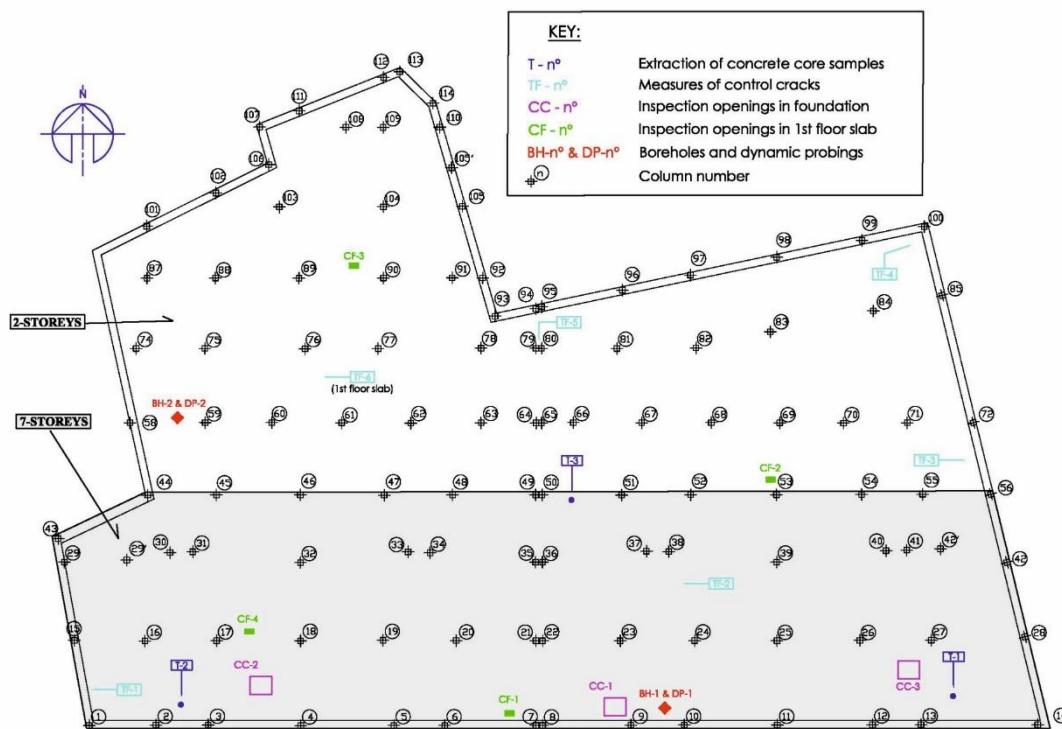
75 The gross floor area of the building is 1861 m<sup>2</sup> (Figure 1). This area is fully occupied by parking  
76 in the basement, and is divided into two different zones, starting from the ground floor: a) the first  
77 zone is founded on isolated footings and has not been strongly affected, and b) the second zone

87 This fact, together with the difference in height between the two areas of the aforementioned  
 88 building, causes asymmetry in the distribution of loads, where the most heavily-loaded columns  
 89 are those surrounding the South façade.

90  
 91 *Figure 1. Basement plan of the building with the location of the tests developed. The shadowed area corresponds to*  
 92 *the 7-storey zone of the building.*
