Restoration of the facade of the church of San Pedro Apostol in Agost, Spain

This work describes the studies and the intervention carried out for the restoration of the facade of San Pedro Apostol in the parish church of Agost. This facade was made at the end of the 18th century in limestone. After an initial inspection and graphic survey of the facade, the lesions, their origin and the solution to them were identified by using advanced restoration techniques. The stone elements damaged or destroyed by the passage of time are composed of calcite, dolomite and silica, with plaster joints, and have been reconstructed either through the use of new elements or, for the most part, through systems of recovery of the initial volume with the use of a light core of polystyrene, lime mortars, expanded clay, fiberglass and carbon together with infiltrations of resins in the disintegrated areas. After a delicate intervention process using innovative techniques, the facade was completed in June 2023.

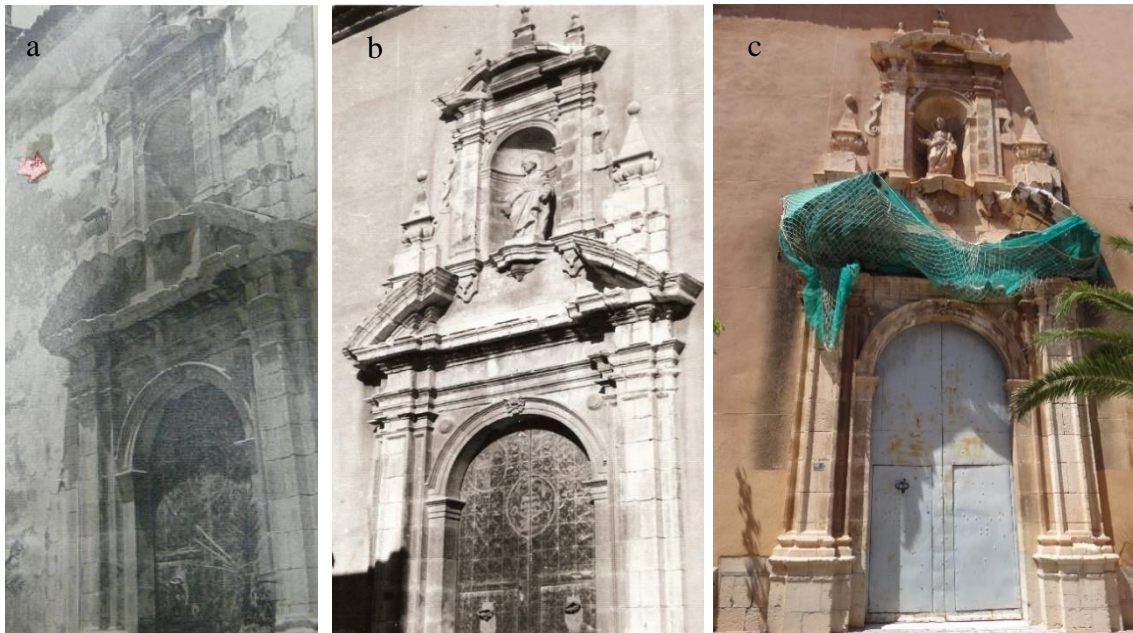
During the Spanish Civil War (1936-39) the building suffered considerable damage and even suffered a fire. The existing images on both façades were destroyed, particularly the image of Saint Peter on this façade (Figure 2a). After a major intervention of the building in the 1960s, there have been no further major structural interventions affecting this façade (Figure 2b). In 2014, some detachments were detected in elements of this façade and a protective net had to be installed, which had to be replaced again in 2021 due to detachments of stone elements (Figure 2c). In 2023, the restoration process began following a study and a project carried out at the University of Alicante.

Figure 2. Photographs of various historic situations (a) 1964, (b) 1973 (c) 2021

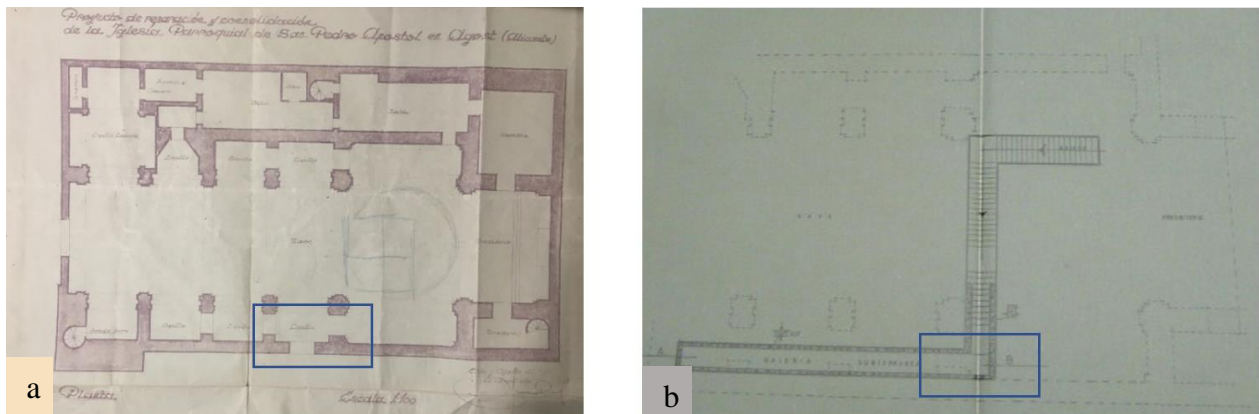
The collection of documentary data has been carried out especially in the parish archive and the Serrano y Valderrama architecture office in Elche, where the studies and project of the architect Antonio Serrano Peral, who worked on the church in the mid-20th century and was the author of the drawing in Figure 3, are kept. Mainly cracks in the interior and façades of the building caused by the excavations carried out inside the church. The damage to the doorway is not described, although the wall that supports it has a crack next to it on the right-hand side, probably due to the same cause as the cracks in the interior. Figure 3b) shows that there is a hollow area next to the façade containing the doorway, which corroborates the origin of the fracture.

Figure 3. a) General drawing of the church made for the intervention carried out in the 1960s by Antonio Serrano Peral. b) Detail of the staircase and excavated area inside the church. The location of the doorway under study is indicated. Source: private archive of the Serrano Peral family.

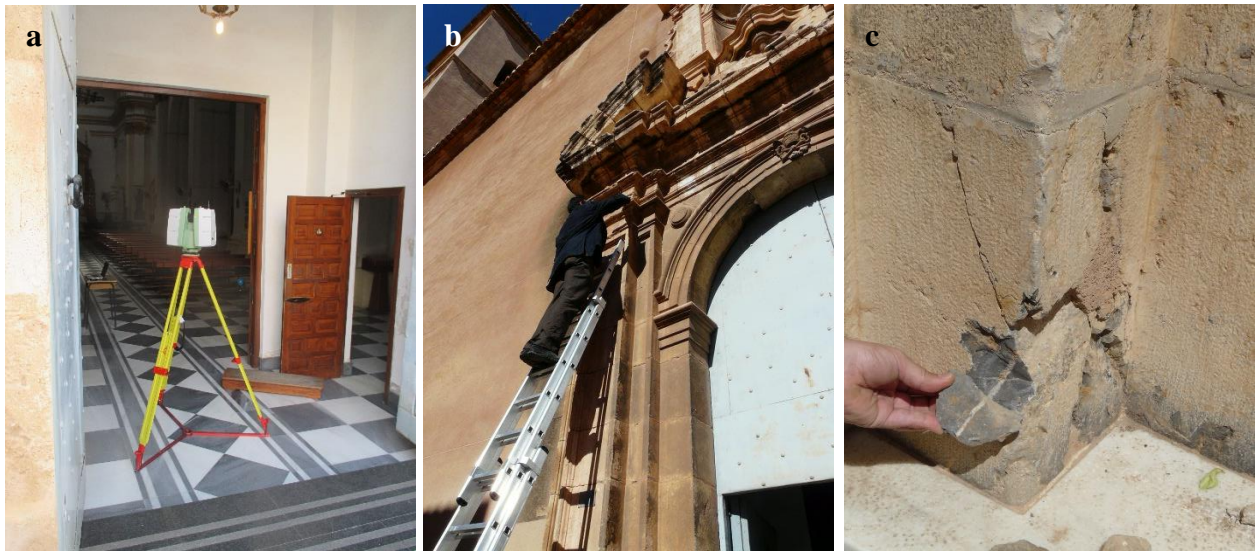
The in situ data collection was carried out on the basis of the point cloud obtained with a laser scanner. Samples were taken without degrading the doorway, following the recommendations of experts such as Esbert and Losada (2003). Small fragments of beige calcarenite stone deposited on the cornices and a loose flake of the black stone at the base were taken (Figure 4).

Figure 4. Different aspects of data and sample collection. a) Detail of geometric recording with laser scanner. b) Collection of samples of loose fragments on the cornice. c) Black stone flake in lower corner for observation.

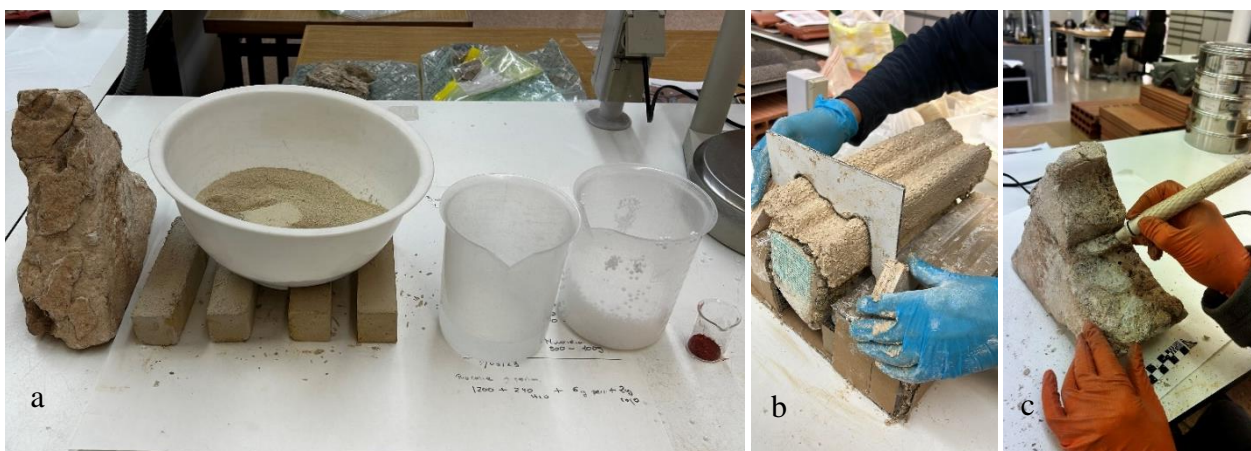
A fragment that had become detached from the façade was taken to the Architectural Constructions laboratory of the University of Alicante and was used as the basis for the study of density and colour, as well as for testing cleaning techniques. Figure 10 shows some of the tasks carried out in the laboratory.

Figure 10. Different aspects of the previous studies carried out for the restoration of the doorway. a) Components prepared to make test specimens for subsequent study together with the fragment of the cornice of the doorway (bio-lime, water, eps beads and natural pigments). b) Detail of the test carried out in the reintegration laboratory with a light polystyrene core and exterior lime mortar. c) Detail of a cleaning test using ultrasound.
