Use of LiDAR Technology for the Study and Analysis of Construction Phases and Deformations in the Gothic Church of Biar (Spain)

Abstract: This work provides new data on the church of Nuestra Señora de la Asunción in Biar, combining the investigation of documentary sources with the analysis of the geometry obtained using LiDAR technology and the study of stone materials. This monument has a Proto-Renaissance façade of great architectural value, as it was the first building in the province of Alicante, in Spain, to use Renaissance decorations at the beginning of the 16th century. Its main façade reflects the four centuries of its construction from the 15th to the 18th centuries. The building has been digitised using LiDAR technology and photogrammetry. The graphic representation of the point cloud obtained from the aforementioned techniques makes it possible to study deformations in colour gradient with respect to a reference plane. The results obtained after the analysis of these data show that the method used in this work has served to detect and corroborate the constructive evolutions of the church obtained from the documentary sources investigated. This work serves as an example

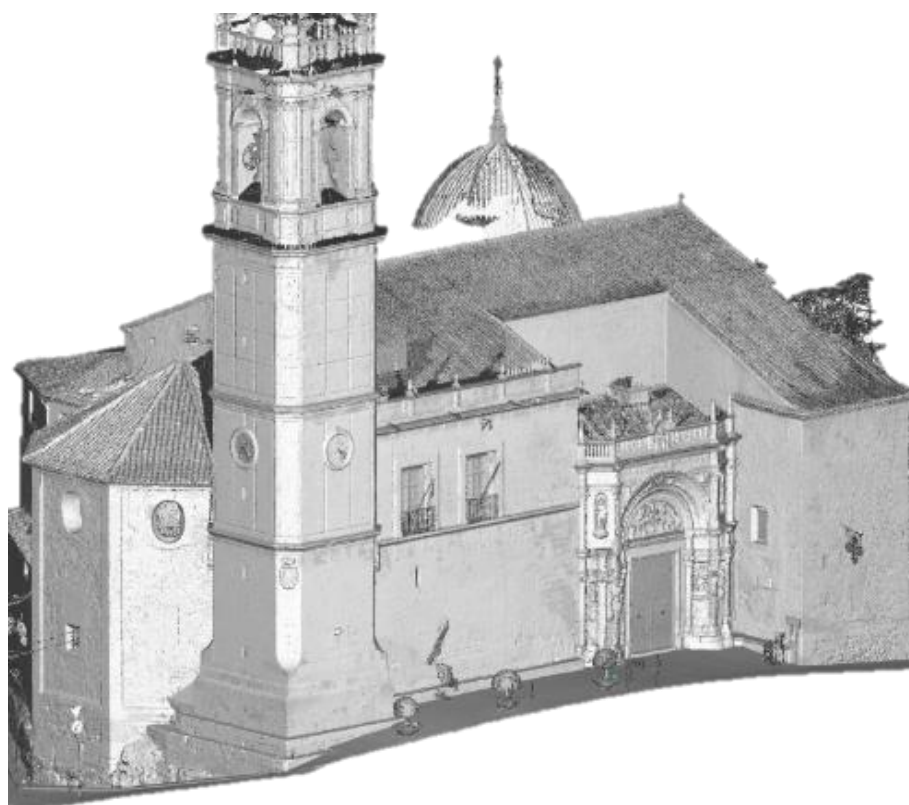
Figure 1. Modelling of the church based on a point cloud obtained with LiDAR. Northeast façade containing the Proto-Renaissance doorway.

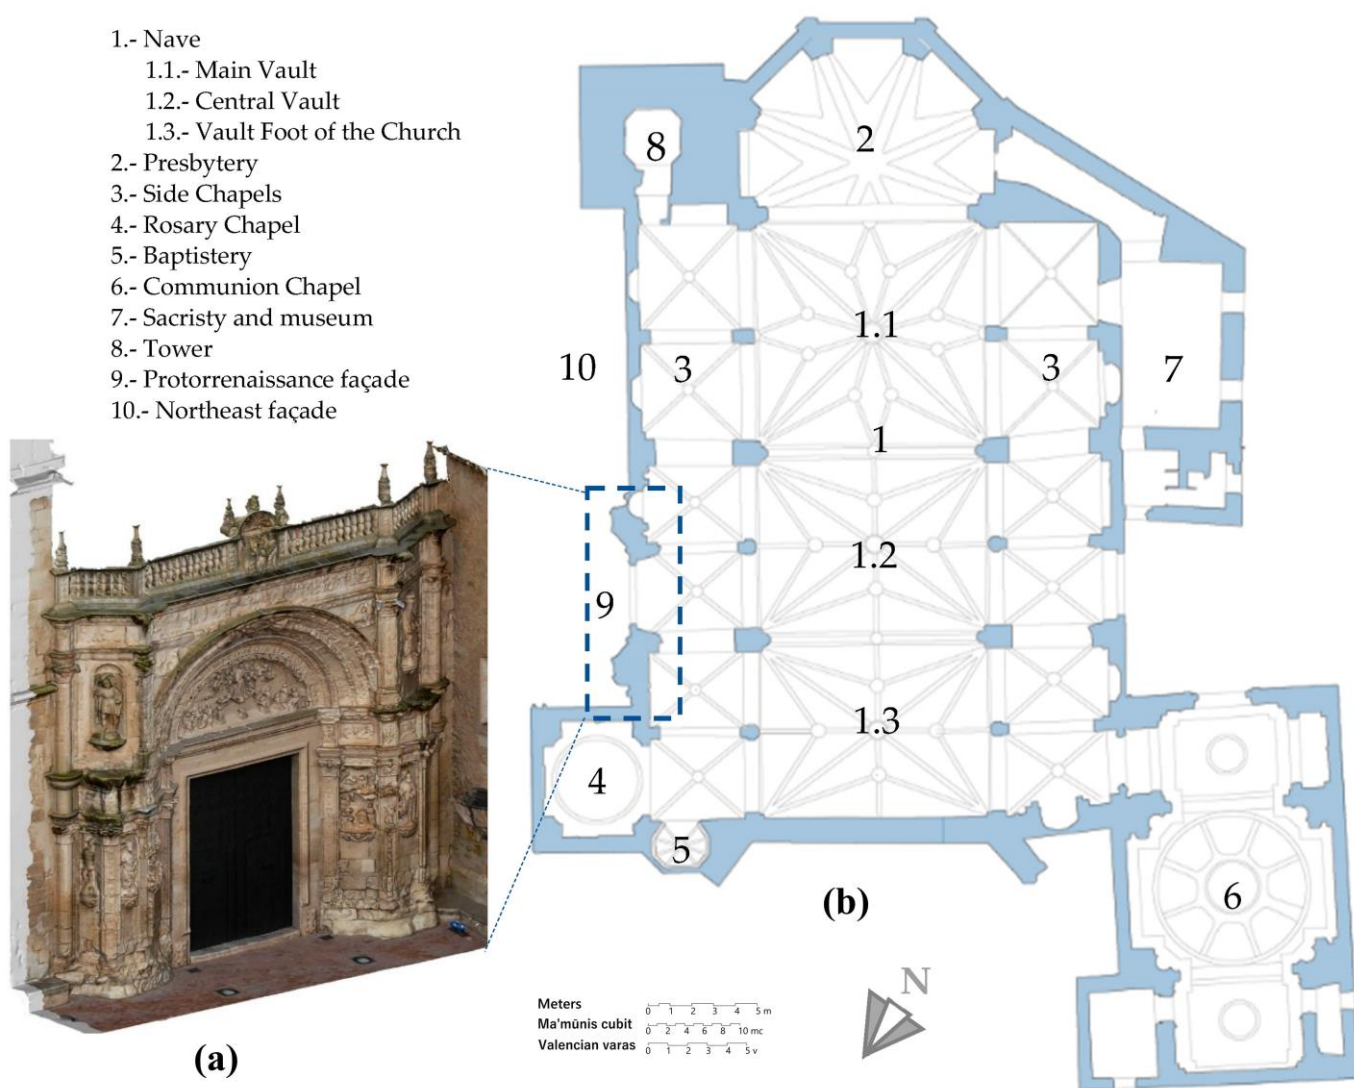
Figure 2. (a) Proto-Renaissance doorway. (b) Plant with identified parts.

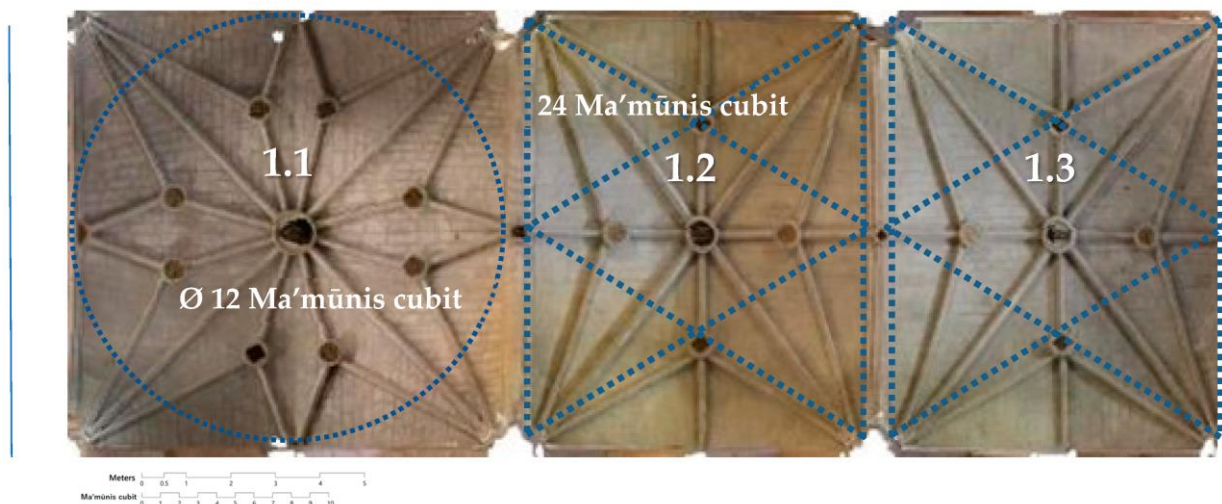
The vault located further south (numbered 1.1 in Figure 3) is made of carved stone with ribs in the shape of an eight-pointed star and, in plan, corresponds to the proportion “ad quadratum” [25–27]; its side measures 10.08 m, which does not belong to the Valencian Gothic, according to Zaragoza [27]. This figure corresponds exactly to 24 cubits Ma’mūnis, the usual measurement in the Almohad period, which corresponds to 42 cm [28,29]. The other two vaults have a rectangular plan, the proportions of which are obtained ad triangulum from the 24 cubits Ma’mūnis, and they are built with a vault with stone ribs forming tercelets. In the aisles, there are six ribbed vaults on each side.

Figure 3. Orthophotography of the central nave vaults.
