Dynamic Investigation of an Ancient Masonry Bell Tower with Operational Modal Analysis

A Non-Destructive Experimental Technique to Obtain the Dynamic Characteristics of a Structure

Abstract: This paper shows the results of an experimental analysis on the bell tower of “Chiesa della Maddalena” (Mola di Bari, Italy), to better understand the structural behavior of slender masonry structures. The research aims to calibrate a numerical model by means of the Operational Modal Analysis (OMA) method. In this way realistic conclusions about the dynamic behavior of the structure are obtained. The choice of using an OMA derives from the necessity to know the modal parameters of a structure with a non-destructive testing, especially in case of cultural-historical value structures. Therefore by means of an easy and accurate process, it is possible to acquire in-situ environmental vibrations. The data collected are very important to estimate the mode shapes, the natural frequencies and the damping ratios of the structure.

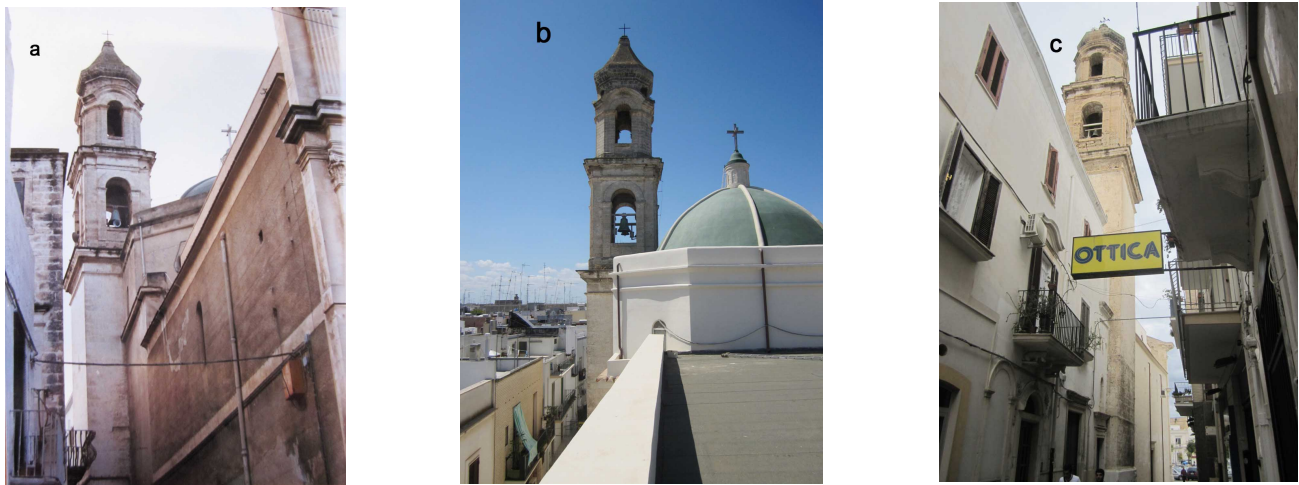
Fig. (1). Bell tower of “Chiesa della Maddalena”: North side (a-b), South Side (c).

The bell tower Fig. (1a, b and c) is built entirely with calcareous tufa, a stone typical of the Apulia region, which should not be confused with tuff, a porous volcanic rock. In fact tufa is a variety of limestone, formed by the precipitation of carbonate minerals from ambient temperature water bodies. It has a white, yellow or red coloration and particular properties like at a high porosity, lightness and toughness. The tufa has high technical characteristics and in particular a good compressive strength.

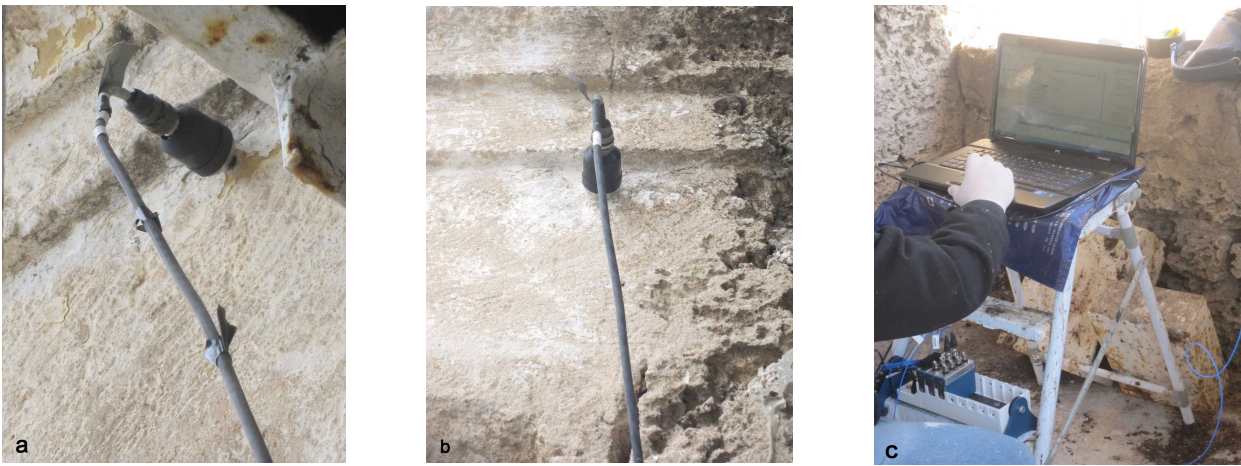
Fig. (5). Accelerometer n°2 (a), Accelerometer n°4 (b), Instrumental system (c).

1. Four piezoelectric accelerometers, with a working range between 0.5 and 2000Hz and a voltage sensitivity, mV/g for both the last two accelerometers Fig. (5a and b);
2. Co-axial cables with low impedance and with a length variable from 4.0 m to 15.0 m;
3. Multi-channel acquisition system (National Instruments- NI 9234), with four simultaneously sampled analog inputs with a ± 5 V input range. It has a maximum sampling rate of 200 kHz pre-channel, 24 bit resolution, 102 dB dynamic range and anti-aliasing filters Fig. (5c);
4. Platform NI Compact DAQ DSA, with eight slots: in each one it is possible to integrate a NI 9234, having the same characteristics.

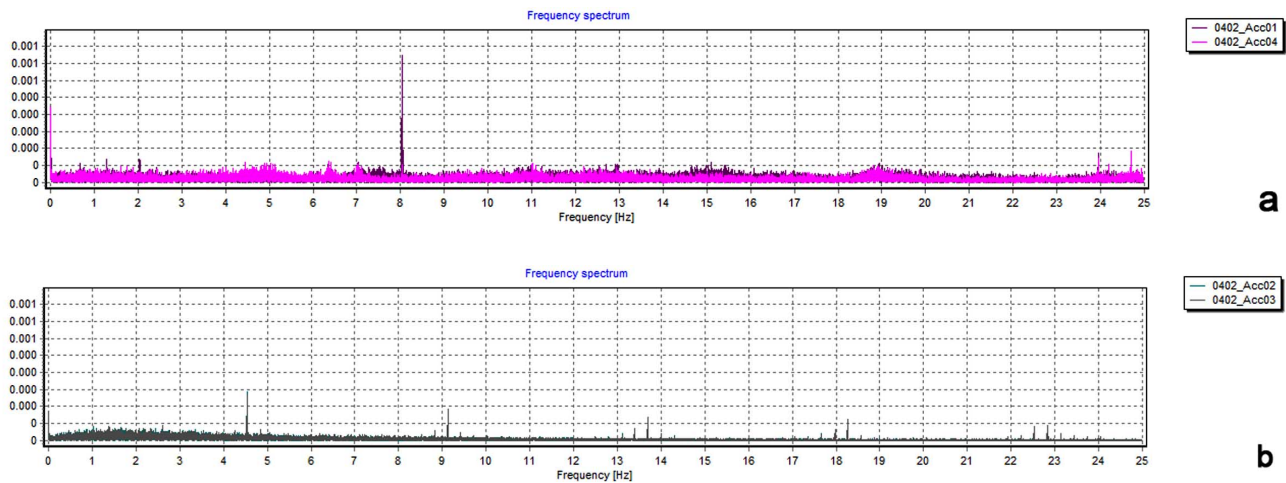
Fig. (7). Power spectrum in the N-S direction (a) and the E-W direction (b) with frequencies in the range [0-25Hz].

From the recordings, using a Fast Fourier Transform (FFT), the frequencies have been obtained together with the power spectral response of the structure in the N-S and E-W directions Fig. (7).

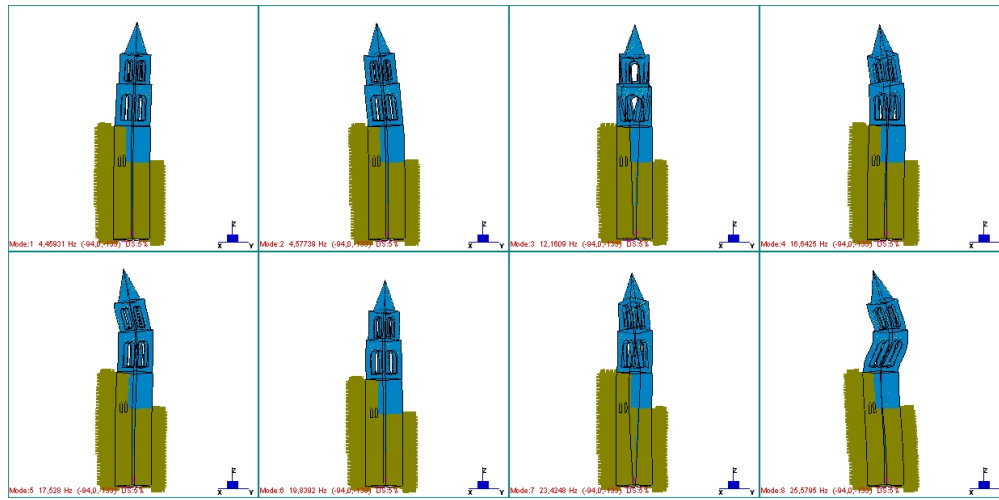
Fig. (9). Modal shapes of vibrations of the Finite element model.

tion. The correlated modal shapes of vibration are shown in Fig. (9).

The first mode corresponds to a bending mode in E-W direction, the second to a bending mode in N-S direction and the third mode is a torsional one.

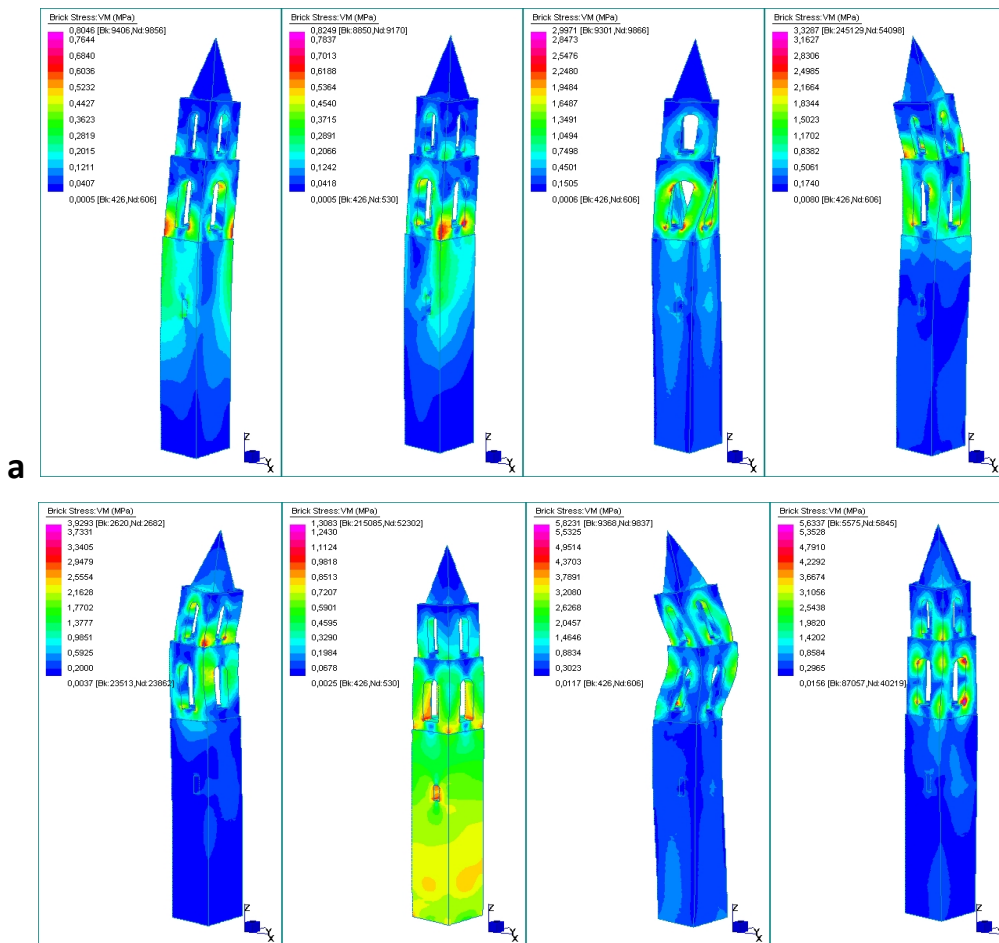
Fig. (10(a-b)). Stresses of the vibration modes from the Finite element model.

Through the model and the analysis of the natural frequencies it is possible to estimate the stress, strains and displacements of the tower. In particular it is useful to understand the stress distribution in the masonry in Figs. (10a and b) with the N-W angulation.
